# COLORADO GEOLOGICAL SURVEY

**Subject: Calwood Fire Emergency**

**Boulder County, CO;  
County Technical Aid Request; CGS Unique No. BO-21-0002**

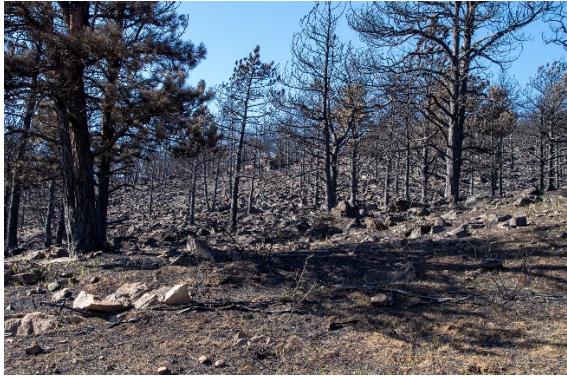
As a rule of thumb, construction or disturbance to slopes as steep as 18-degrees or gradients of 3:1 (the ratio of vertical to horizontal) does not require stabilization or engineering in unconsolidated material that includes a mixture of clay, silt and sand. Long term stability generally requires engineering for unconsolidated material steeper than this. There are important exceptions to this general rule but both subdivisions include large areas steeper than 18 degrees as can be seen in Figure 2. These areas have been significantly disturbed by the fire in terms of the vegetation that helps maintain slope stability. There are boulders, cobbles, and fine-grained soil and ash that are no longer held in place by tree roots and other vegetation. This loose surface material can be seen in pictures 1 and 2.

Picture 1. Loose boulders

Mudflows, mudslides and debris laden flooding are hazards typical of burned forests especially where steep ground occurs such as at these locations. CGS has not evaluated the risk of these hazards but our experience in other recent fires in Colorado and Boulder County indicate a high probability these hazards will impact these subdivisions to some extent especially through the first rain and snow cycles. Exacerbating the problem is hydrophobicity of soils after fires. A hydrophobic soil results from the intense heat and gas being driven into the soil resulting in formation of a waxy substance that expels moisture resulting in an increase in volume of surface runoff. These fire-related hazards are directly related, to varying degrees, to hydrophobic soils, abundant ash and other fine debris, loose boulders and cobbles, downed trees and the slope of the ground. These new hazards are not related to the pre-existing landslide susceptibility of the underlying deposit but are related to the burn horizon at the ground surface. Hydrophobicity can take several years to be reduced naturally to the point where rainfall infiltrates significantly and surface runoff is decreased. The healing process can be helped by soil seeding and other labor-intensive activities that can break up the hydrophobicity of the soil.

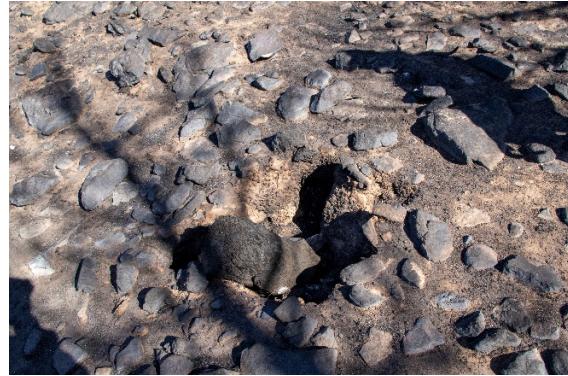
Picture 2. Loose cobbles, ash, and soil.

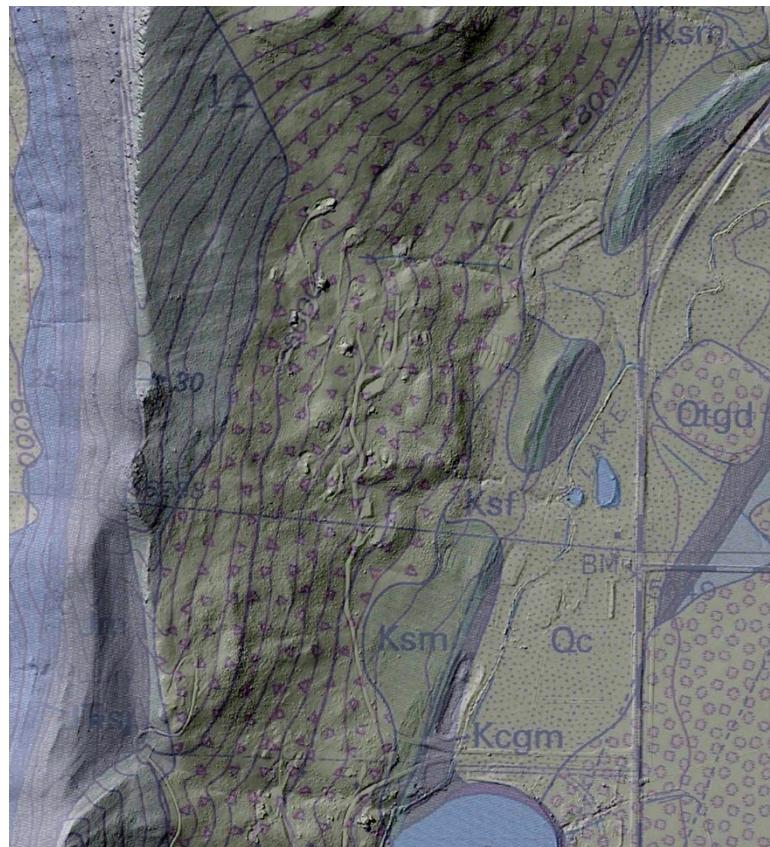
- in landslide susceptibility zones as defined by Boulder County Geologic Hazard mapping; and,
- were constructed in a previous landslide deposit as depicted in the published (1988) geologic map of the Lyons Quadrangle (1:25 000 scale). The geologic map depicting the landslide deposit is overlain on Lidar imaging in Figure 1.

We did not observe any features related to the fire that would indicate any change in the landslide susceptibility at these locations. The geomorphology of the ground has not been significantly altered by the fire event. However, these locations remain susceptible to landslides and the water and grading recommendations by CGS in 1988 (limited irrigation; limited cuts and fills) remain valid.

Our observations indicate the original development made sound decisions about home site locations and associated cuts and fills within the landslide deposit. The extent and depths of cuts and fills are not excessive and do not appear to have created instability in the mapped landslide. We did not observe visible evidence of instability at the ground surface or at house locations. The Lidar image does not reveal active instability. The trees do not indicate soil creep or growth responses to ground movement such as “piston butting” of tree trunks. In our opinion, potential for slope stability has not been altered due to the fire. CGS is not recommending a regional landslide study be conducted now due to the fire.

Figure 1. Lidar hillshade depicting pre-fire home sites overlain by the Geologic Map of the Lyons Quadrangle, USGS GA-1629, published in 1988. Subdivisions are within the landslide area with triangular symbols. The morphology of the landslide feature (hummocky ground) is illuminated by the Lidar image.

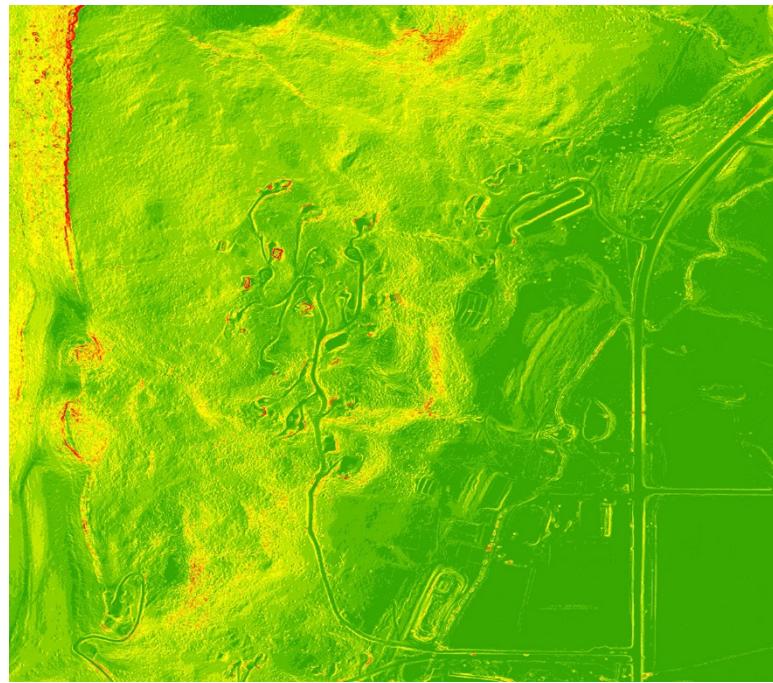
**Fire-related geologic hazards:** There are new geologic based hazards related to the fire that have not been previously mapped in these locations. As a direct result of the fire there is a high probability for mudflows, mudslides and debris laden flooding within the subdivisions at least through the first rain season and possibly as a result of snowfall this winter. We consider the entire area within both subdivisions vulnerable to surface runoff accompanied by mudflows, mudslides and debris laden flooding. It is unknown at what slope angle mudflows and/or mudslides may occur here. Publications by the United States Geological Survey and others (Springer) indicate landslide susceptibility (mudflows and mudslides are a type of landslide) on slopes as low as 10-degrees but these numbers are not specific to mudflows and mudslides at these locations. Figure 2 is a slope map derived from Lidar data showing slope angles in degrees.

Figure 2. Slope map derived from Lidar data. Color legend is based on slope in degrees.
