## CULTURAL RESOURCES EXISTING CONDITIONS MEMORANDUM

**Subject:** Boulder County TO 3 Fourmile Canyon Drive, Cultural Resources Existing Conditions Memorandum

The Fourmile Canyon Drive Flood Recovery Project is located along Fourmile Canyon Drive (CR 118) between Salina Junction and Boulder Canyon Drive (SH 119) approximately 2.5 miles west of Boulder, Colorado. This project is part of the permanent repair work being performed by Boulder County in response to flood events that occurred in September 2013. The Fourmile Canyon Drive Project is approximately 5-miles long, and is located in a narrow mountain valley characterized by residential development along the Fourmile Creek Basin. Prior to the September 2013 floods, Fourmile Canyon Drive was a 20-foot-wide paved roadway.

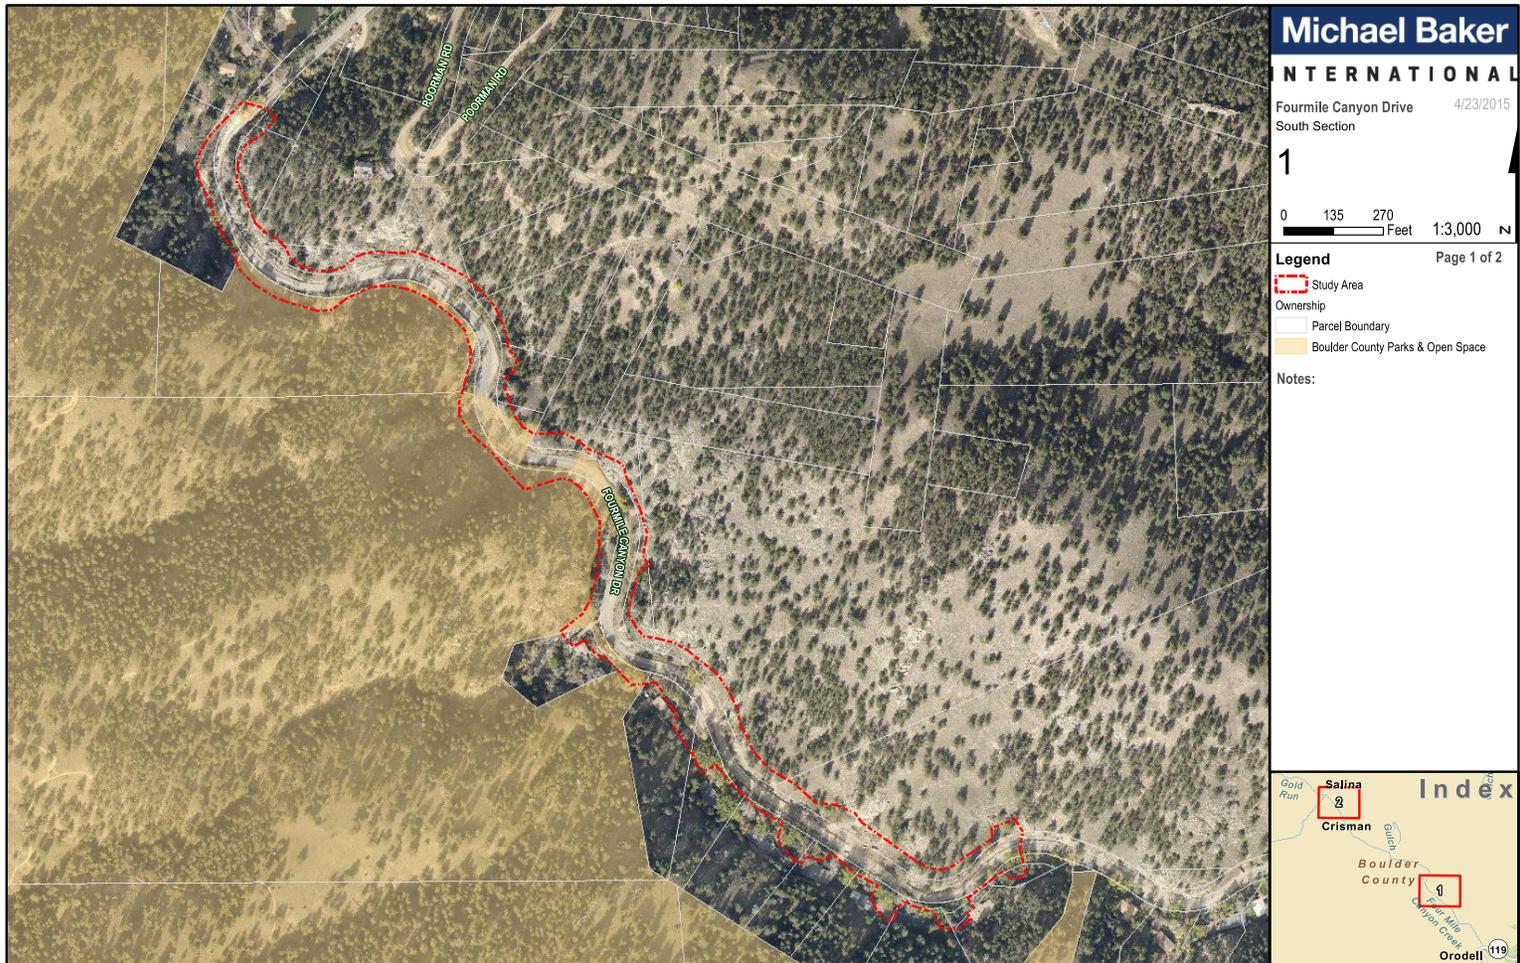
**Figure I APE South**

- **Fourmile Canyon South (Figure 1)** The Fourmile Canyon South section starts a mile north of Boulder Canyon Road and extends northwest approximately 3,600 feet to Poorman Road. Temporary easements and any Right-of-Way acquisitions have not been identified at this time.
- **Fourmile Canyon North (Figure 2)** The Fourmile Canyon North section starts just south of Salina Junction and extends approximately 3,300 feet southeast. Temporary easements and any Right-of-Way acquisitions have not been identified at this time.

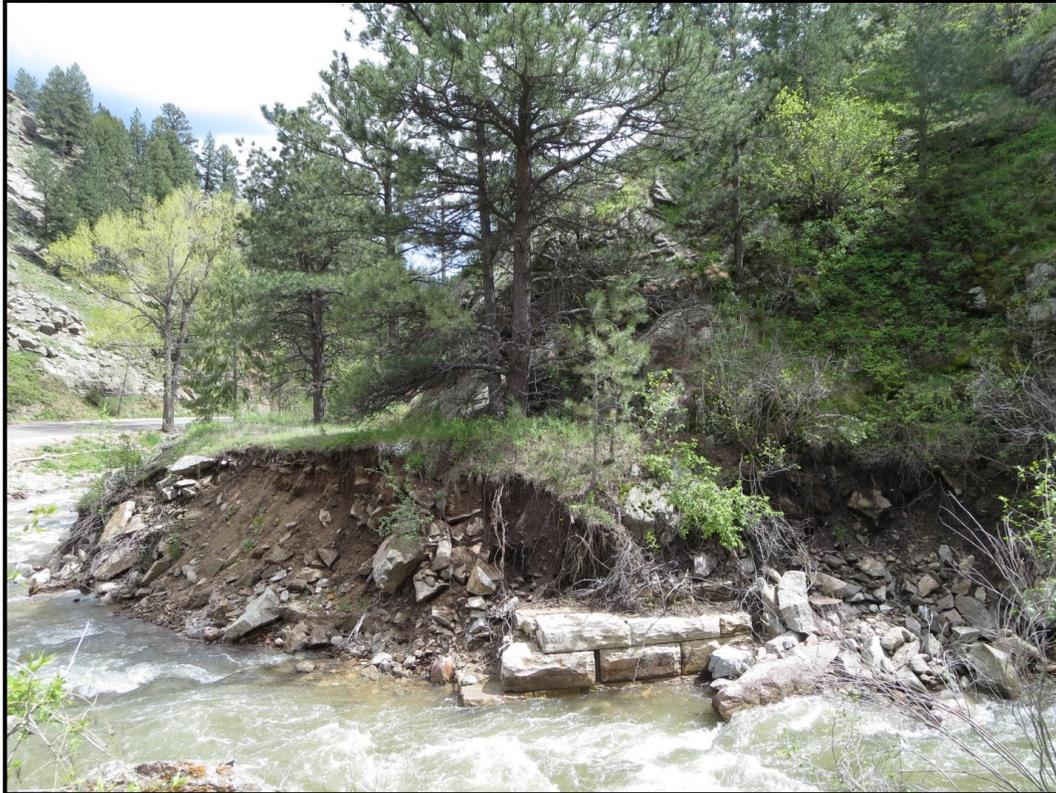
Pinyon Historian Liz Walker visited the area on May 21, 2015, and observed possible evidence of the Switzerland Trail Railroad near the north end of the southern section of the APE (Figure 3). However, it was located on the opposite side of the creek, and not accessible by foot. If this site will be impacted, a linear component site form will need to be completed to determine the railroad bed's eligibility.

**Figure 3:** Possible remnants of the Switzerland Trail Railroad grade on the west side of the creek, near the north end of the South APE.

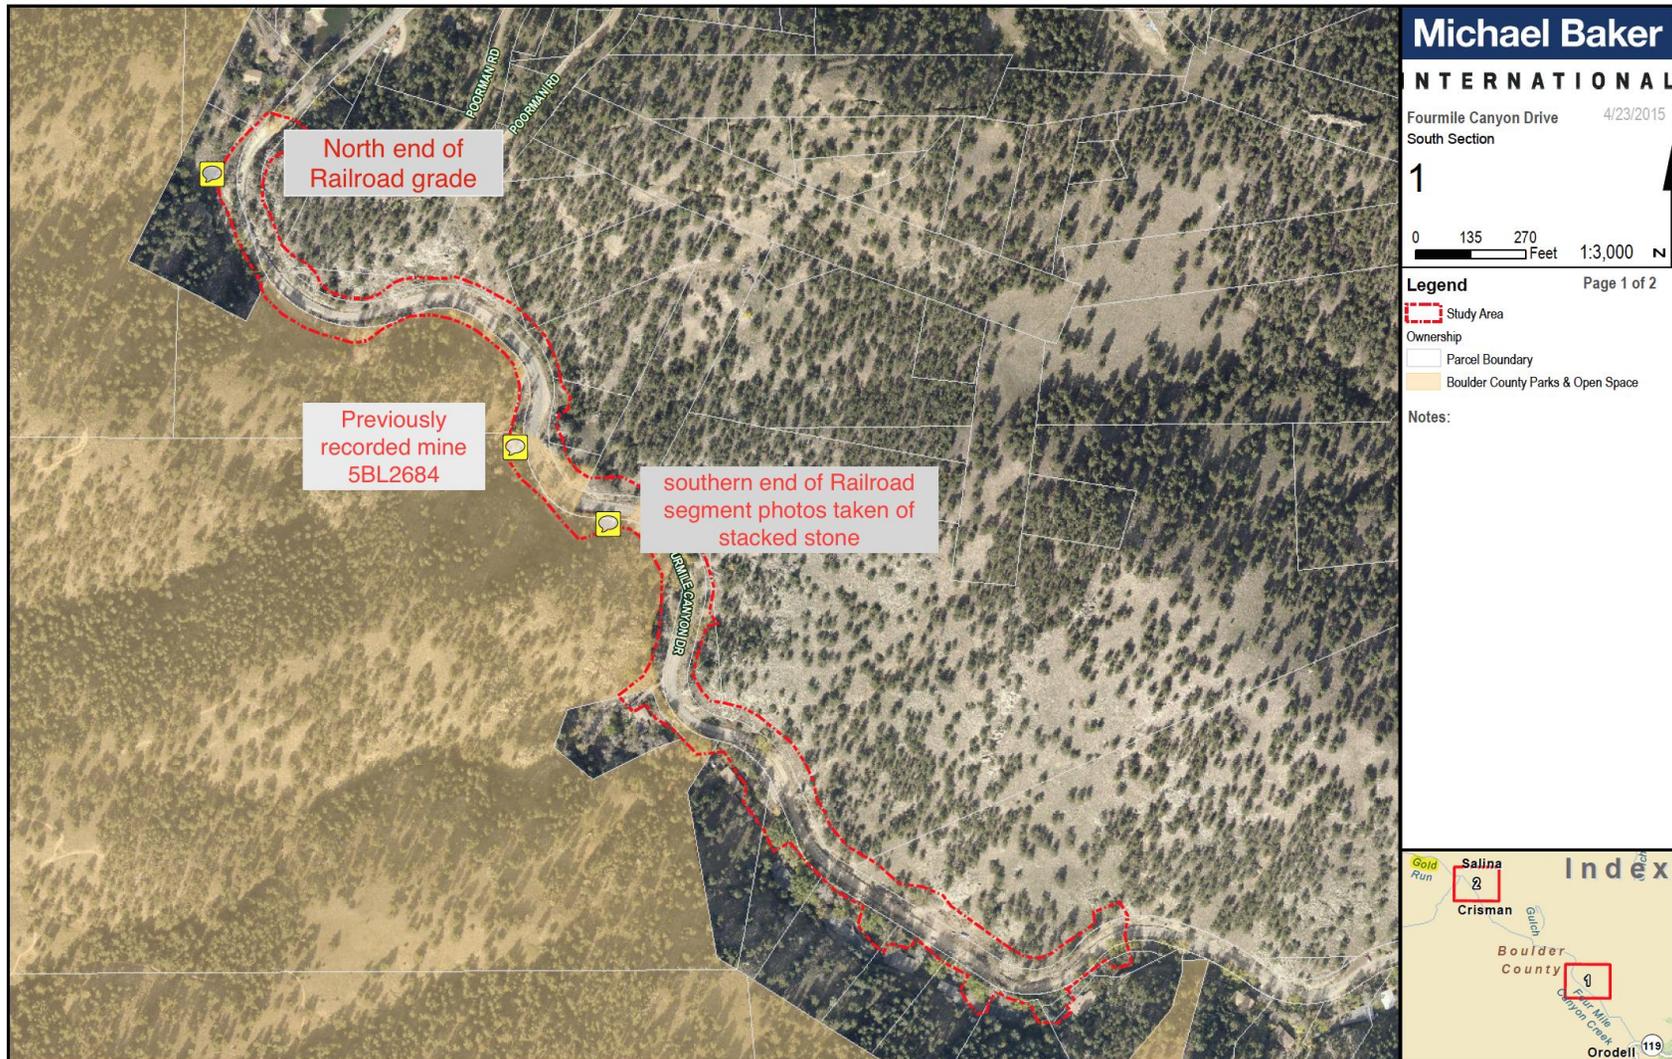
Figure 4 South end with comments of archeological sites

A capped mine adit was encountered within 20 feet of Fourmile Canyon Drive on the east side of the road and approximately 390 feet from the Fourmile and Gold Run intersection (See Figure 4 for location of the adit and Figure 6 for a photo of the adit). This adit is unrecorded and within the APE, so if construction will impact it, it should be recorded and a National Register of Historic Places (NRHP) recommendation should be made prior to any earth-moving activities.

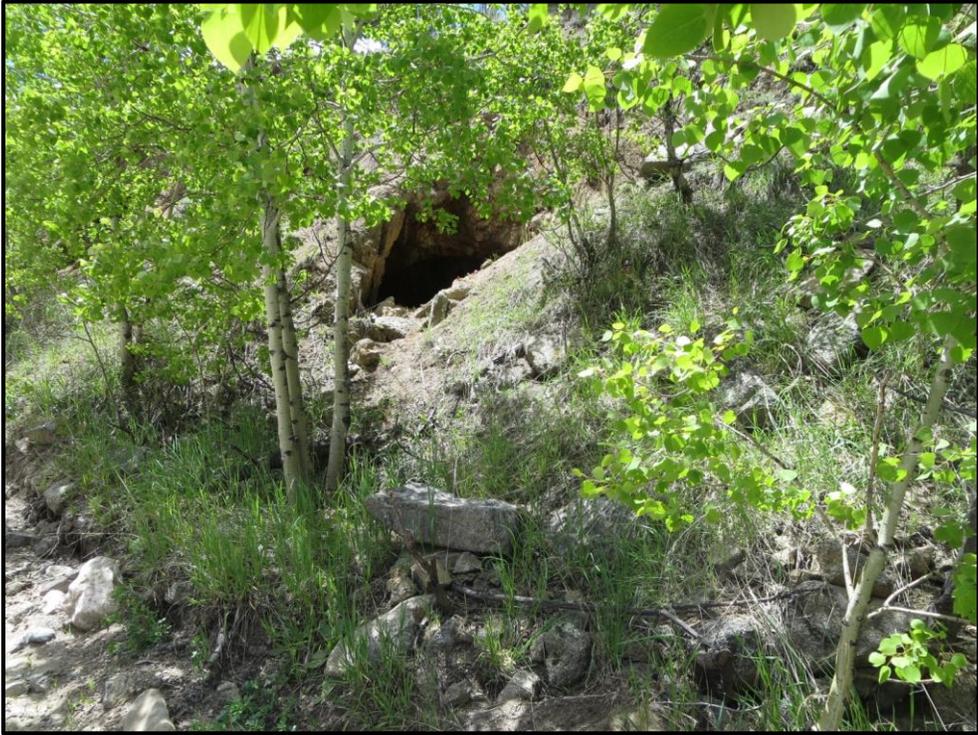
**Figure 6:** The adit adjacent to and north of Fourmile Canyon Drive in the North APE. View is to the west.

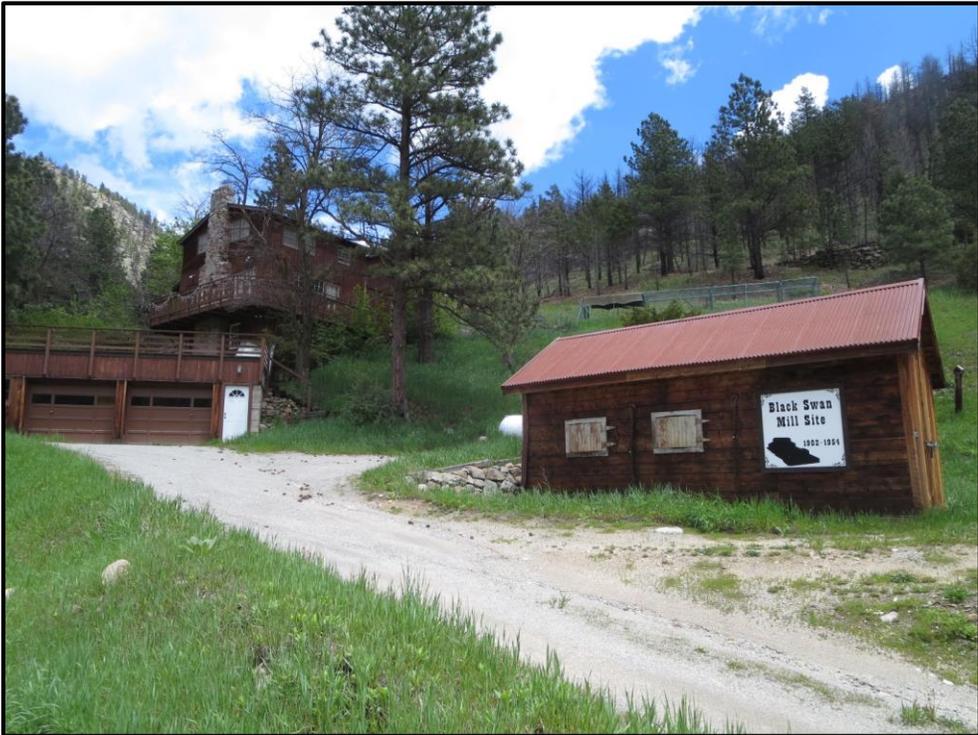
The remains of the Black Swan Mill is also on the east side of the road, further south near the middle of the North APE (Figure 6). The site is located at 4472 Fourmile Canyon Drive, which is also the location of a historic house identified in the Boulder County Assessor Search Results (Figures 7-8). The Mill was operational from 1902 through 1954. The remains of the mill site (stone walls near the APE and possible remnants of foundations further east and outside of the APE) that could be seen from the road are likely outside of the APE, and no obvious artifacts or features were seen near the road. The site was not formally surveyed for archaeological artifacts and features, as this was a reconnaissance survey only. If the project may impact this historic property and site, the site should be recorded and a NRHP recommendation should be made prior to earth-moving activities.

**Figure 7:** The historic house at 4472 Fourmile Canyon Drive in the North APE. This is also the location of the Black Swan Mill. View is to the northeast.

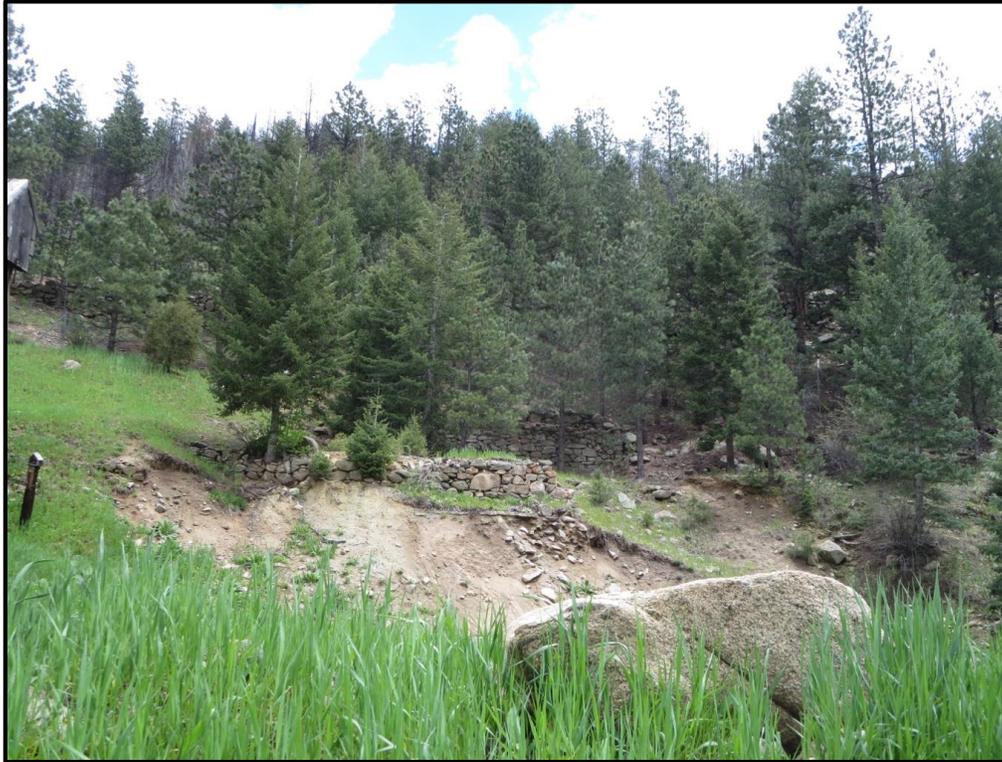
**Figure 8:** The mill site remains at 4472 Fourmile Canyon Drive in the North APE. View is to the east.

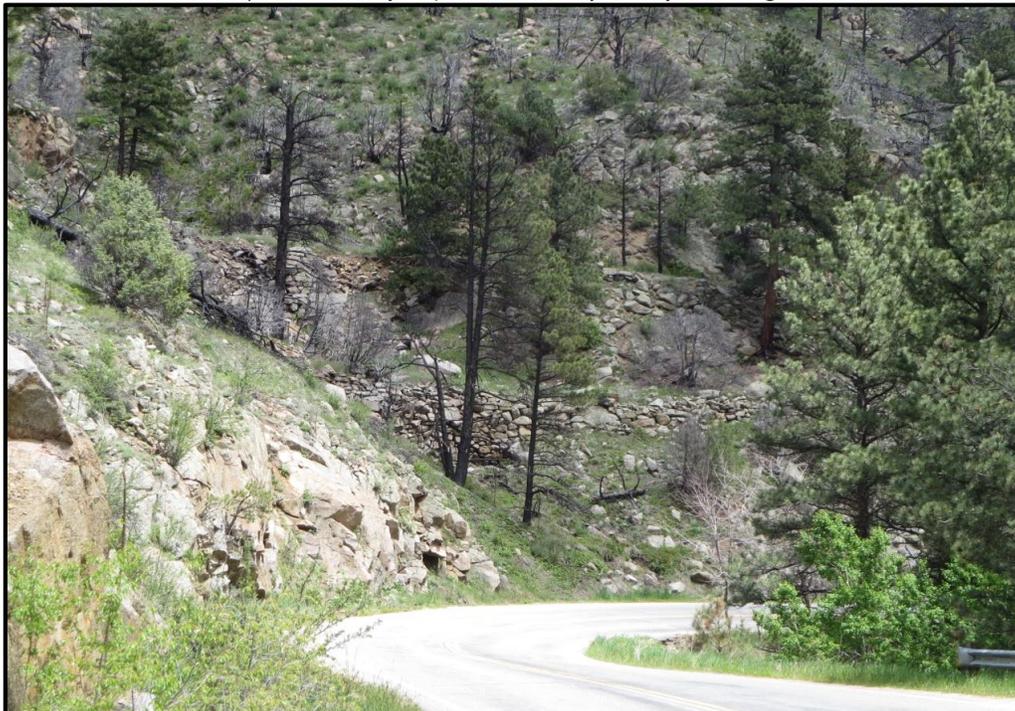
At the far south end of the North APE, also on the east side of the road, there are a series of erosion-preventing stacked rock walls that appear to be the base of historic roadways, or areas where there may have been historic buildings or features (Figure 9). These walls are currently unrecorded. The upper (northern) walls are outside the APE, but the lower wall may abut the APE. It seems unlikely that the proposed work within the canyon will have a direct impact on the walls since they are high up the hill slope above the road, on the opposite side of road from the creek. If the walls are avoided and construction will have no impact on them, then no further work is necessary. If there is a chance that work will damage the walls, then they should be recorded and a NRHP recommendation should be made prior to earth moving activities.

**Figure 9:** Rock walls at the southern terminus of the North APE. The walls are north of the road (the opposite side from the creek) immediately adjacent to and possibly abutting the APE. View is to the ENE.
