**TO:** Dan DeLange, Boulder County  
**FROM:** Tamara Keefe, Michael Baker International  
**DATE:** May 13, 2015  
**SUBJECT:** Fourmile Canyon Drive (Task Order 3) Wildlife and Tree Memorandum

## 1.0 Introduction

## 2.0 Project Description

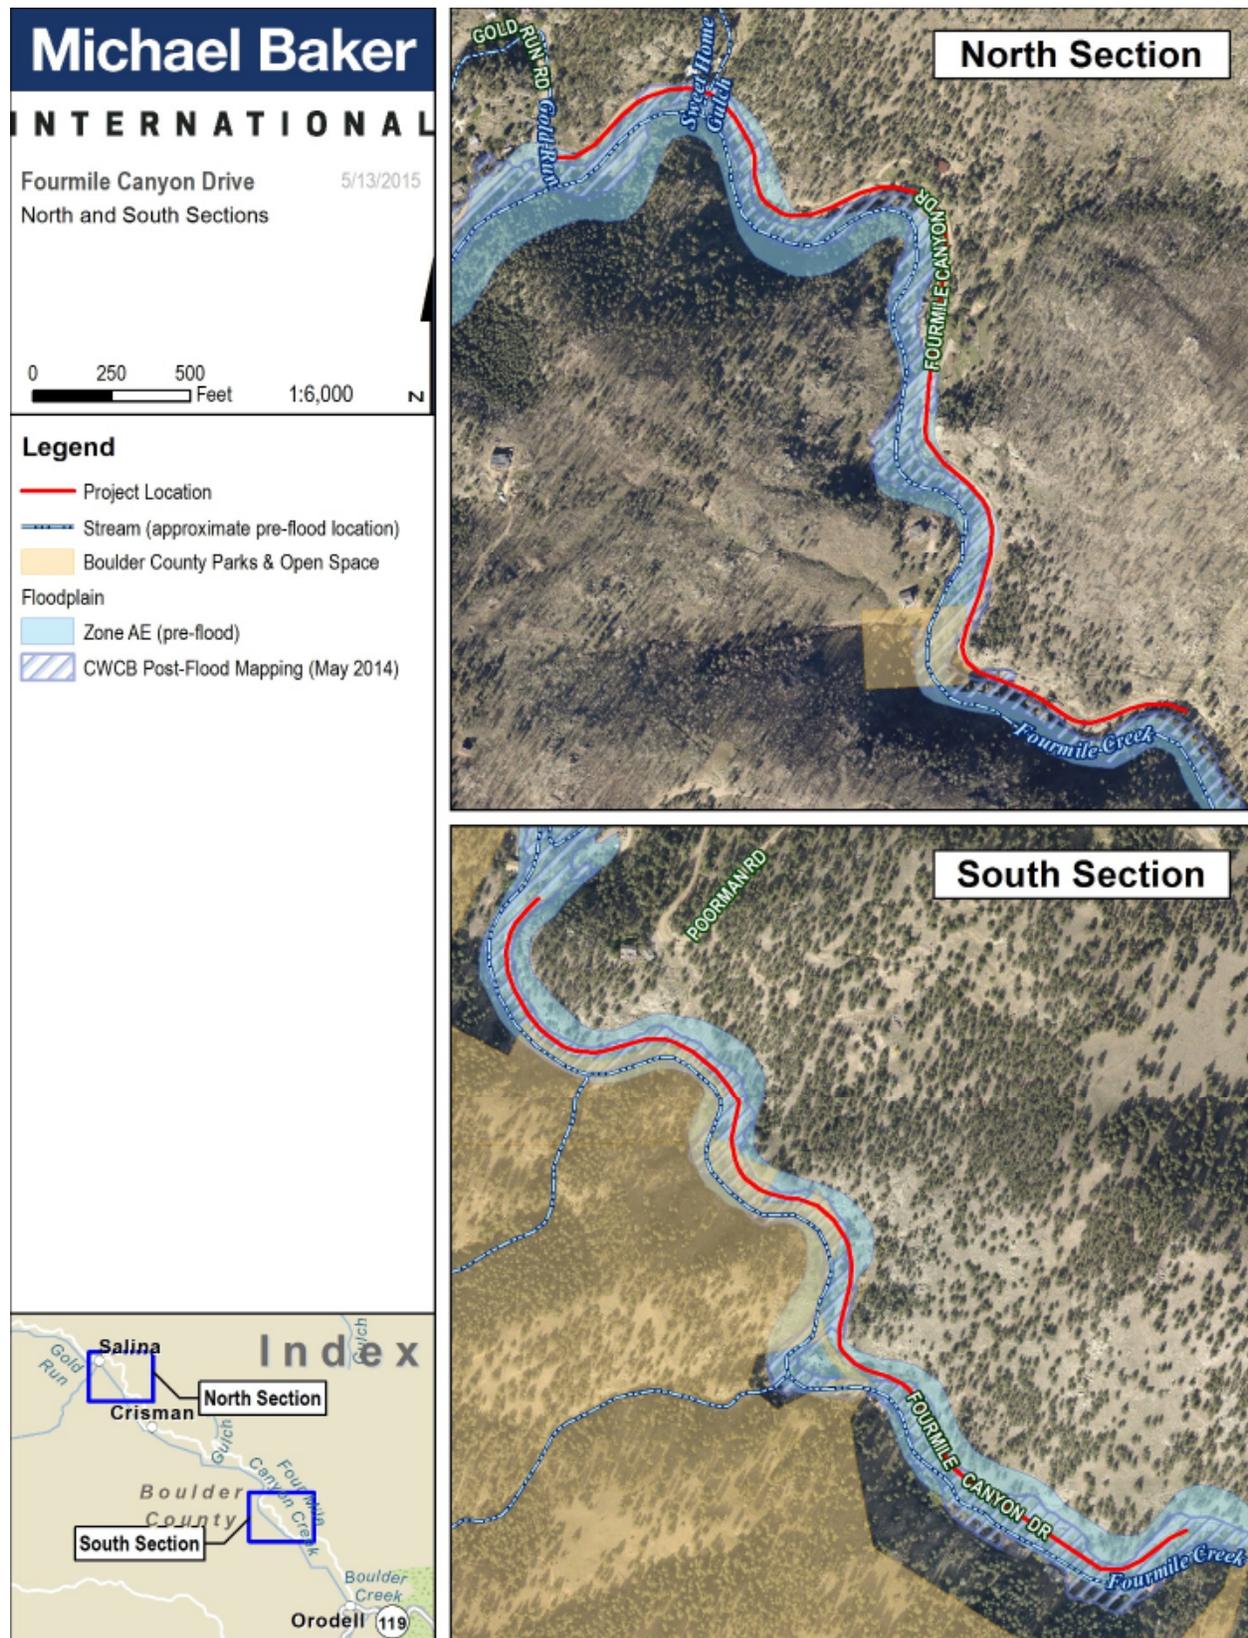
Figure 2: North and South Sections

The purpose of this project is to permanently improve the roadway and drainage in the Fourmile Canyon Drive area. Boulder County has identified two sections of Fourmile Canyon Drive that need permanent repairs, identified as the “North” and “South” sections (see **Figure 2**). The Fourmile North section starts just south of Salina Junction and extends approximately 3,300 feet southeast. The Fourmile South section starts a mile north of Boulder Canyon Road and extends northwest approximately 3,600 feet to Poorman Road. The proposed project would include a 27-foot wide typical section consisting of a 4-foot bikeable uphill shoulder, two 11-foot lanes, a 1-foot downhill shoulder, and a drainage system which includes drainage inlets, manholes, roadside ditches, offsite ditches, storm drain pipe, riprap and energy dissipaters.

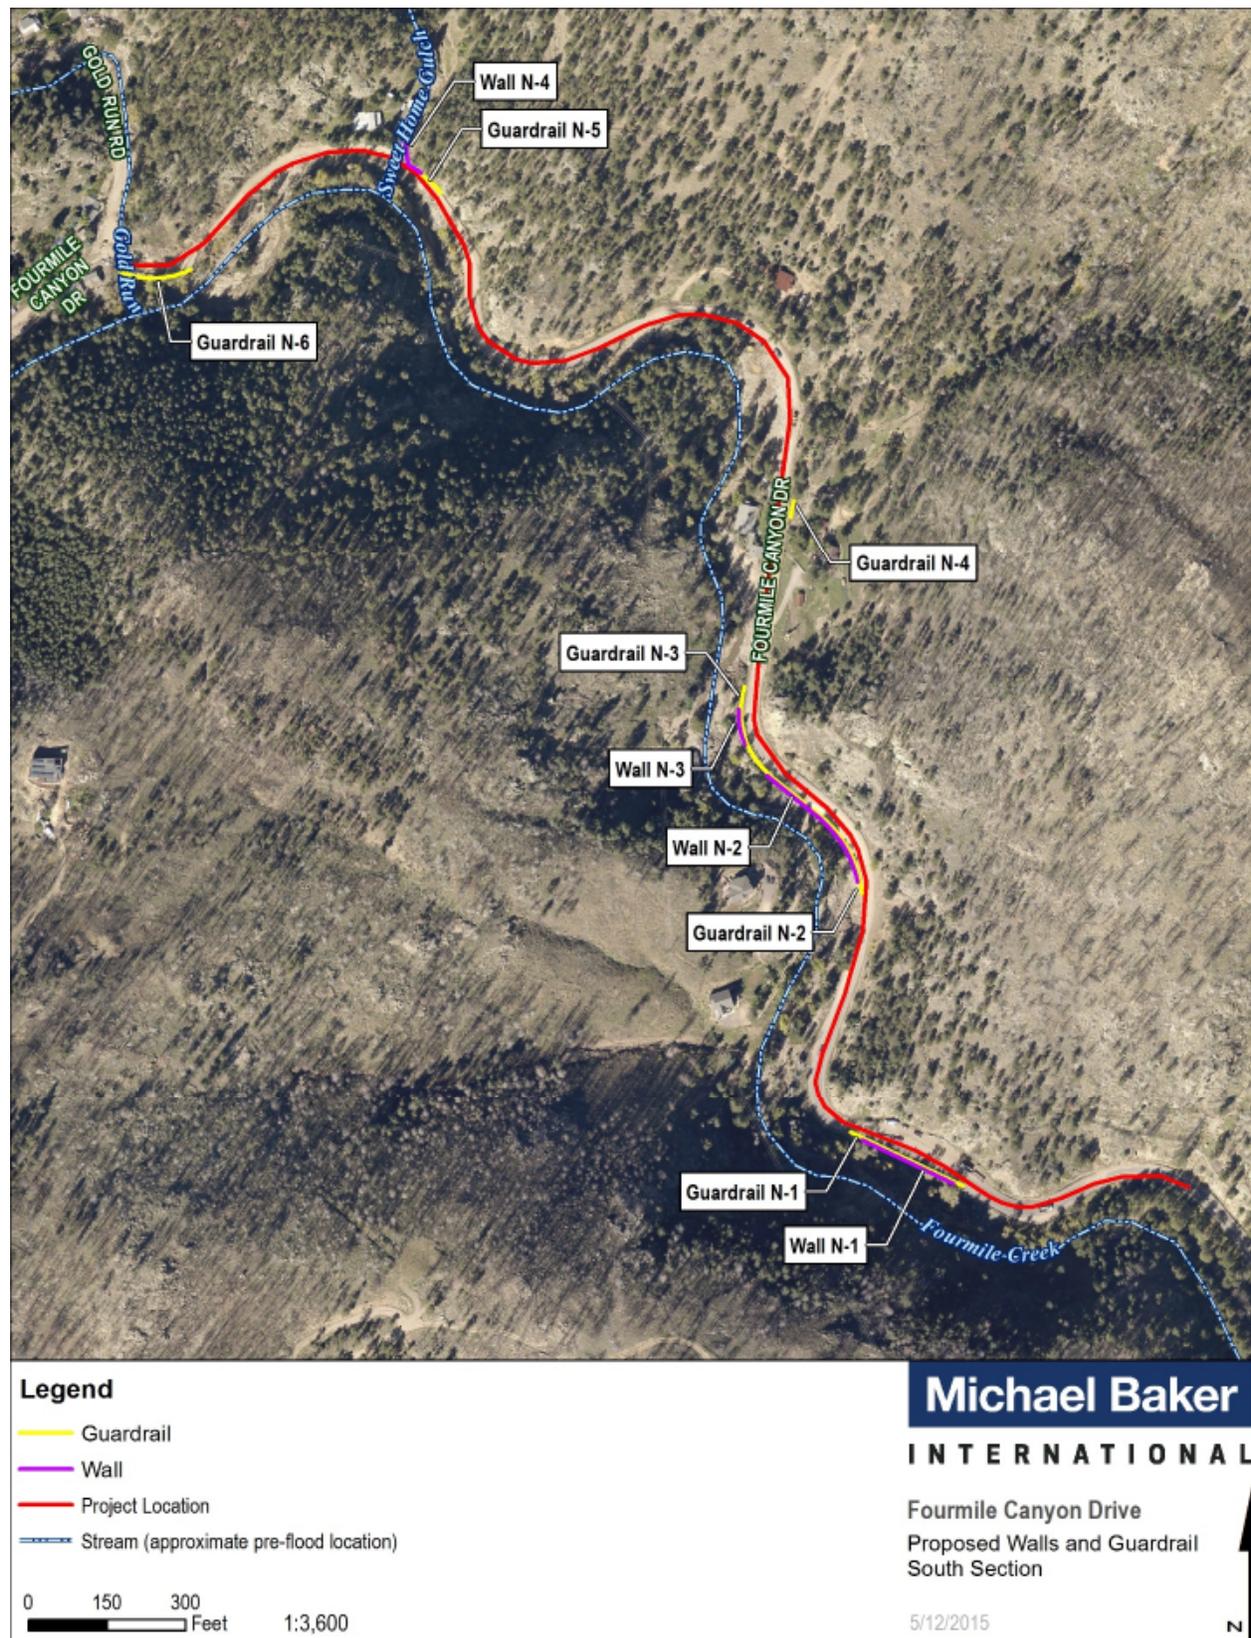
Figure 3: Proposed Walls and Guardrail Locations in North Section

**Table 1** and **Table 2** lists the walls and guardrails for each section of the proposed project. **Figure 3** and **Figure 4** shows the location of the walls and guardrail.

Section	Name	Approximate Length	Approximate Wall Height Range
North	Wall N-1	192 ft	6 ft – 17 ft
	Wall N-2	273 ft	5 ft – 16 ft
	Wall N-3	68 ft	4 ft – 7 ft
	Wall N-4	71 ft	4 ft – 14 ft
South	Wall S-1	191 ft	3 ft – 12 ft
	Wall S-2	232 ft	3 ft – 6 ft

Section	Name	Approximate Length
North	Guardrail N-1	238 ft
	Guardrail N-2	295 ft
	Guardrail N-3	374 ft
	Guardrail N-4	32 ft
	Guardrail N-5	53 ft
	Guardrail N-6	138 ft
South	Guardrail S-1	240 ft
	Guardrail S-2	275 ft

The proposed project is along an existing roadway; however retaining walls will be constructed adjacent to the roadway, which would present a new barrier to wildlife movement. Effects to wildlife include possible disturbance to normal travel patterns as a result of retaining walls. Wall lengths vary upon location from 68 to 273 ft. The purpose of the new walls is to protect private property and to avoid placing fill into the stream.

The guardrail was limited as much as possible; however, there are areas where it is required for safety. The current typical section provides 3 feet between the edge of pavement and the face of the guardrail on the creek side.

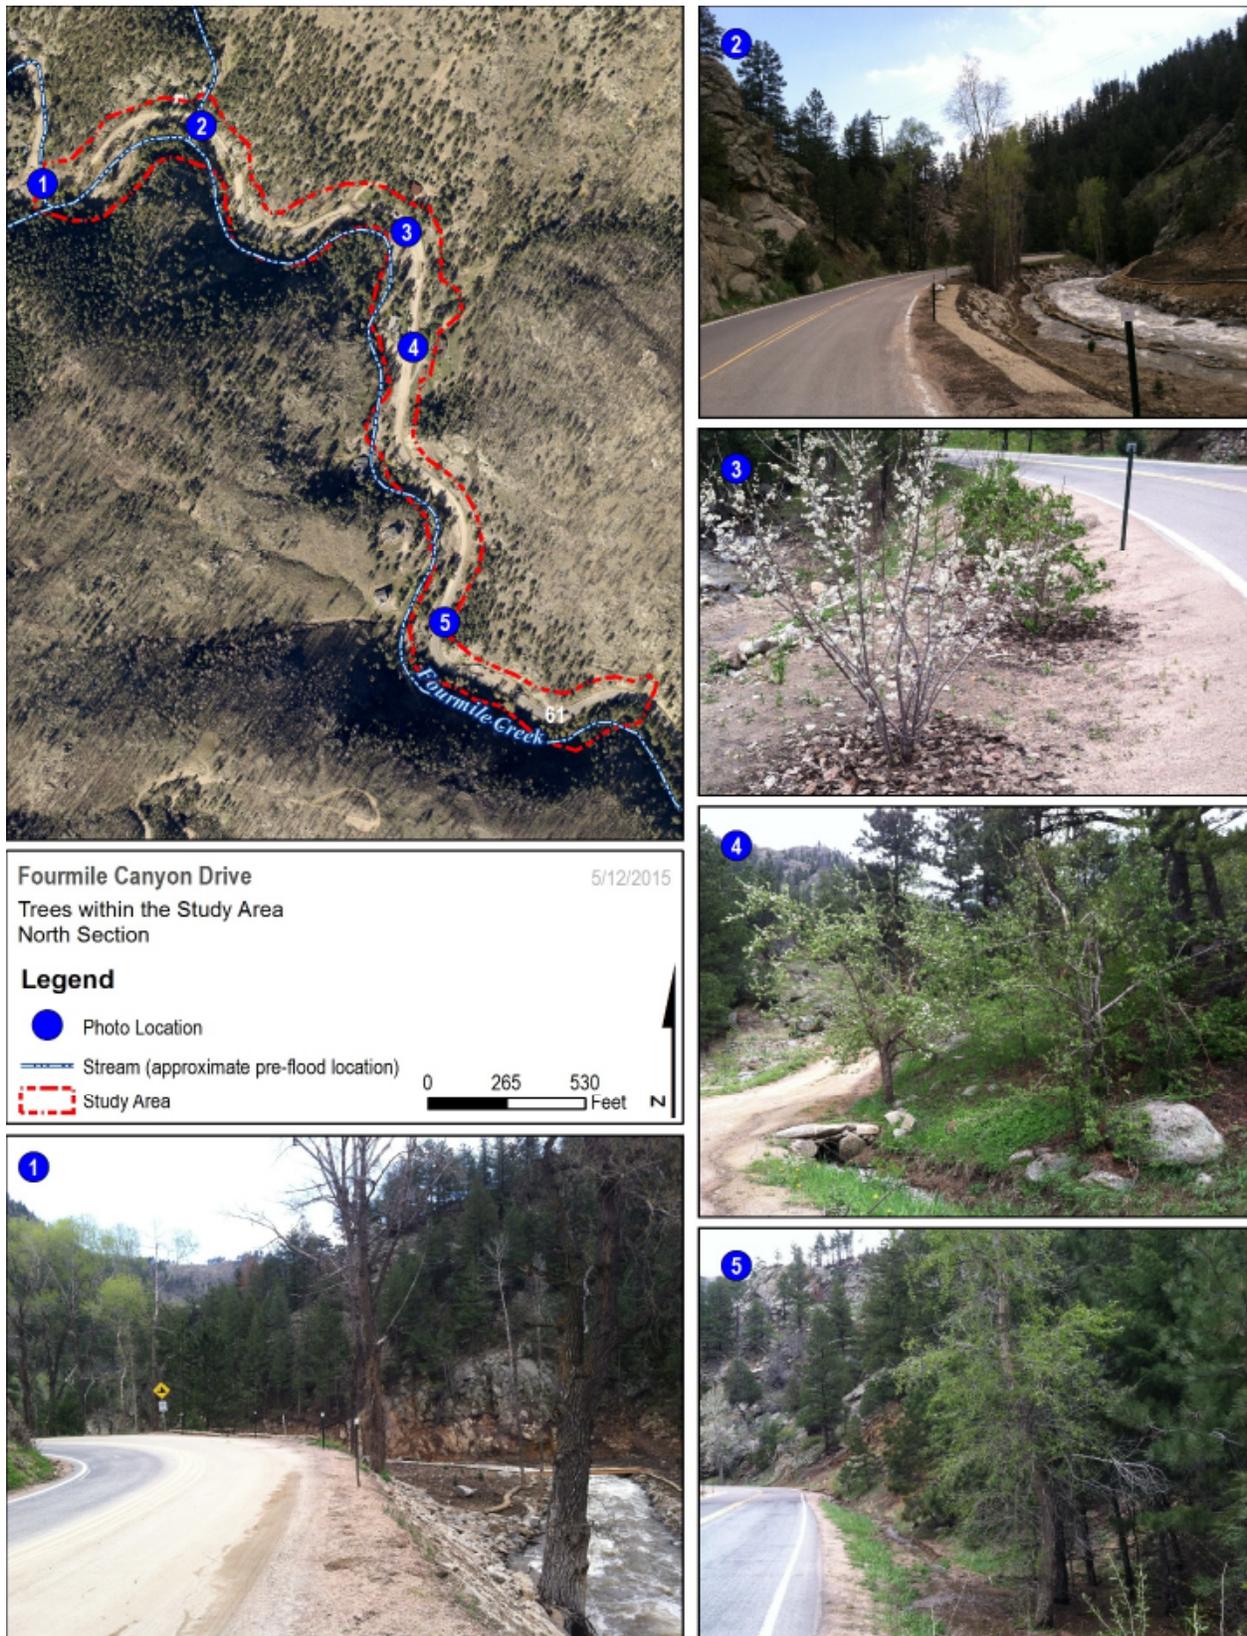
Figure 5: North Section Typical Tree Photos

The vegetation present is typical for a mountain terrain habitat. Elevations within the project area range from 5,863 ft to 6,637 ft. Dominant trees within the project area include Ponderosa pine (*Pinus ponderosa*) and Douglas fir (*Pseudotsuga menziesii*) with some aspen (*Populus tremuloides*), narrowleaf cottonwood (*Populus angustifolia*), Siberian elm (*Ulmus pumila*), Rocky Mountain juniper (*Juniperus scopulorum*), and several species of willow (*Salix* sp.). Trees near private residences also included apple trees (*Malus pumila*), choke cherry (*Prunus virginiana*), Lilac (*Syringa* sp.), wild plum (*Prunus Americana*), and Russian olive (*Elaeagnus angustifolia*). See **Figure 5** and **Figure 6** for typical trees within the study area.
