# Preliminary Basis of Design Report

## For South St. Vrain Creek Restoration at Hall Ranch

**Boulder County, Colorado**

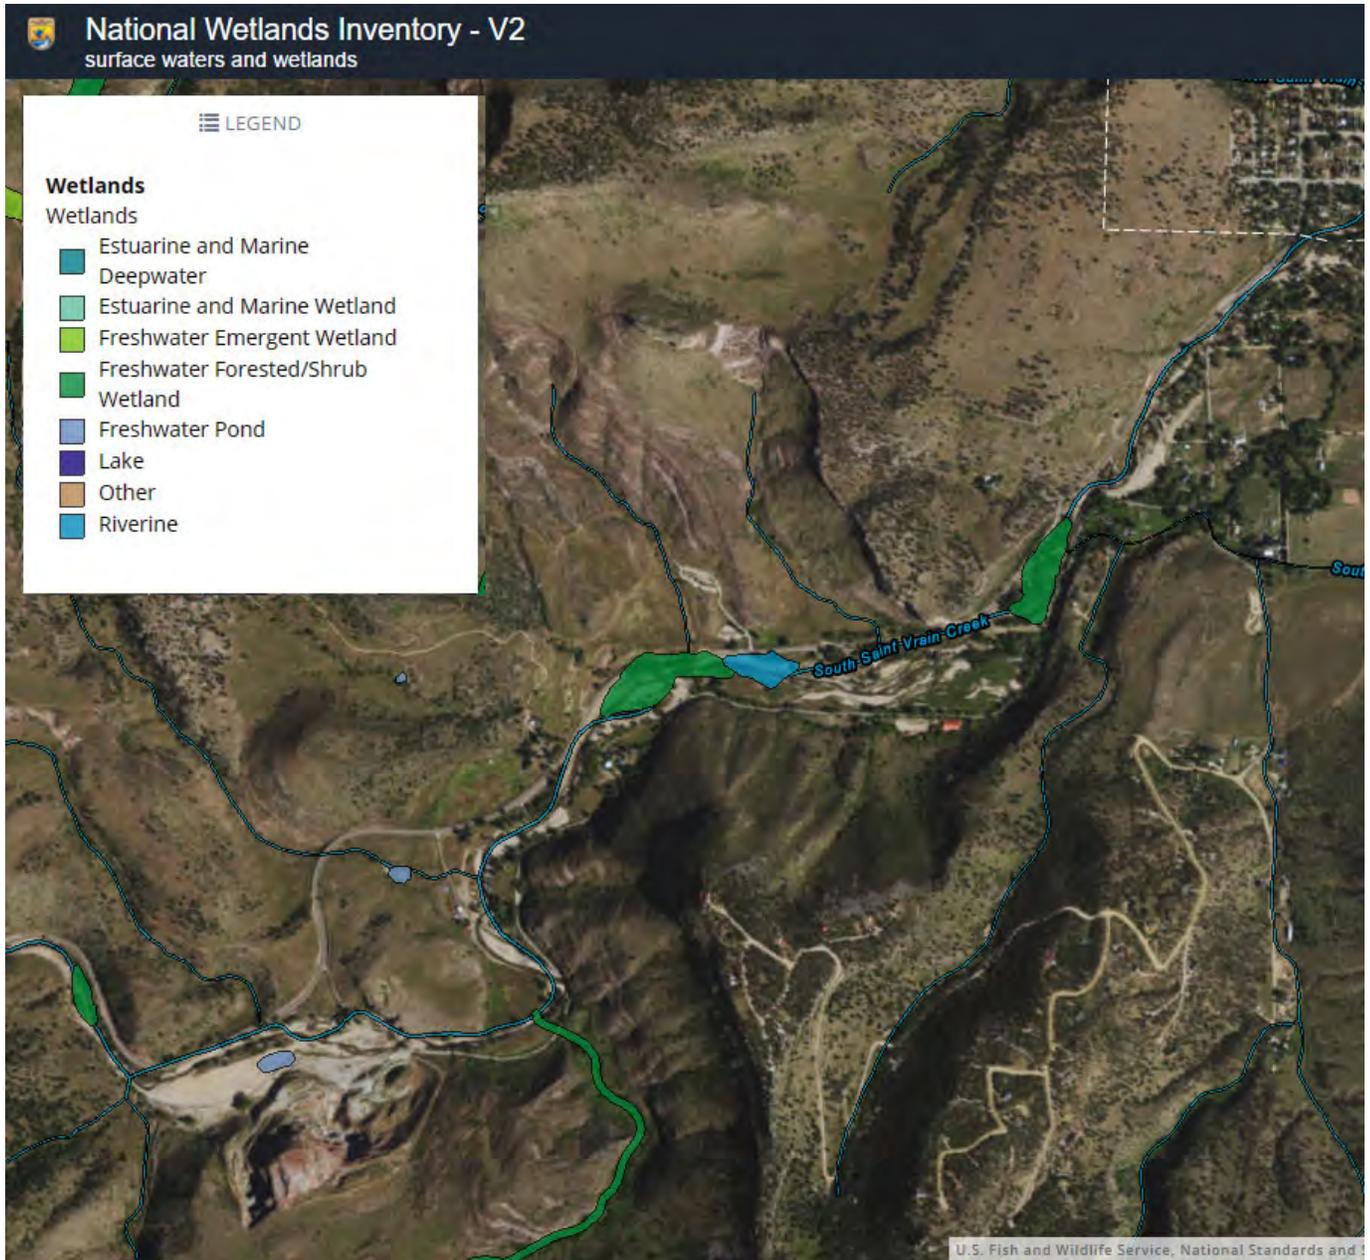
Figure 4. National Wetlands Inventory Map of existing Wetlands found on site, 2009

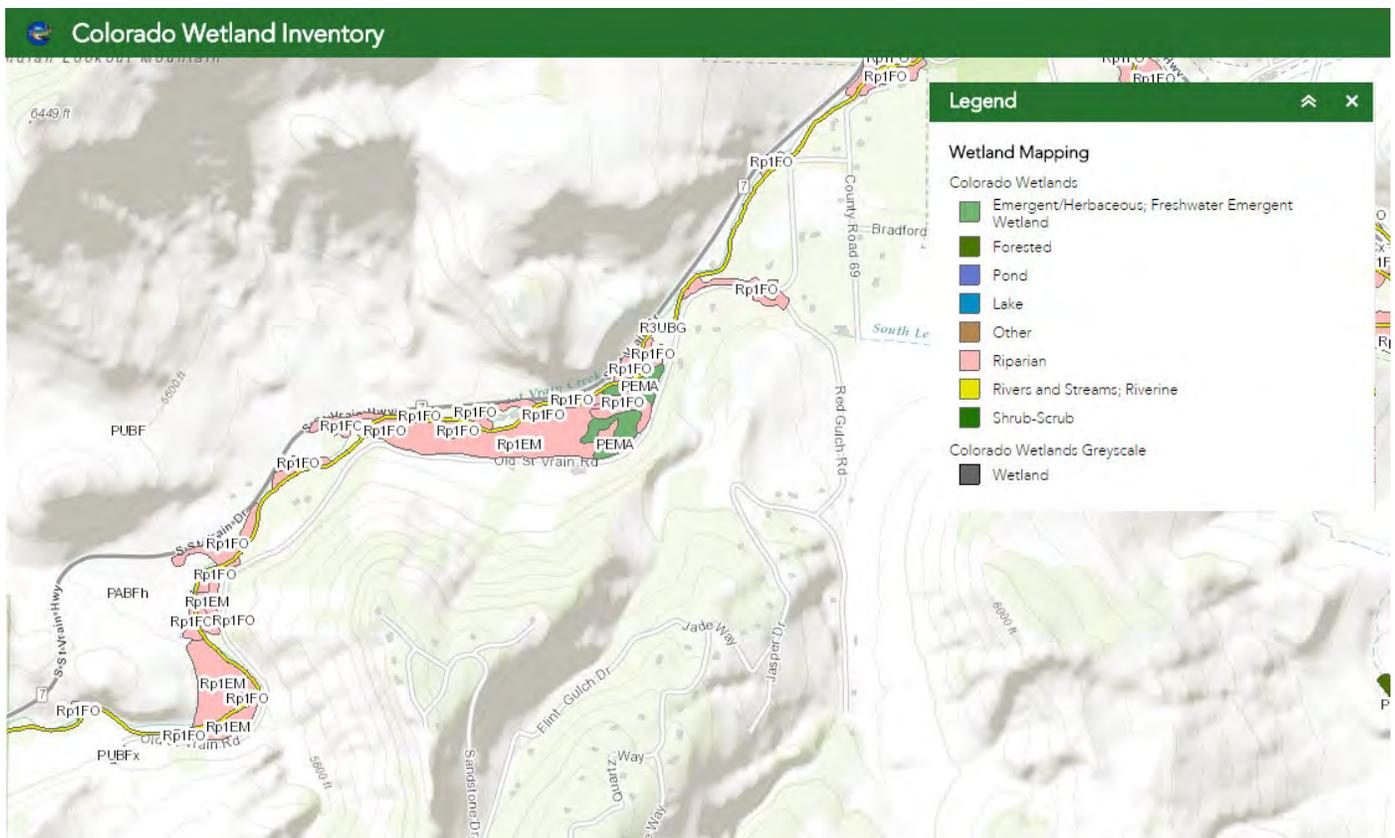
Additional information provided by CNHP shows riparian plant communities which occur alongside existing wetlands as seen in Figure 5, and provides locations of plant community sub categories which include:

- Rp1FO – Riparian Lotic Forested
- Rp1EM – Riparian Lotic Emergent
- PEMA - Palustrine, Emergent / Herbaceous, Temporarily Flooded

Figure 5. CNHP Colorado Wetland Inventory Map of existing Riparian Communities within the wetland area, 2009.

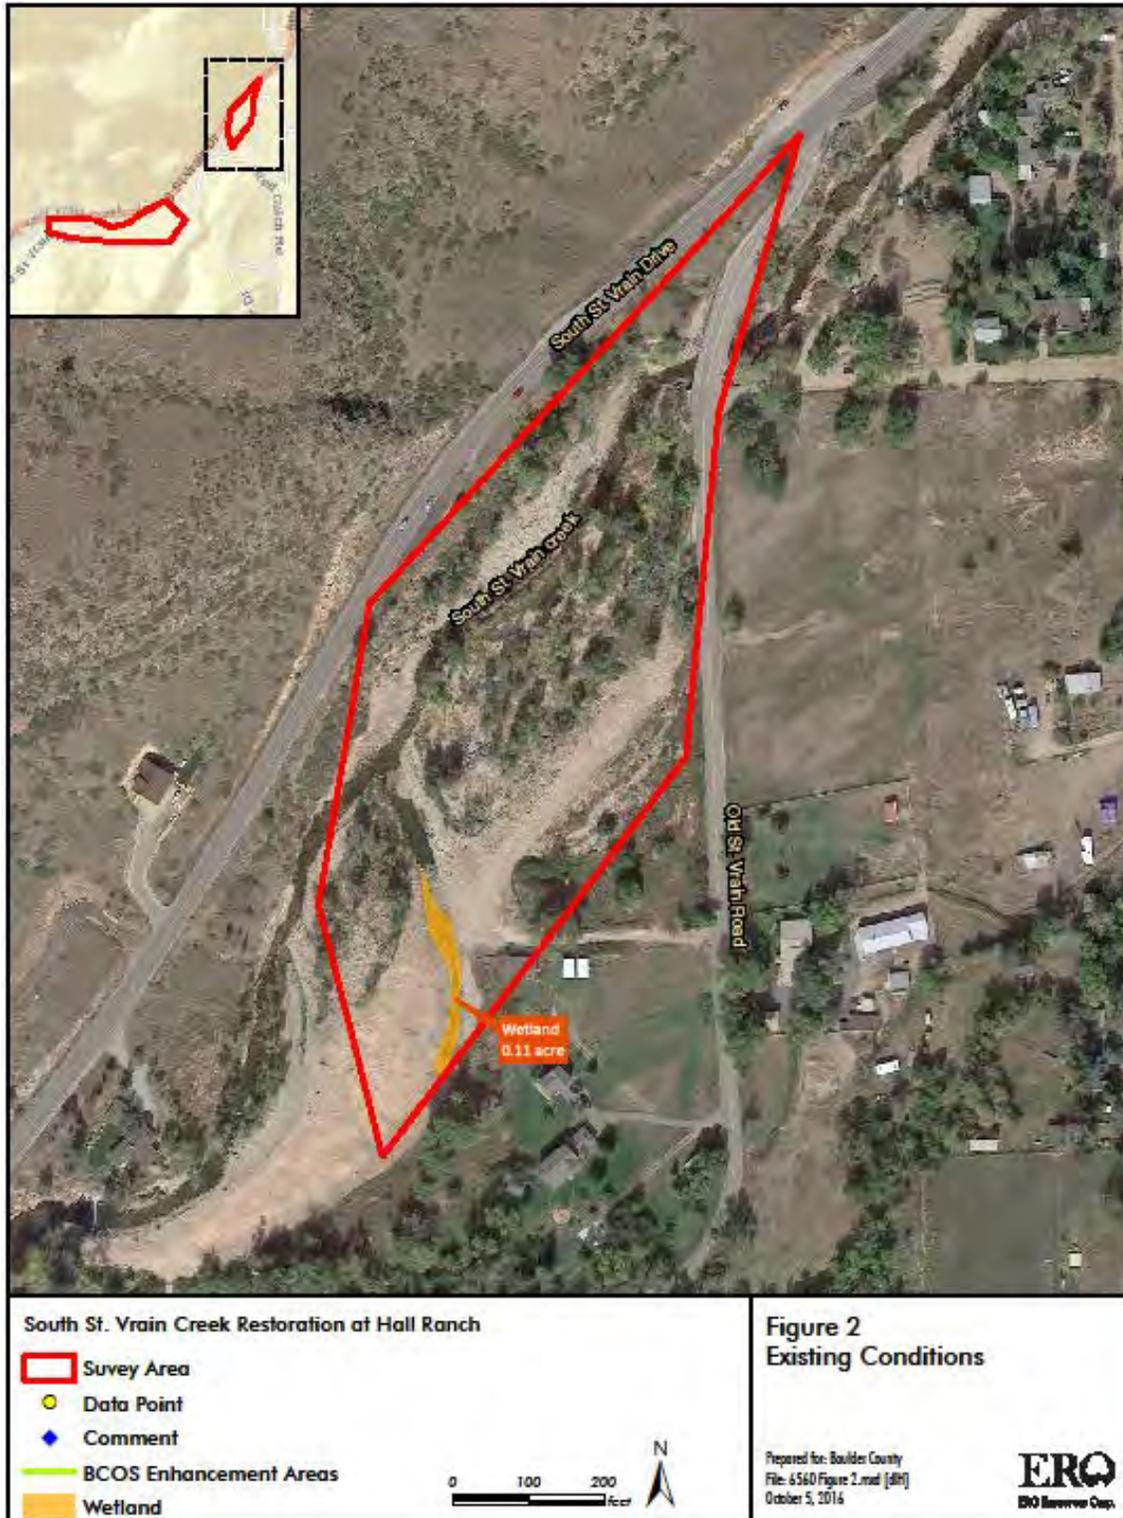
Figure 7. Wetland Delineation: EWP #2

A wetland delineation was conducted for portions of the project area on August 1, 2016. Wetlands consist of palustrine emergent wetland dominated largely by sedges and grasses. Wetland delineation data has been provided to the County. Mapping on the following two pages represent the results of the onsite assessment. Additional information is in Appendix M – Wetland Delineation.

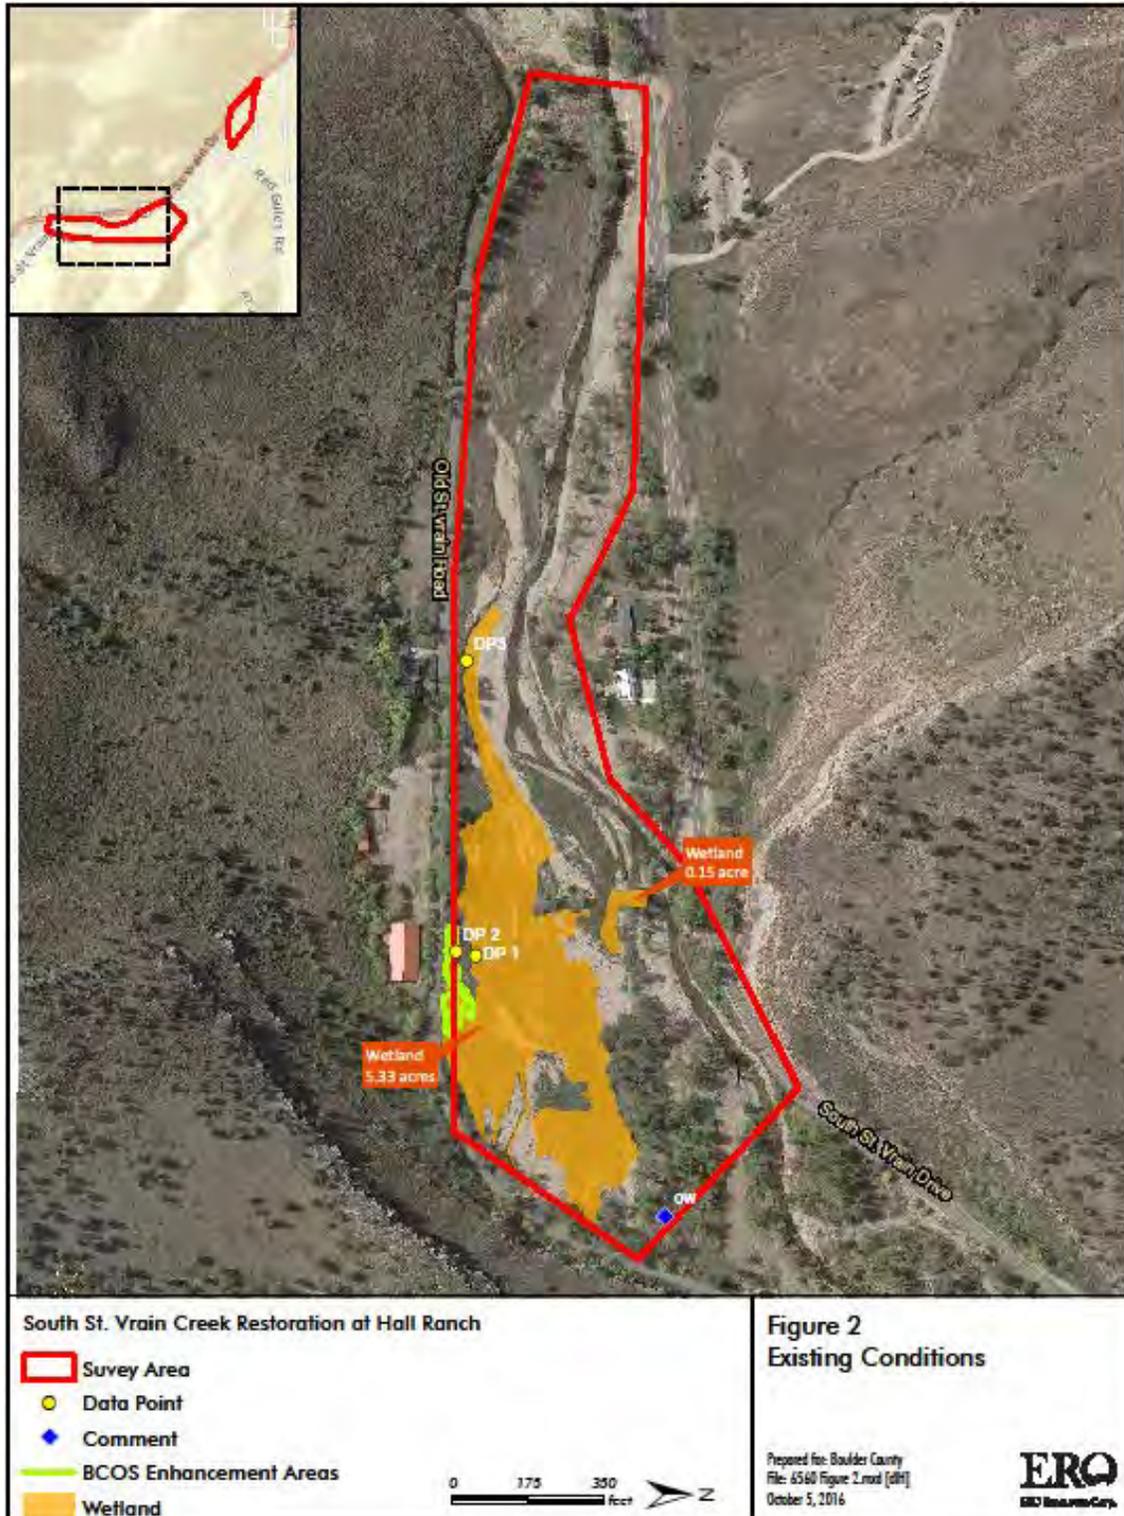
Figure 8. Wetland Delineation: EWP #1

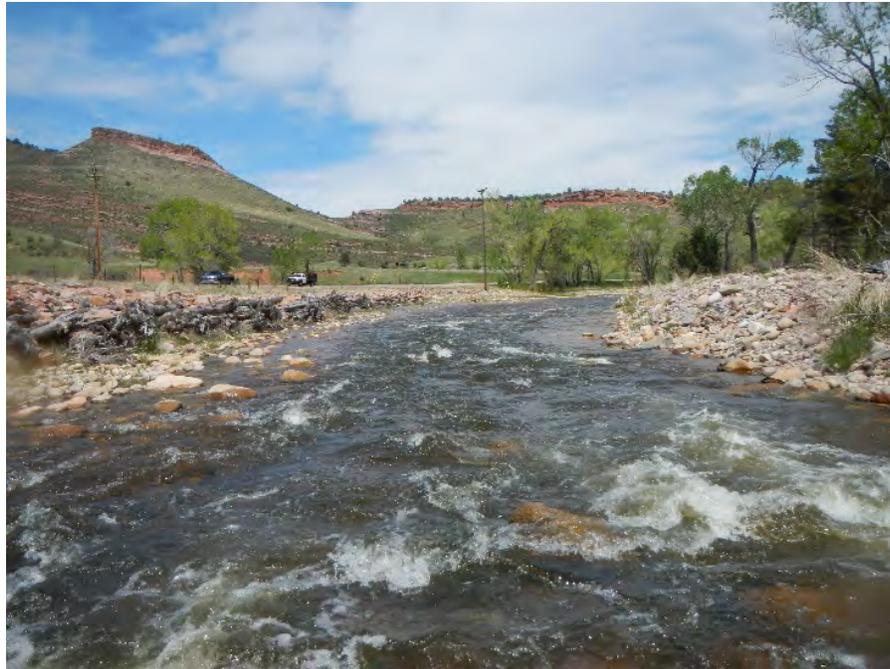
*Figure 16. Existing Rootwad Protection at Hwy 7*

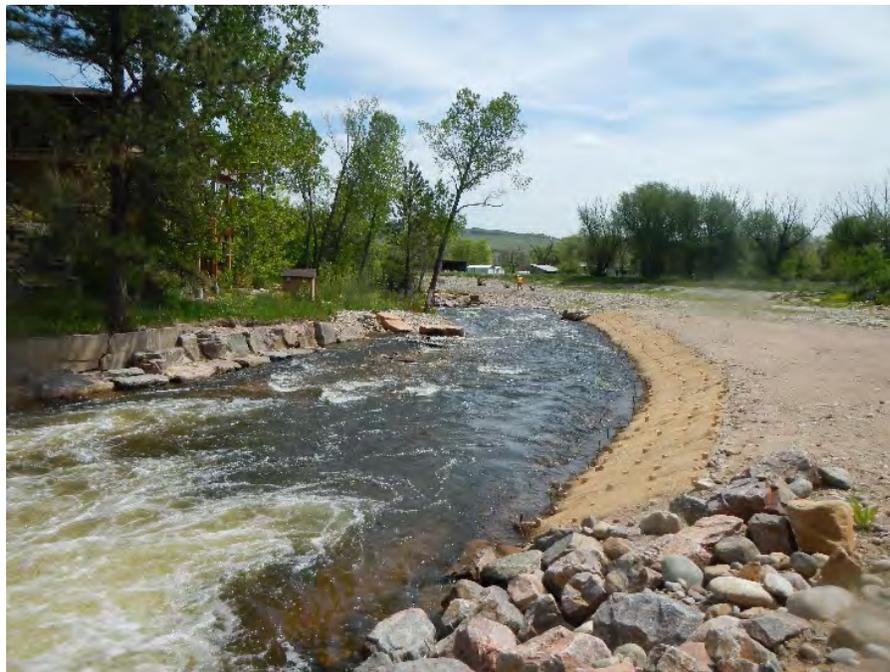
Figure 19. Longmont Diversion Post-Flood Work

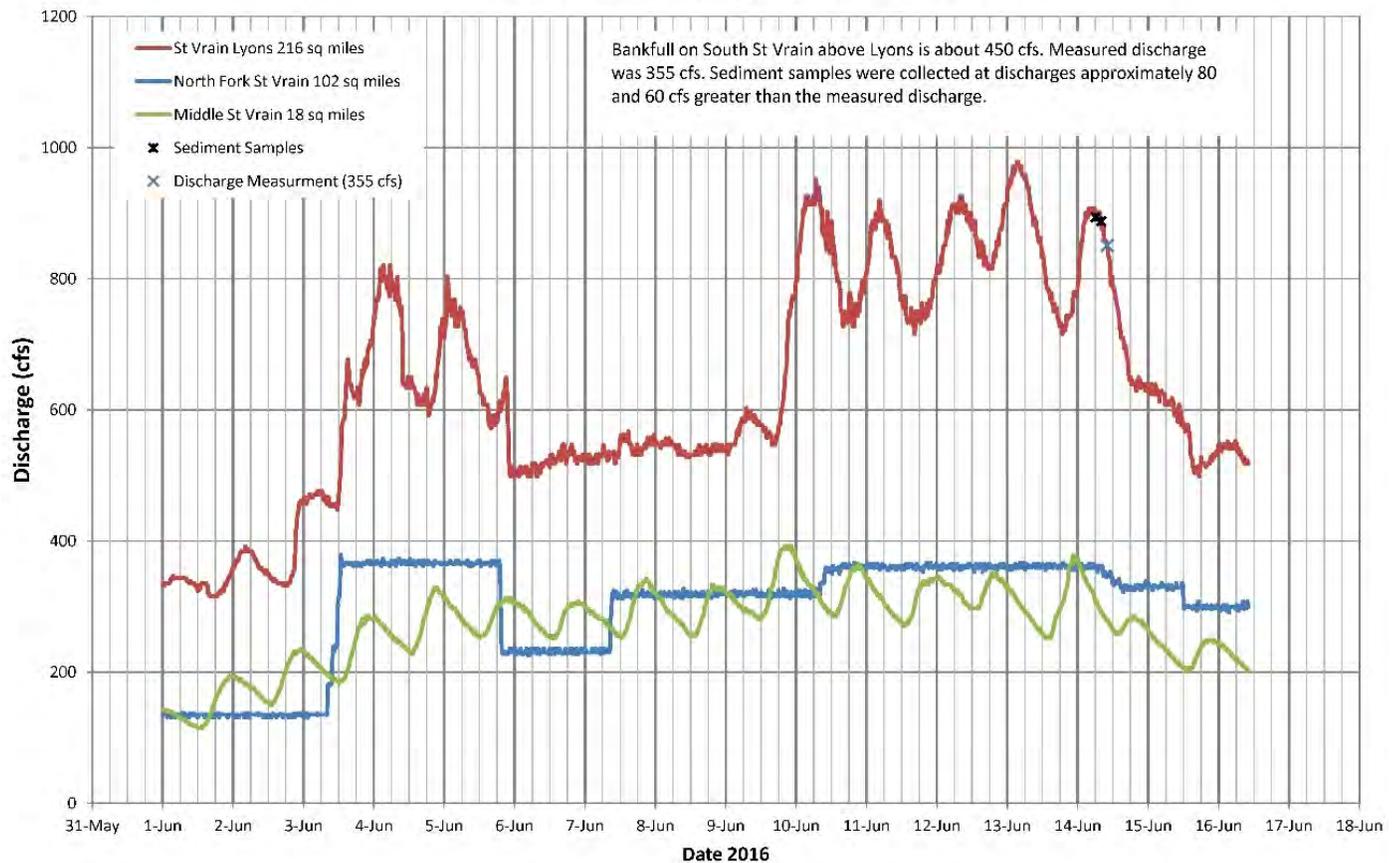
Figure 21 shows the June 2016 hydrographs for 3 stream gages in the St. Vrain system, as well as the timing for the measured sediment and discharge samples on June 14, 2016. Bankfull discharge is estimated to be 450 ft<sup>3</sup>/s and based on the Design Team's discharge measurement, the lag to the St. Vrain stream gage in Lyons (SVCLYOCO) and the North St. Vrain gage below Button Rock Reservoir (NSVBBCO). The discharges at the bridge during the sediment samples were estimated to be 437 ft<sup>3</sup>/s and 411 ft<sup>3</sup>/s, respectively. It is assumed that these measurements were taken at bankfull discharge, and sediment transport is an average of the two samples, understanding the natural variability in sediment transport rates. The estimated bankfull bedload transport rate was calculated to be 0.5813 kg/s, and the estimated bankfull suspended sediment concentration is 122.28 mg/l (sand fraction, only).

Figure 21. Hydrographs for Three Gages

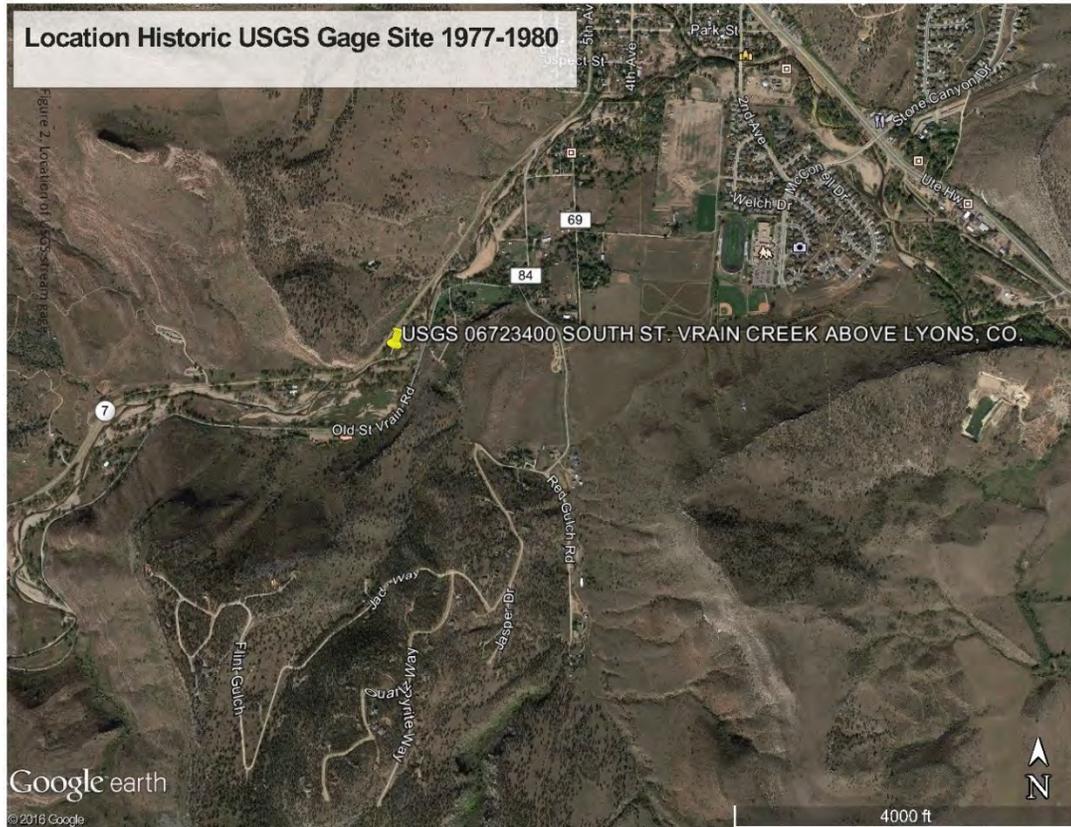
Figure 22. Location of Historic Gage

While there is no current stream gage on South St. Vrain Creek in the vicinity of this study, the USGS did operate a stream gage for four water years (1977-1980: USGS Gage No. 06723400) that was located within a few hundred feet of the location of the June 14, 2016 discharge measurement (Figure 22). Though the gage was operated for only a short period of the time, the flows it measured represent a reasonable range of discharges from wet and dry years (Figure 23). The measured flows at that location are considered more accurate compared to scaling flows from other nearby gages that perhaps would not reflect the operational hydrology and flow regulation that influences the South St. Vrain Creek hydrograph.

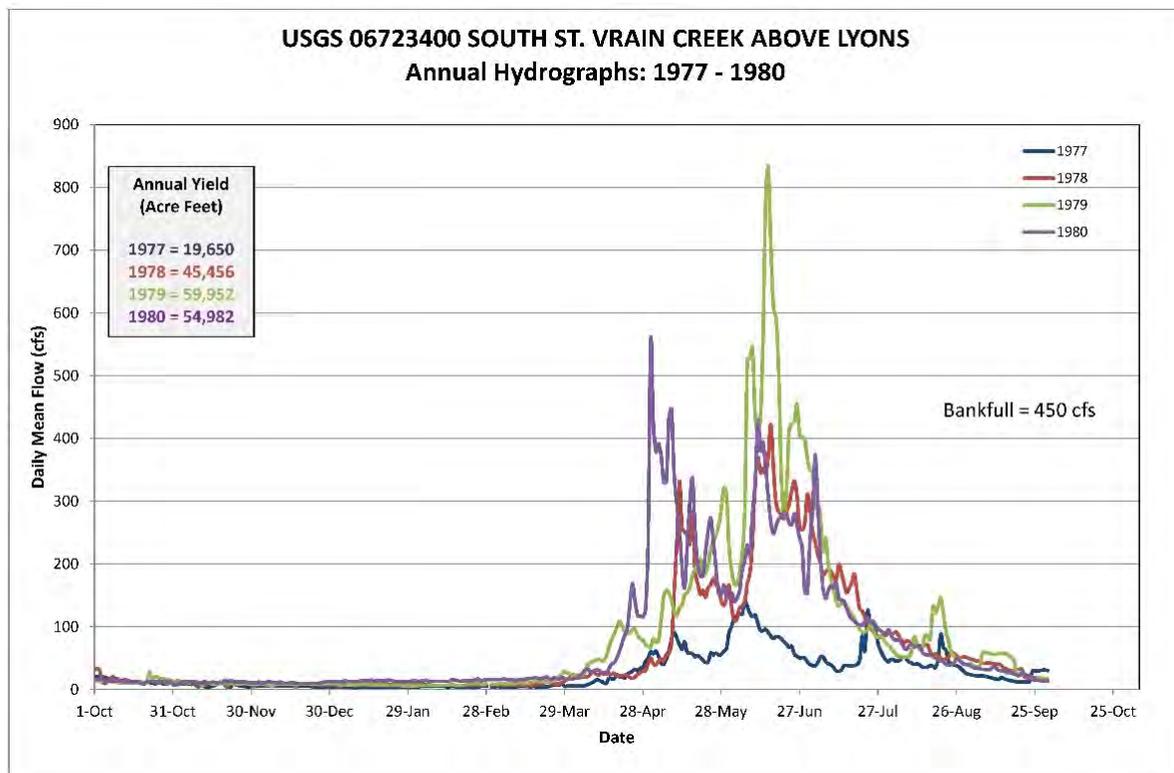
Figure 23. South St. Vrain Creek Above Lyons Hydrograph

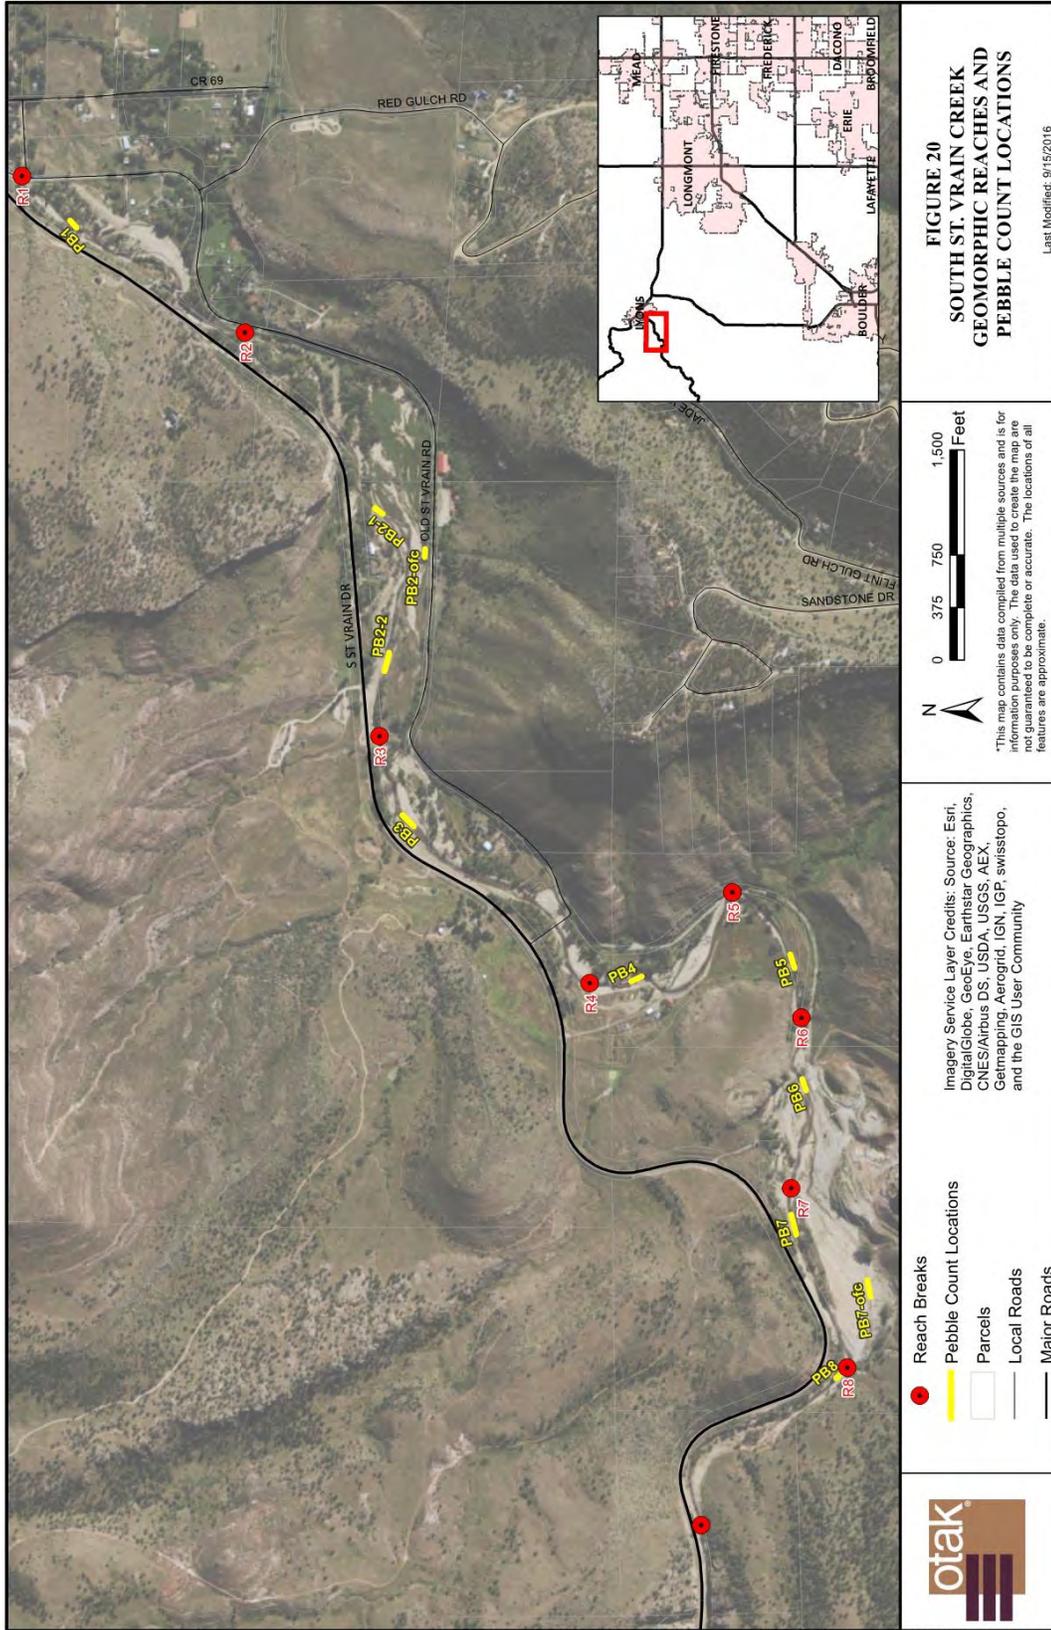
Figure 24. Geomorphic Reach Breaks

The sediment sampling location map is included in Figure 24 and shows the locations of the pebble counts, and the sediment gradation results are presented in Table 2 and Figure 24. The median bed material size found along the project reach ranges from coarse gravel to small cobble. The shape of the sediment gradation curves are fairly similar for most of the main channel locations, with the exception of the sediment sample collected in Reach 5 (PB5), where there is a lack of the smaller material (D10 is 41 mm, compared to the other reaches with D10 of less than 10 mm), and the sediment samples collected in Reach 2 (PB2-2) and Reach 7 (PB7) where the upper range of the gradation includes smaller material than other reaches.

In all, the study identified 8 reaches on the South St. Vrain Creek, within the project area (Figure 24).

Based on the alternative analysis presented in the previous section, an emphasis for the preferred alternative was placed primarily on floodplain connectivity, secondarily on revegetation, thirdly on channel complexity, and infrastructure protection was incorporated in select areas. The main channel alignment will remain in its existing flow path for the majority of the project reach, with the exception of three locations (vicinity of the quarry, vicinity of Hall property, upstream portion of EWP #1 reach, and downstream of the Longmont Diversion). Given the dynamic nature of the project reach, as discussed in Section 8 Geomorphology, in most locations there is not necessarily a preferred alignment from a geomorphic standpoint, the channel will move laterally across the valley as it adjusts to the incoming discharge and sediment load. In the locations where infrastructure is at risk, the channel alignment can be located to minimize that risk, but with the inherent understanding that in larger flows the channel will adjust. Additionally, design calculations suggested that it is possible to achieve equilibrium channel dimensions with the current alignment. Therefore, considerable construction budget can be re-purposed for other aspects of the restoration. Reach map is provided as Figure 24.

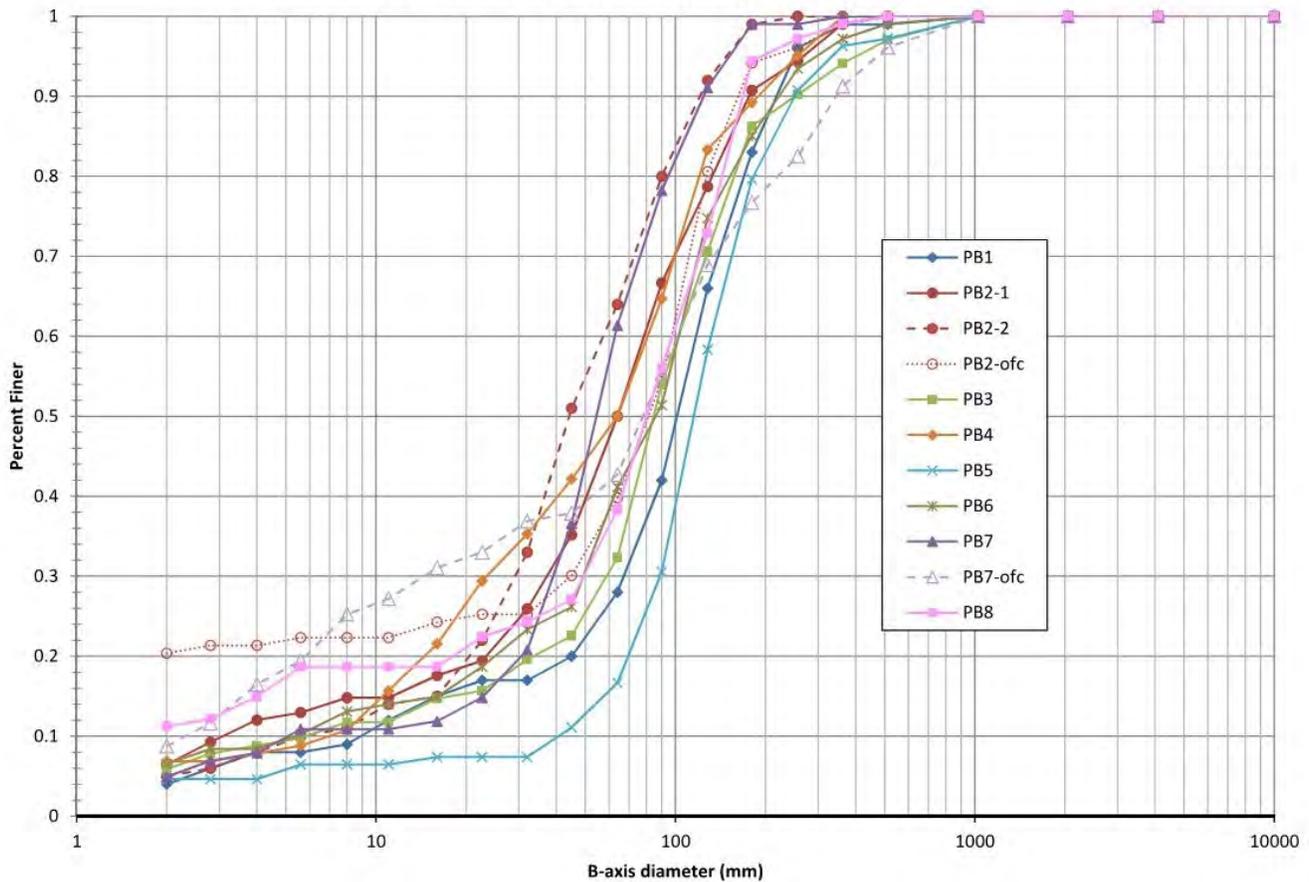
Figure 25. South St. Vrain Sediment Gradation

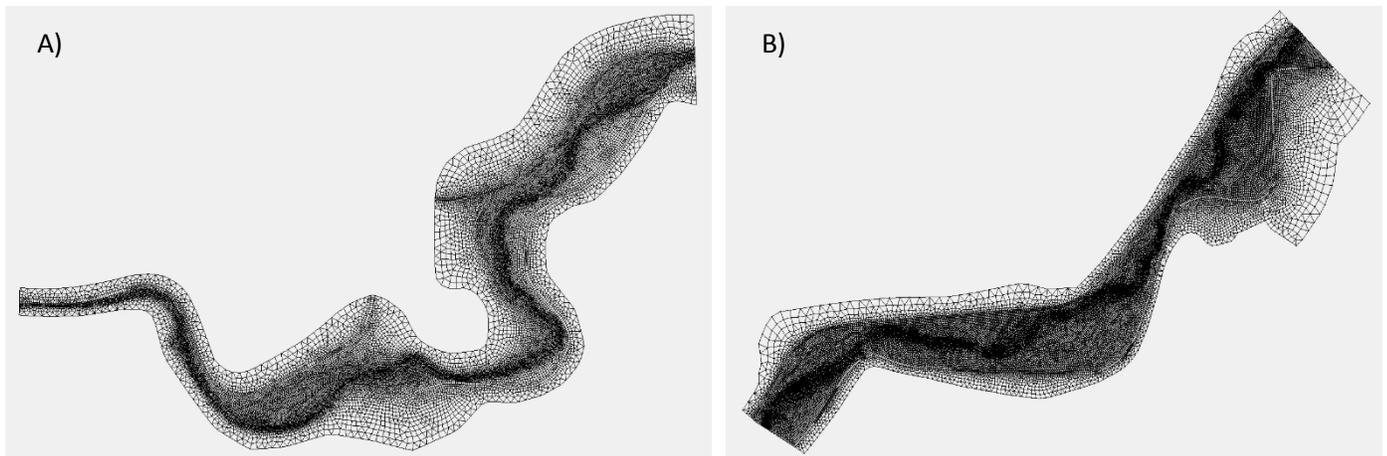
Figure 26. Screenshots of the mesh for A) upper and B) lower sections of the South St. Vrain.

A terrain model of the South St. Vrain Project Area was imported into SMS to develop the 2-D hydraulic model. All elevation data was extracted from this terrain to produce the mesh and for flow computations. Mesh generation began by defining the boundaries or breaklines of important features in the terrain. A combination of the hillshade terrain model and overlaid aerial imagery was utilized to delineate channel/side channel boundaries, floodplains, and roads. The mesh was developed using the paving mesh type in combination with the merged triangles feature. This builds the mesh using triangular elements between nodes and merges triangular features into quadrilateral elements where possible. This technique can help maximize the efficiency of the model computations while retaining a high level of detail with mesh elements. The mesh was inspected to meet details needed to capture in-channel variations and have quality non-irregular shaped mesh elements. The entire South St. Vrain model was broken into two sections (upper and lower) for computational efficiency purposes as shown below in Figure 26. An example of the mesh overlaying the terrain model is presented in Figure 27.

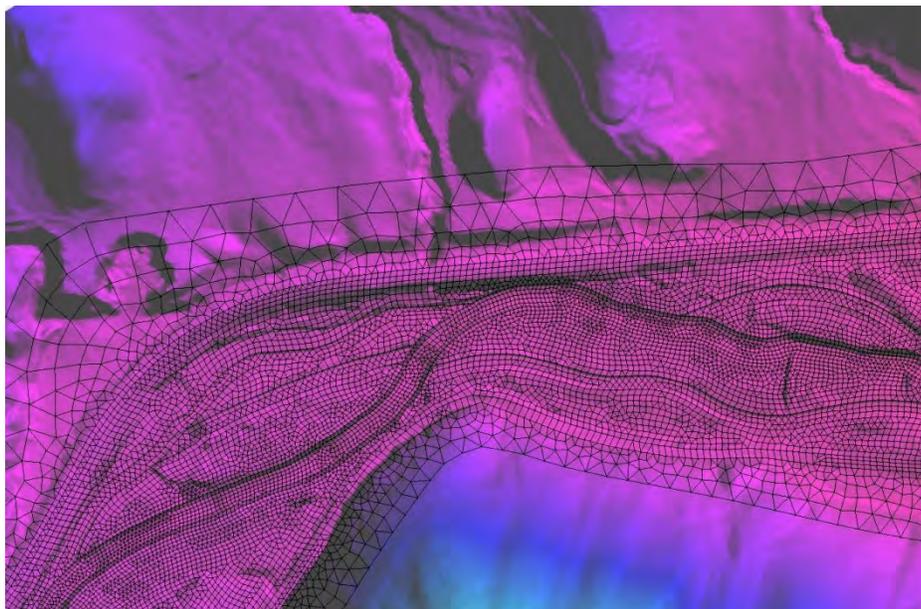
Figure 27. Example screenshot of lower mesh zoomed-in overlaying terrain model.

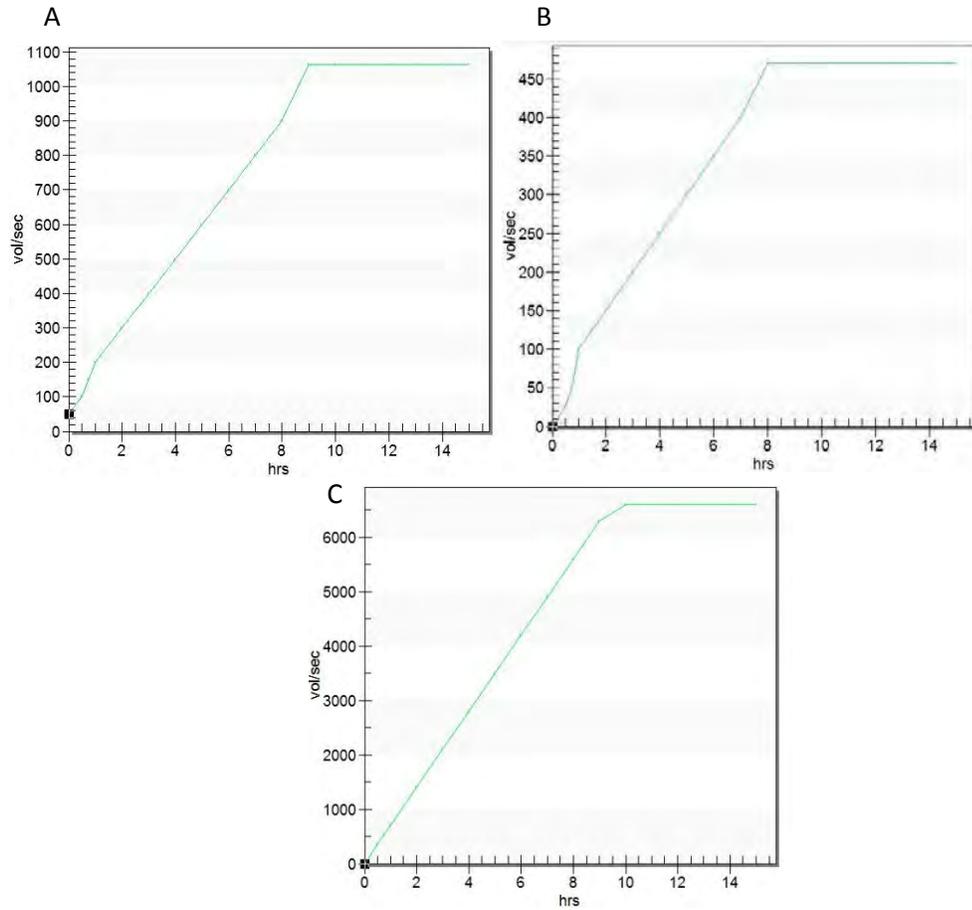
Figure 28. Upstream inlet discharge boundary condition for both the upper and lower sections for A) Q1.5, B) Q5, and C) Q100

The boundary conditions for the 2-D model were set for the upstream and downstream edge of the mesh. An inlet-discharge time series curve was generated for the upstream boundary condition. The discharge is ramped up by doubling every half an hour of simulation until it reaches the design discharge of interest, and is then held constant (Figure 28). A rating curve of water surface elevation (WSE) versus discharge was chosen for the downstream boundary condition (Figure 29). The rating curve was derived from a pre-existing 1-D HEC-RAS (Otak, 2016) model that had WSE information for each design discharge tested in the model. The cross section that aligned with the downstream boundary was selected to extract the rating curve.

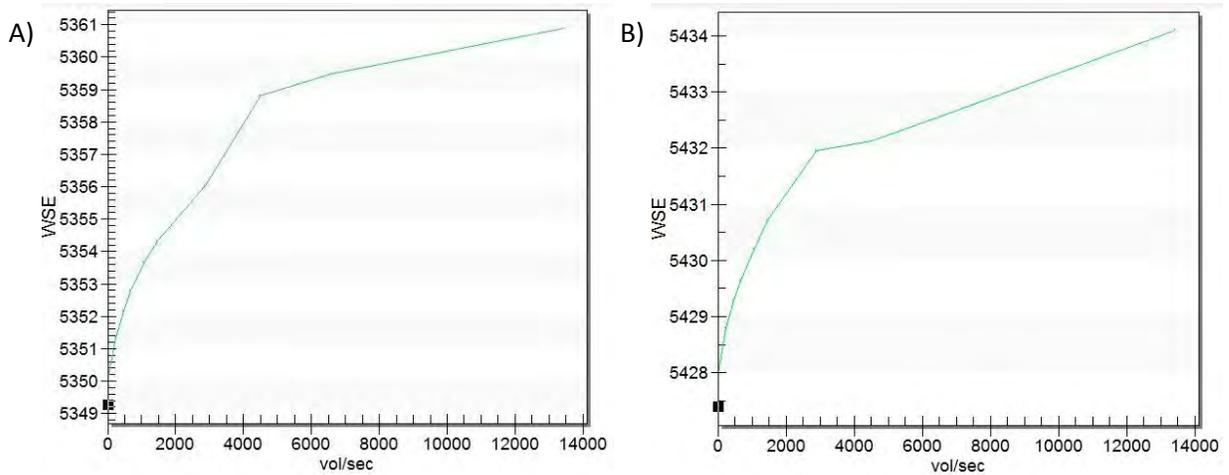
Figure 29. Downstream WSE rating curve boundary conditions from 1D HEC-RAS model for A) upper section and B) lower section.

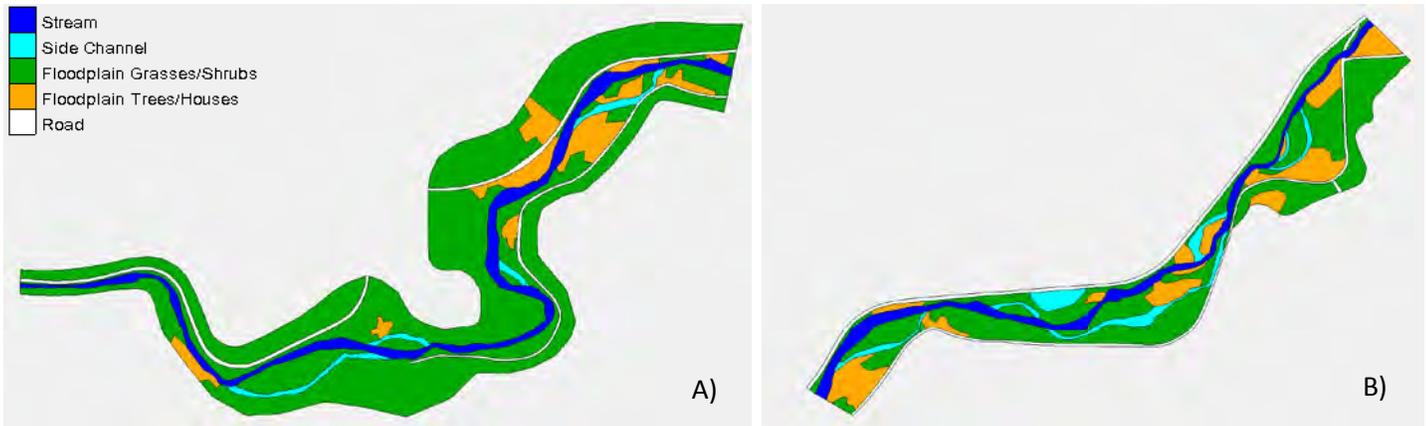
Figure 30. Roughness categories for A) upper and B) lower sections of South St. Vrain model.

The areas delineated in the mesh generation process for the stream boundary, floodplain, and roads were used to assign roughness characteristics to be used in the 2-D computations. In addition, areas of high roughness, such as patches of trees and houses, were delineated using aerial imagery and assigned a separate roughness value. A Manning’s n value of 0.035, 0.045, 0.06, 0.08, and 0.025 were selected for the stream, side channels, floodplain (grasses and shrubs), floodplain (trees and houses), and road roughness characteristics, respectively. The spatial reference for these categories for the upper and lower sections of the model is shown in Figure 30. These values were selected based on field observations, aerial photography, previous models, and engineering judgment in conjunction with calculations based on (Bathurst, 1985; Hey, 1979; Chow, 1959). The (Bathurst, 1985) and (Hey, 1979) equations along with previous models were used to select the in-channel roughness value. This value also took into account the increased ability of 2D models to account for bed forms and roughness at meander bends. The chosen values were held static and not vertically varied with increasing flows.

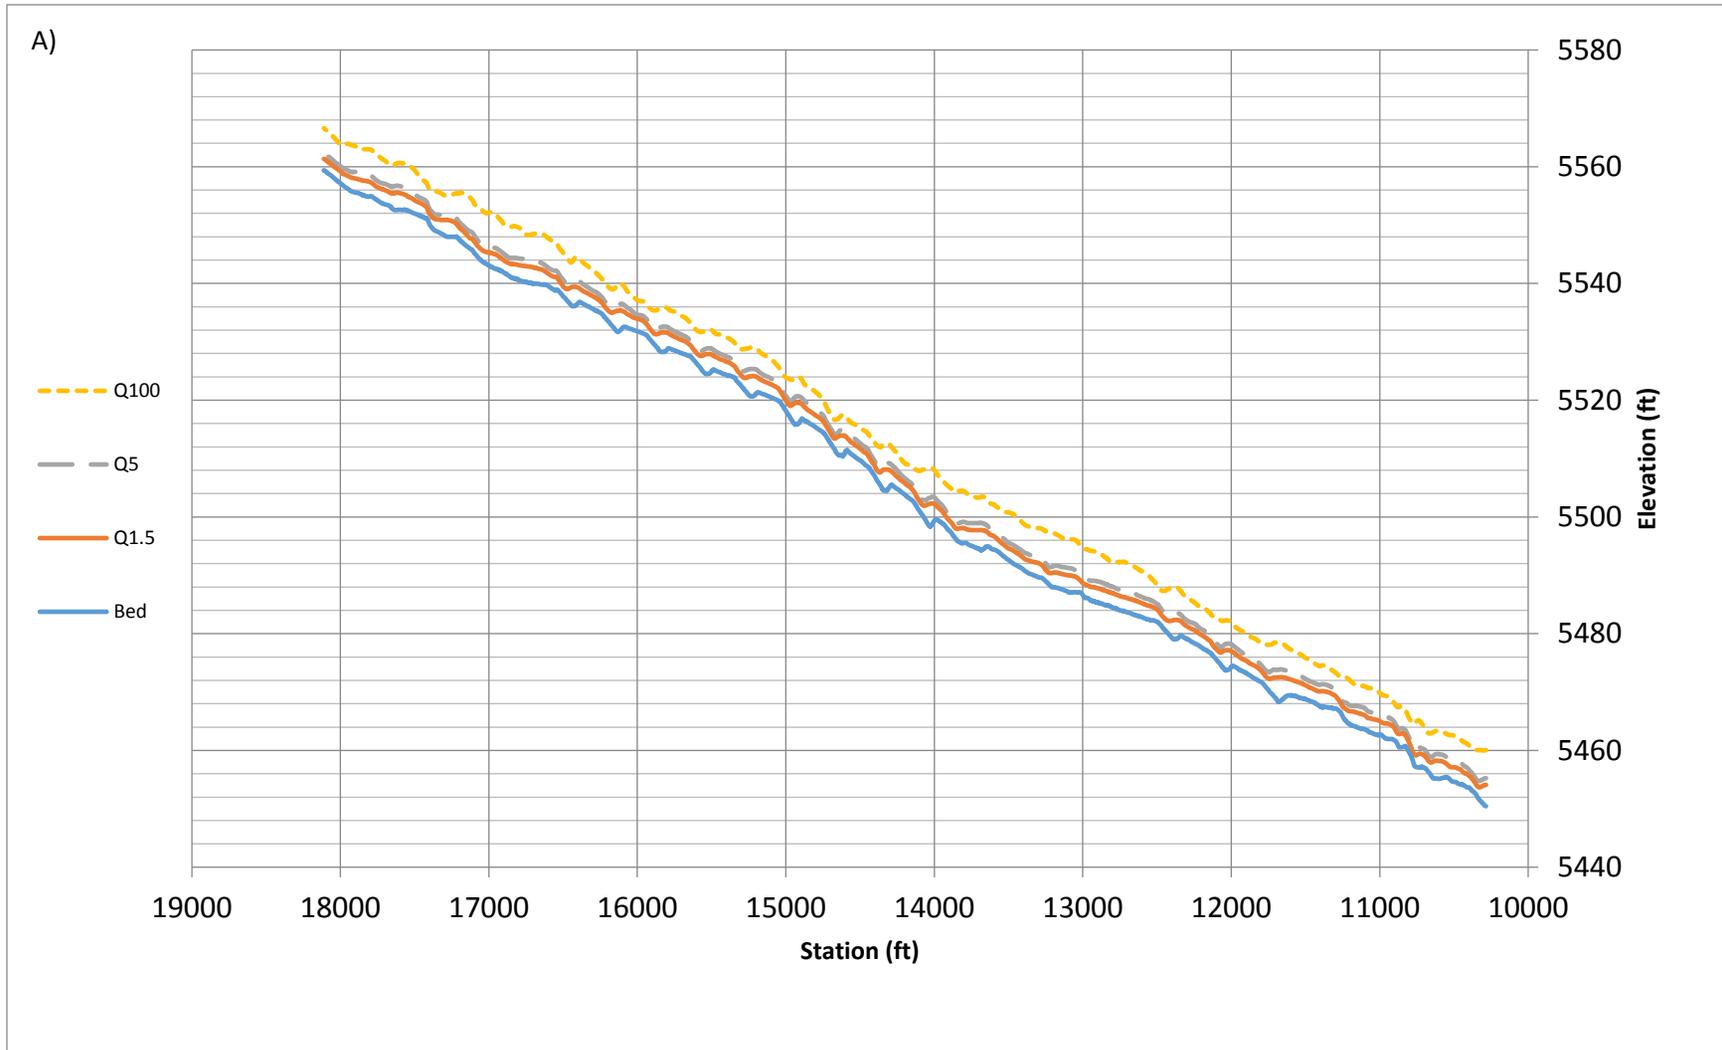
Figure 31. WSE profiles of Q1.5, Q5, and Q100 proposed conditions from SRH-2D model for upper sections of model.

Model results for the proposed conditions were computed for the  $Q_{1.5}$ ,  $Q_5$ , and  $Q_{100}$  design discharges for at least 15 hours of simulation to reach a steady state solution for analysis and for comparison to the existing conditions output. The output WSE profiles for each design discharge are shown below in Figure 31 and Figure 32.

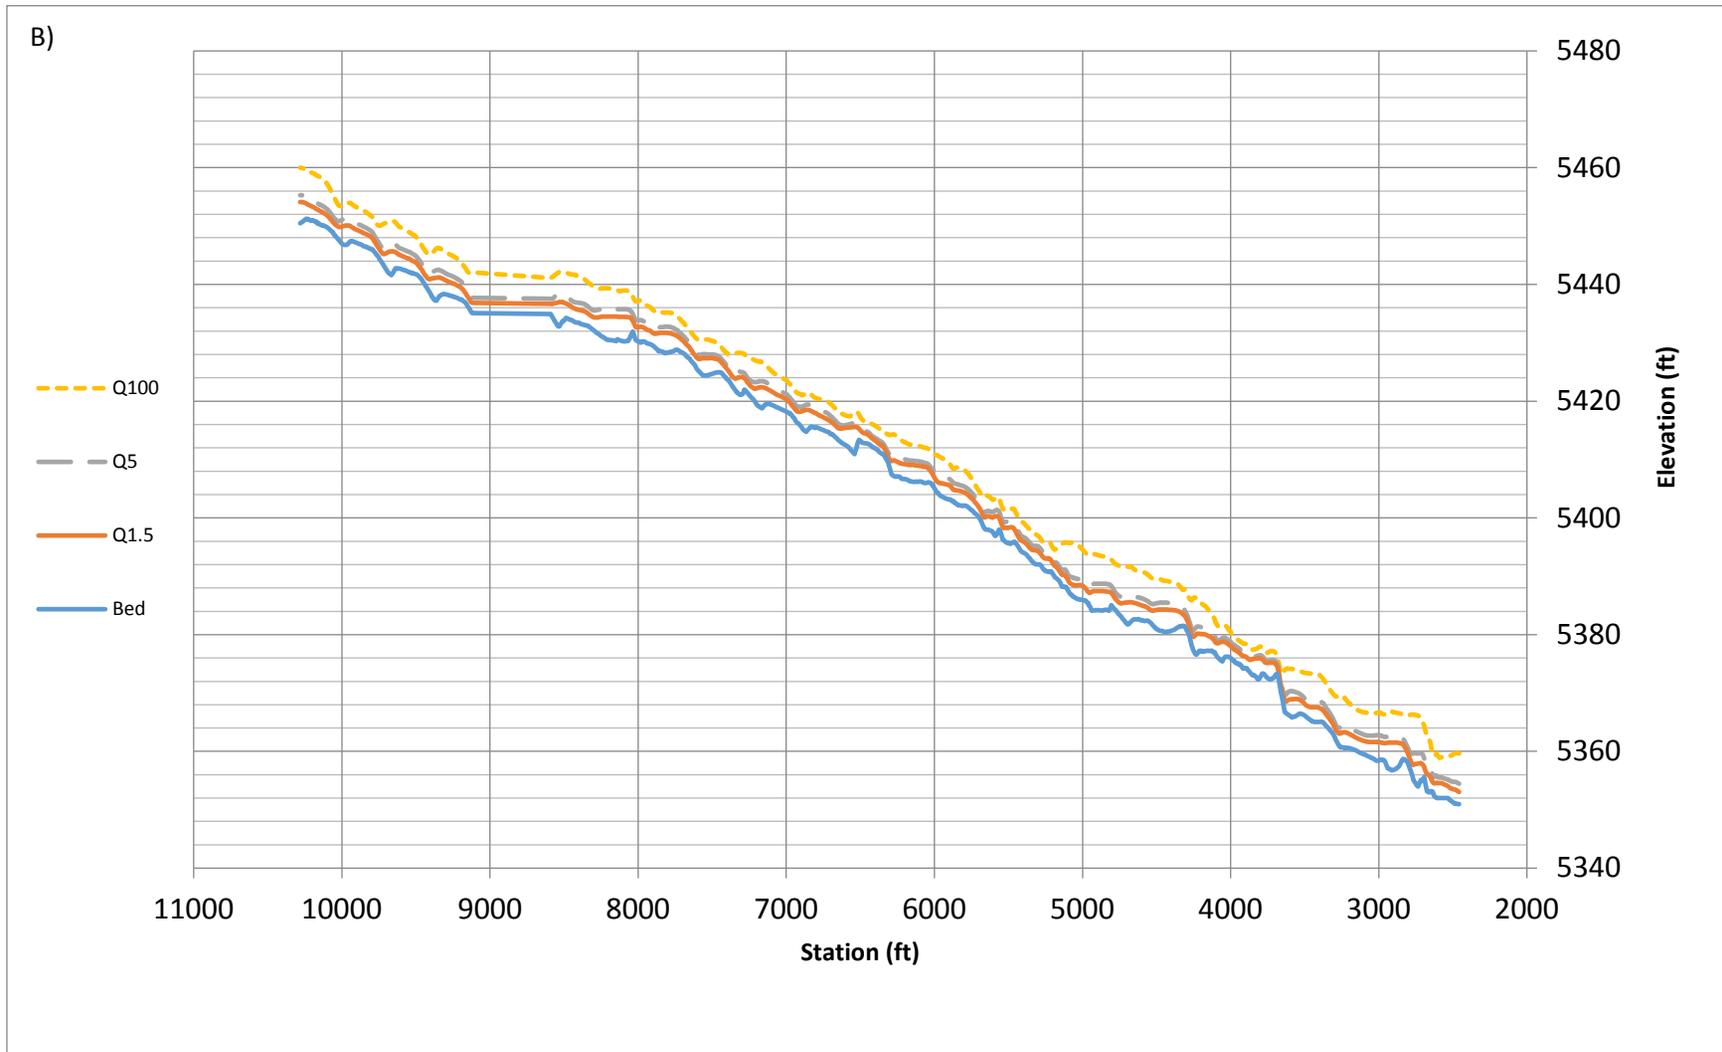
Figure 32. WSE profiles of Q1.5, Q5, and Q100 proposed conditions from SRH-2D model for lower sections of model.
