# Preliminary Basis of Design Report

## For South St. Vrain Creek Restoration at Hall Ranch

**Boulder County, Colorado**

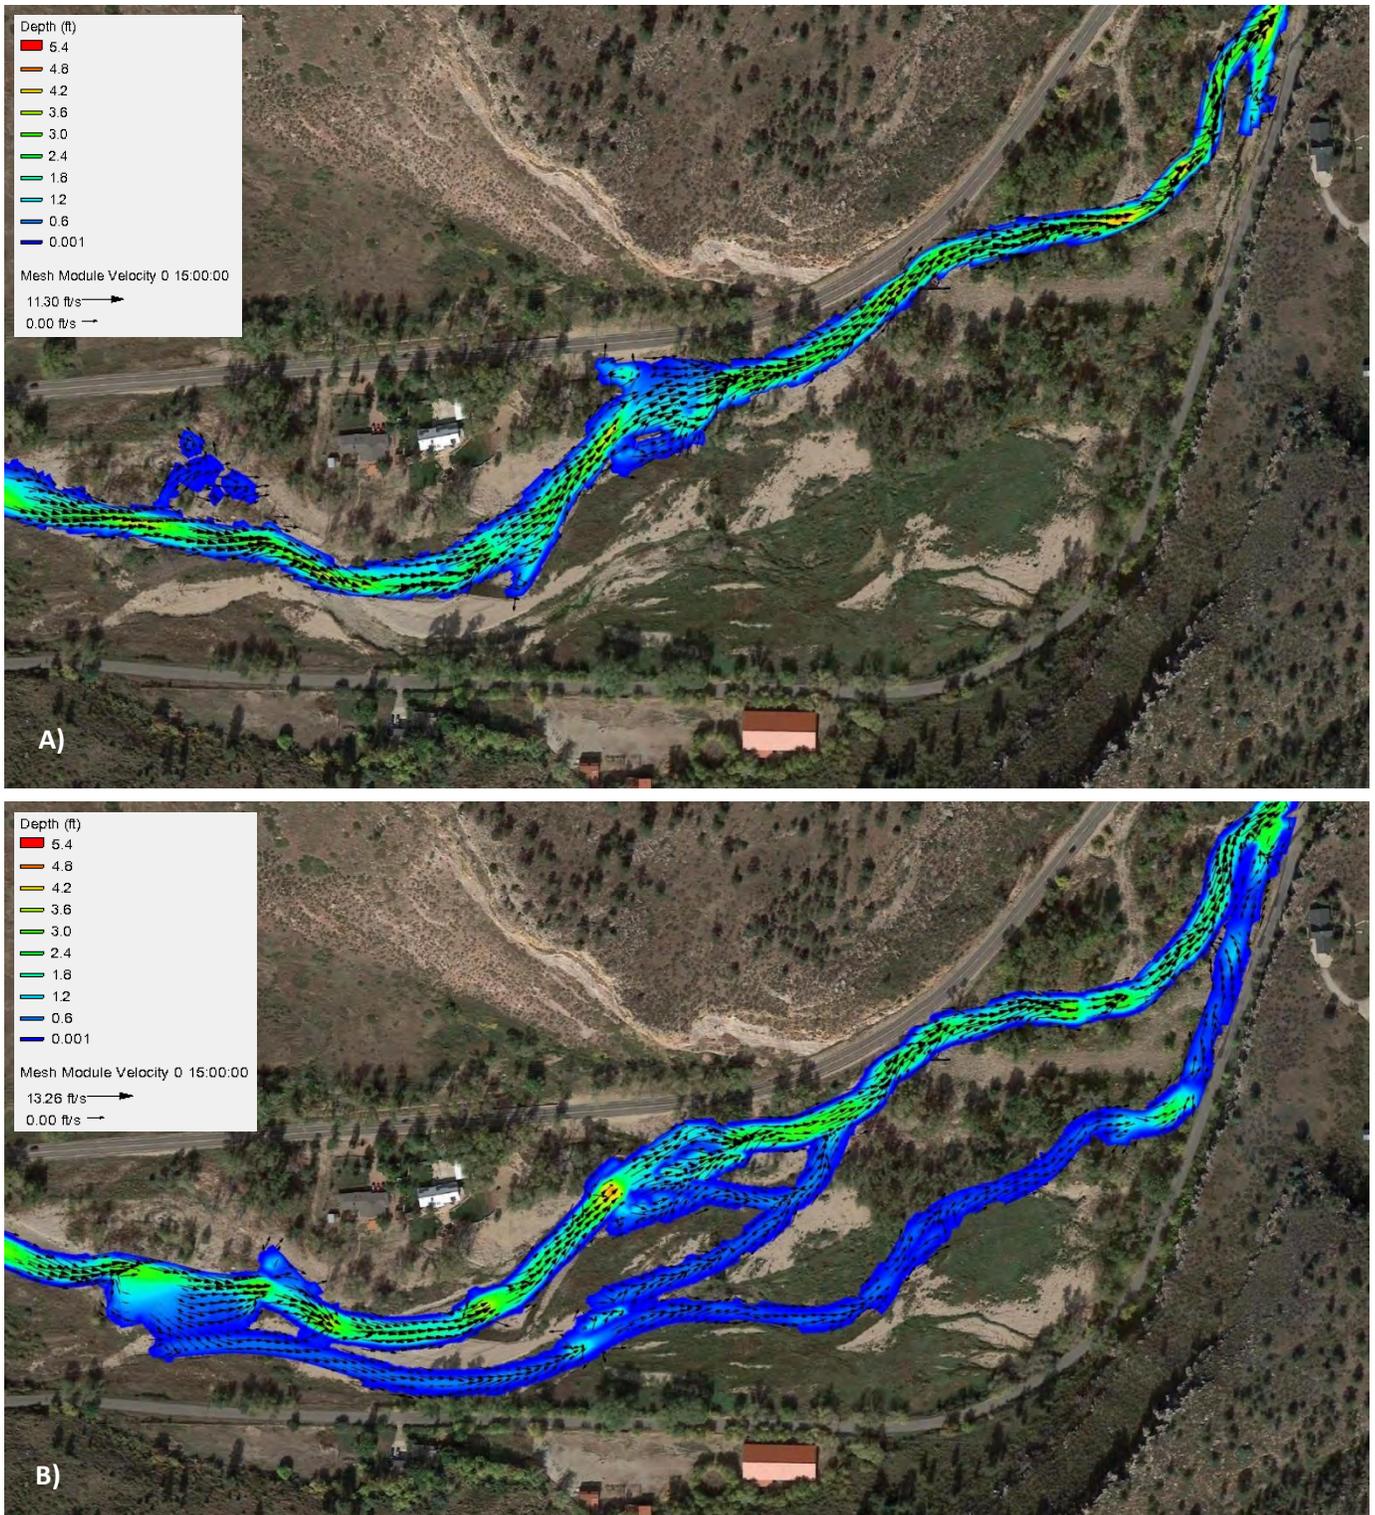
Figure 33.  $Q_{1.5}$  depth contour maps with velocity vectors for A) existing and B) proposed conditions.

The outputs for the existing and proposed conditions model can be directly compared for each of the design discharges run in the simulations. The screenshots in Figure 33 show example outputs of SRH-2D for the Q<sub>1.5</sub> flow in a lower section of South St. Vrain Creek for existing and proposed conditions (additional SRH-2D results can be found in Appendix E – SRH 2D Hydraulic Model Output). The proposed design output shows greater floodplain connection and the initiation of several side channel flow paths compared to the existing conditions model. The reconnection to the floodplain was a goal of the design which can help mitigate the concentration of flood flows and reduce overall velocities in the channel that can help bring the sediment transport balance closer to an equilibrium state as discussed in Section 8c of this report. These results are consistent with the other model outputs for the remainder of the South St. Vrain and for the Q<sub>5</sub> and Q<sub>100</sub> design discharges as well.

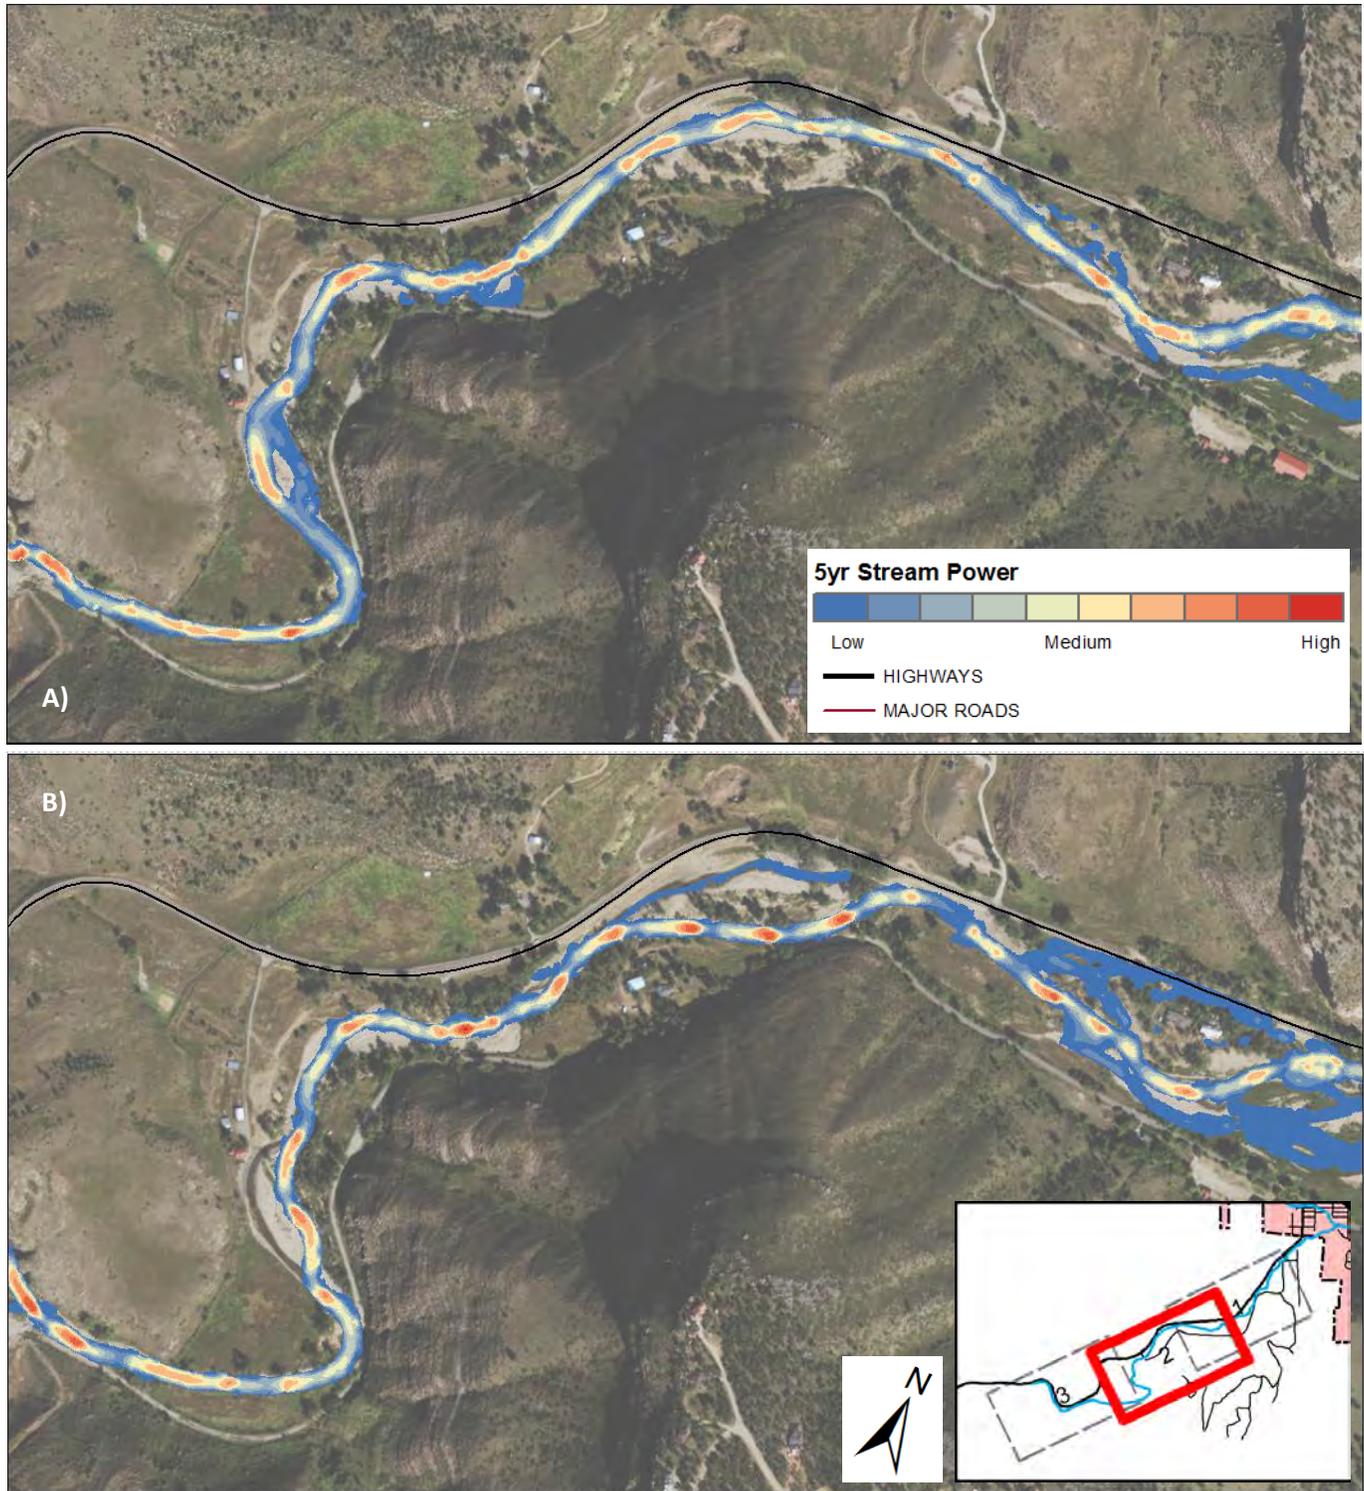
Figure 34. Example  $Q_5$  Stream Power maps for middle section of South St. Vrain for A) existing and B) proposed conditions.

The stream power maps for the existing and proposed conditions (as illustrated by Figure 34) show clear differences in the distribution of stream power along the channel. The proposed condition stream power is higher in certain concentrated areas but more consistently distributed along the channel. These areas of concentrated stream power are at the crest of riffle features in the proposed design. This higher stream power can help maintain riffle features and sequentially scour pools below the feature. The existing condition model displays stream power over longer stretches of river length and more sporadically placed along the channel length. This can potentially lead to discontinuity in sediment transport capacity which is evident in the sediment transport balance results for the existing conditions model.

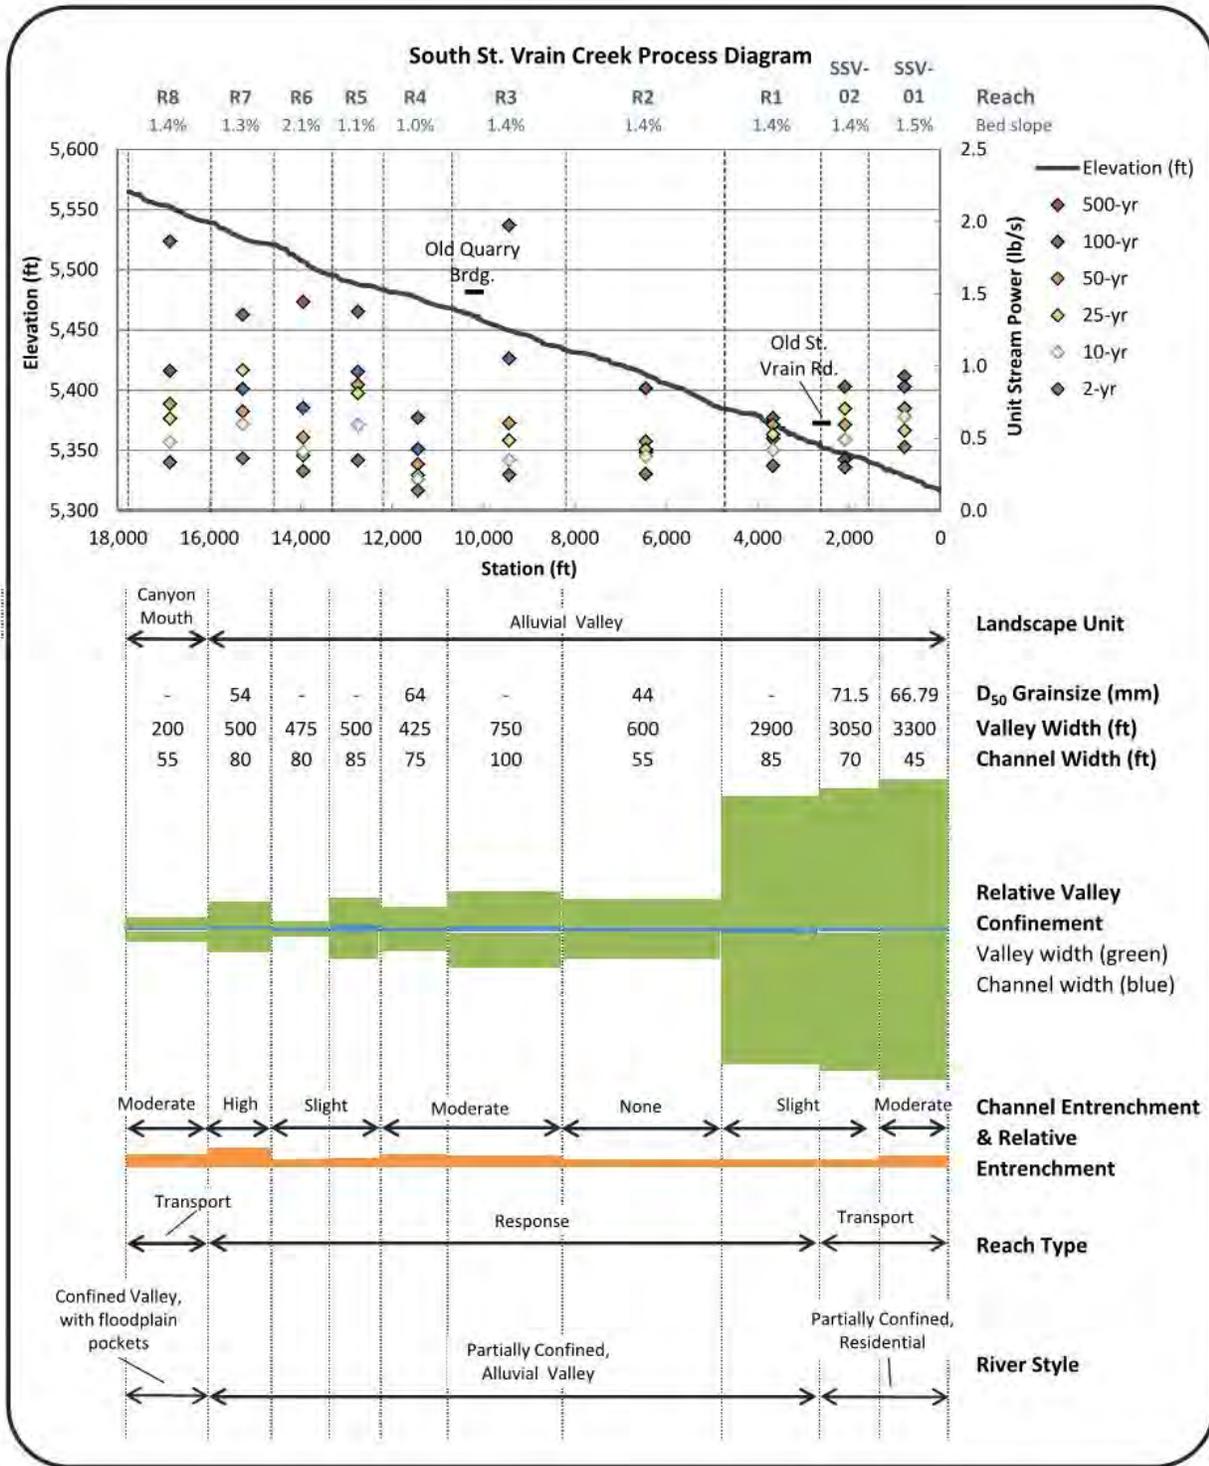
Figure 35. South St. Vrain Creek Geomorphic Process Diagram (Otak, 2016)

The process diagram presented in Figure 35 (Otak, 2016) is a useful tool to align reach and landscape scale geomorphic variables. The diagram shows the longitudinal (i.e., downstream) progression of dominant channel process variables. At the landscape scale, the portion of the South St. Vrain covered in this project is located in alluvial valleys, with the Town of Lyons at the downstream end of the project sitting on an alluvial fan (Reach 1, SSV-02 and SSV-01 in the process diagram). Alluvial valleys and fans are areas where rapid reduction in downstream channel gradient causes the channel to deposit its sediment load and frequently shift its alignment. Over time, the position of the channel will vary vertically and horizontally across the valley, without preference for any particular location – the channel is merely adjusting to the incoming discharge and sediment load. These landforms, in more natural states, serve the function of moderating the sediment loads to downstream reaches (Cluer and Thorne, 2013). As the high energy canyon environment transitions to lower gradient alluvial valleys, South St. Vrain creek deposits its bedload, building the floodplains upon which the Town of Lyons was constructed. Much of South St. Vrain Creek has been pushed into a simplified single thread channel, with limited floodplain connection, in order to armor property and re-purpose floodplain for various land uses. The unfortunate side effect is that sediment loads transmitted downstream are increased, translating the disturbance downstream and overwhelming the capacity of the lower gradient floodplains and channels. The natural behavior of this environment was observed throughout the 2013 flood by rapid channel expansion, avulsion, and significant sediment deposition.

Figure 35 illustrates the reaches of South St. Vrain Creek in the context of the surrounding reaches and the larger system. The profile of the creek is shown along with stream power values, valley and channel width measurements, valley setting characteristics, entrenchment, and river style.

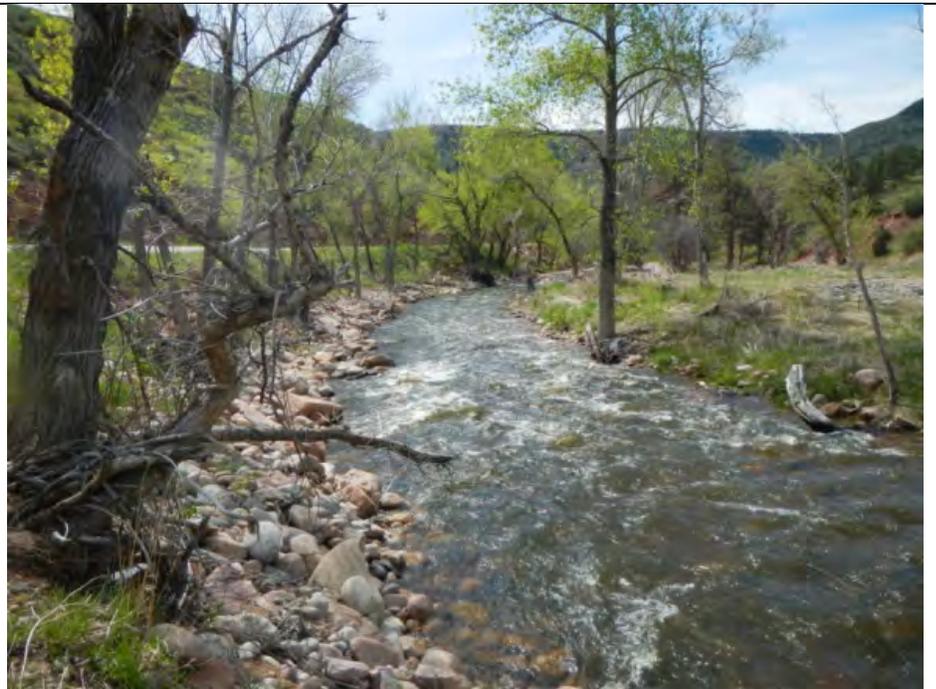
<p><b>Confined Valley with Floodplain Pockets (CFP)</b></p>	
<p><b>Properties:</b>                  Generally, found along meander bends in canyon settings, these reaches contain “floodplain pockets” or limited areas of less confinement where sediment may be temporarily stored and where the channel may be more alluvial in nature. Where these reaches share the valley with a road, stream banks are often heavily armored. Because this reach type tends to have a milder slope (observed average slope 1.4%) and has areas with wider valley bottoms than the confined reaches that bracket them, some upstream sediment supply may fall out of transport here aiding in channel avulsion and braiding during floods, resulting in these styles being more geomorphically sensitive and potentially hazardous. Substrate in these reaches ranges from gravel to small boulder.</p>	
<p><b>Reach: 8</b></p>	
<p><b>RIVER CHARACTERISTICS</b></p>

Valley Setting	Confined. Observed confinement ratio of 4
Channel Planform	Channel is generally single thread and straight, but floodplain pockets may contain overflow, secondary, and chute channels.
Bed Morphology	Typical: step-pool, with potential pool-riffle at lower gradient pockets; Large wood is stored in these reaches, providing channel structure, floodplain roughness and jams. Observed: step-pool and plane bed
<p><b>RIVER BEHAVIOR</b></p>	
Current Stream Evolution Stage	N/A
Flood Response	Confined areas generally experienced channel degradation and expansion. Floodplain pockets experienced substantial aggradation and loss of established vegetation, with lateral channel migration and avulsions.
Stage Behavior	Low flows are generally single thread, storing sediments in pools and channel margins in confined sections. In the floodplain pocket areas, sediments are stored in bar complexes, along channel margins and in pools. At bankfull flows, pool-riffle sequences and pool structures are flushed of fine sediments. At flood stage, these steep, armored reaches have excess transport capacity for all but the largest sediment (boulders), but the pocket areas are able to store flood energy and debris. Overflow channels activate and chute cutoff channels form in response to vertical accretion in the floodplain.

Figure 36. Confined Valley with Floodplain Pockets

As part of the Expanded Study (Otak, 2016), the reaches within the South St. Vrain project area were classified into two different River Styles. The key properties of each River Style are summarized below and presented in detail in Figure 36 and Figure 37.

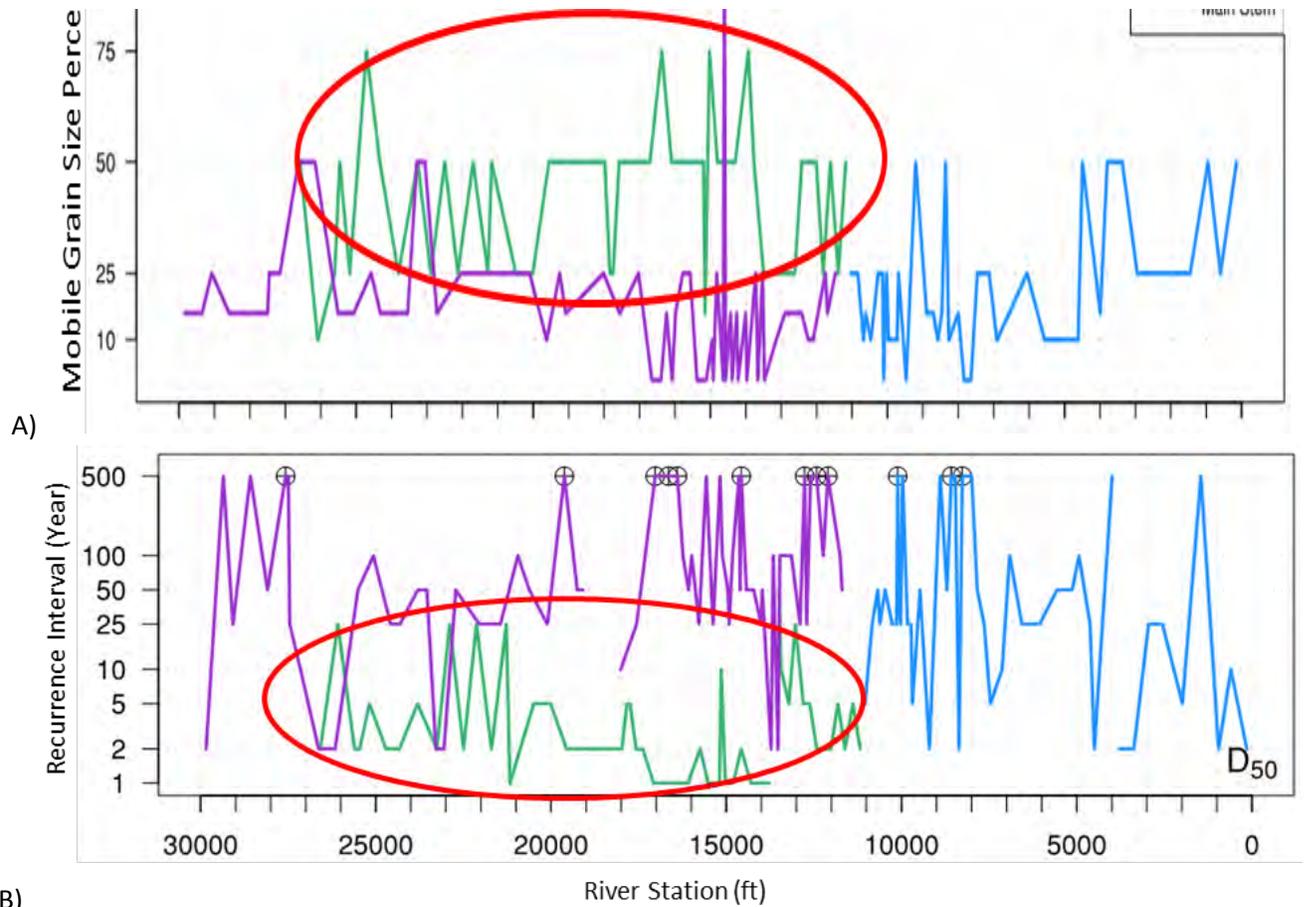
Figure 38. Bed mobility, reproduced from Otak, 2016. South St. Vrain Creek is represented by the green line.

As discussed in Otak (2016), bed mobility was calculated for all reaches of South St. Vrain Creek from the canyon mouth to the Town of Lyons. Bed mobility refers to the ability of a given flow rate and associated shear stress to mobilize sediment. Results show that reaches in South St. Vrain Creek are more readily mobilized. Figure 38 shows that through the South St. Vrain (green line, circled in red), mobile grain sizes are relatively larger than the North St. Vrain and main stem (A) and are mobilized by more frequent flows (B). This behavior is largely a response to the relatively steeper slopes finer bed observed in the South St. Vrain. This also suggests that South St. Vrain Creek is likely to undergo further adjustment.

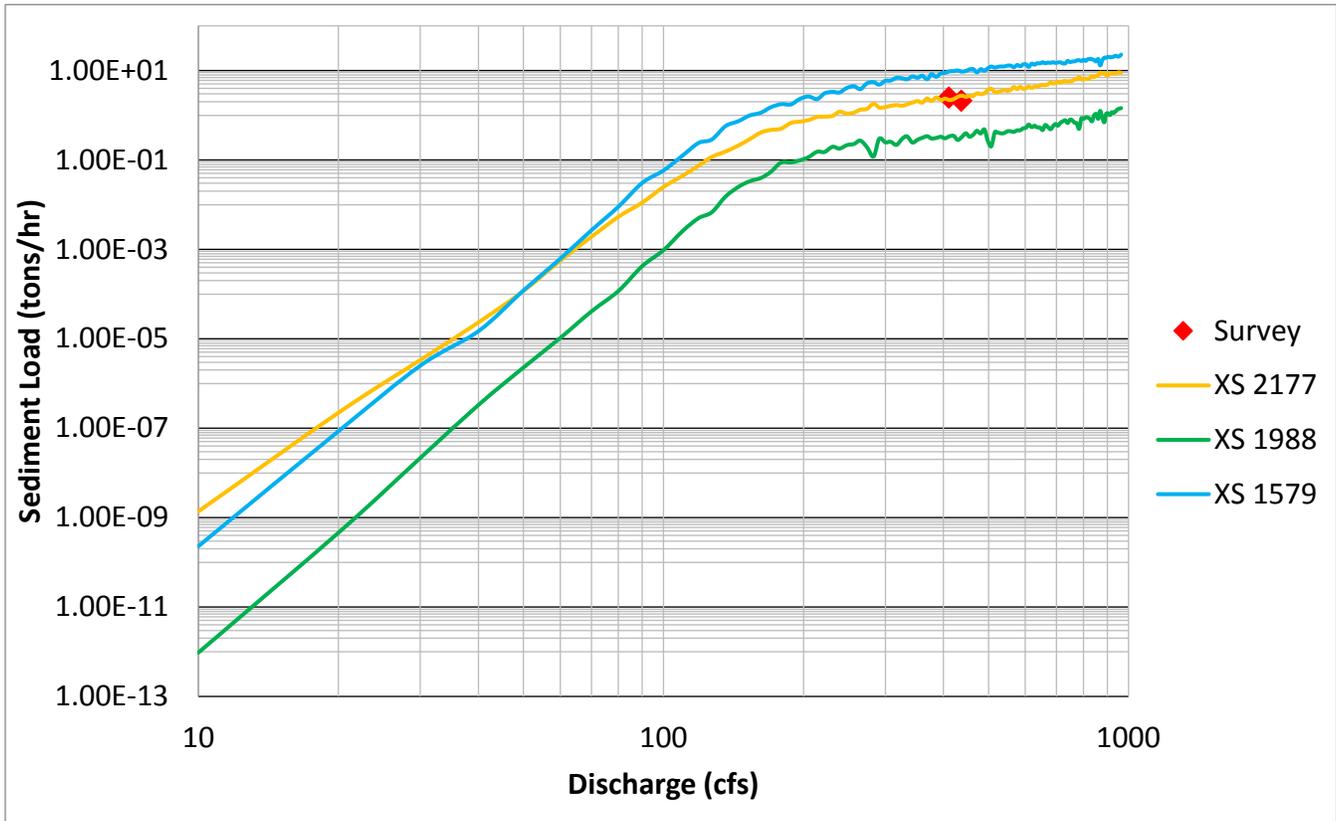
Figure 39. Sediment rating curves for three cross sections of existing conditions and field measurements of sediment transport rates.

Field estimates of bedload and suspended load sediment transport rates were taken on June 14, 2016 near the Old St. Vrain Road Bridge on South St. Vrain Creek. As discussed in the Field Sediment Sampling section of this report (Section 6.h), the bedload transport rate was estimated twice using a six-inch Helley-Smith sampler for flows near bankfull discharge. The measured bedload value was compared with the sediment rating curve of bedload transport rate for three cross sections closest to the bridge, which were also produced using the existing 1-D hydraulic model (Otak, 2016). The comparison of field measurements and the sediment rating curves produced from the existing conditions model is shown below (Figure 36).

The orange line in Figure 39 is the cross section closest to the Old St. Vrain Road Bridge on the downstream side. The field measurements were sampled off of the bridge and align well with the predicted transport from the hydraulic model for this cross section. This result seems to support the validity of the transport and hydraulic models, but this comparison is recognized only to be a snapshot representation of the sediment transport at one particular flow, in a stream undergoing significant adjustment to a large disturbance event.

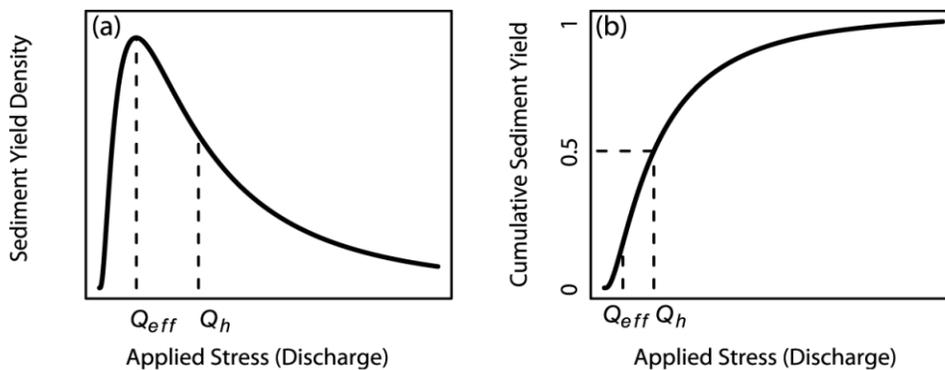
Figure 40. a) Conceptual diagram of sediment yield effectiveness curve used to calculate the effective discharge. (b) Cumulative sediment yield curve used to calculate the half-yield discharge (Otak, 2016)

Design discharges used to size bankfull channel dimensions often rely on regional hydraulic geometry relations and/or flood frequency estimates such as the 1.5- or 2-year flood peaks. Consideration of the range of geomorphically-effective flows as well as the relationship between discharge and sediment movement can better inform channel design, especially in systems adjusting to a disturbance, such as post flood St. Vrain Creek (Doyle et al., 2007). The effective discharge,  $Q_{eff}$ , is that which transport the most sediment on average over time. It is calculated from a flow frequency distribution representing a long-term flow record (e.g., a flow duration curve) and a relationship between the flow rate and sediment transport rate for a given reach and bed material size distribution (Figure 40a; Biedenharn et al., 2000). In gravel and cobble bed rivers such as St. Vrain Creek,  $Q_{eff}$  tends to predict bankfull discharge well (Sholtes and Bledsoe, 2016). The half-yield discharge,  $Q_h$ , is the discharge associated with a cumulative 50% of sediment transport on the sorted flow (and sediment yield) record (Figure 40b). Its calculation relies on the same data as  $Q_{eff}$ . It is also a good predictor of bankfull discharge in most river types and often corresponds with  $Q_{eff}$  in coarse bed rivers.

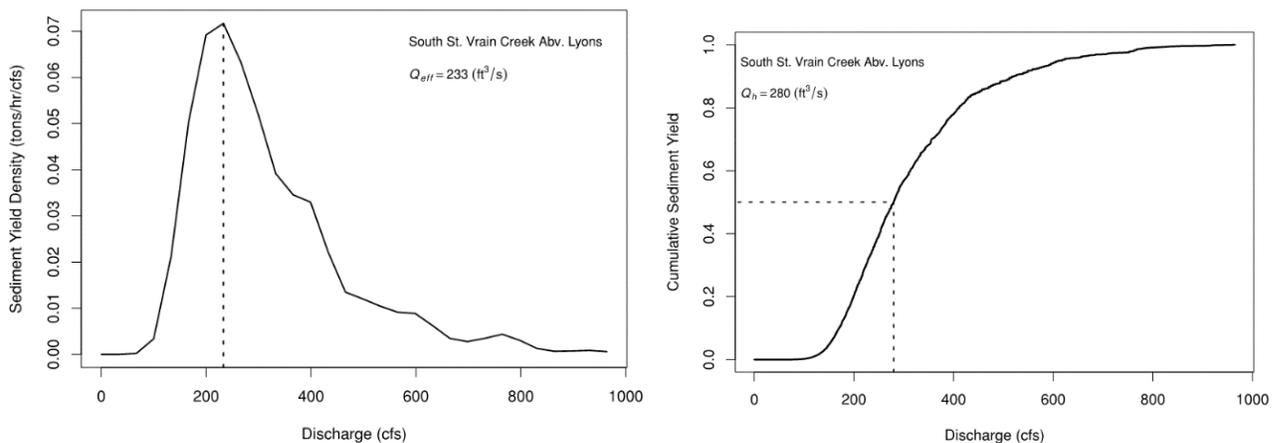
Figure 41. Effective discharge and cumulative sediment yield curves for South St. Vrain Creeks.

Resulting values of  $Q_{eff}$  and  $Q_h$  on South St. Vrain Creek are similar in magnitude to each other at approximately 230 and 280 cfs, respectively (Figure 41). These values approximate the 1-year recurrence interval flood. Both  $Q_{eff}$  and  $Q_h$  are most influenced by flow variability, bed material grain size, and channel geometry. All things being equal,  $Q_{eff}$  and  $Q_h$  decrease with decreasing grain size and increasing channel entrenchment (Sholtes et al., 2014). For this study,  $Q_{eff}$  and  $Q_h$  were calculated based on post-flood channel geometry and bed material, both of which are likely still adjusting to this disturbance. In general, the flood created larger and deeper channels and brought in finer sediment from upstream bank erosion and hillslope failure. This may have resulted in producing estimates of  $Q_{eff}$  and  $Q_h$  that are smaller than their pre-flood values. This is likely the case for the South St. Vrain, which exhibits finer sediment and the most geomorphic change relative to St. Vrain and North St. Vrain Creeks.

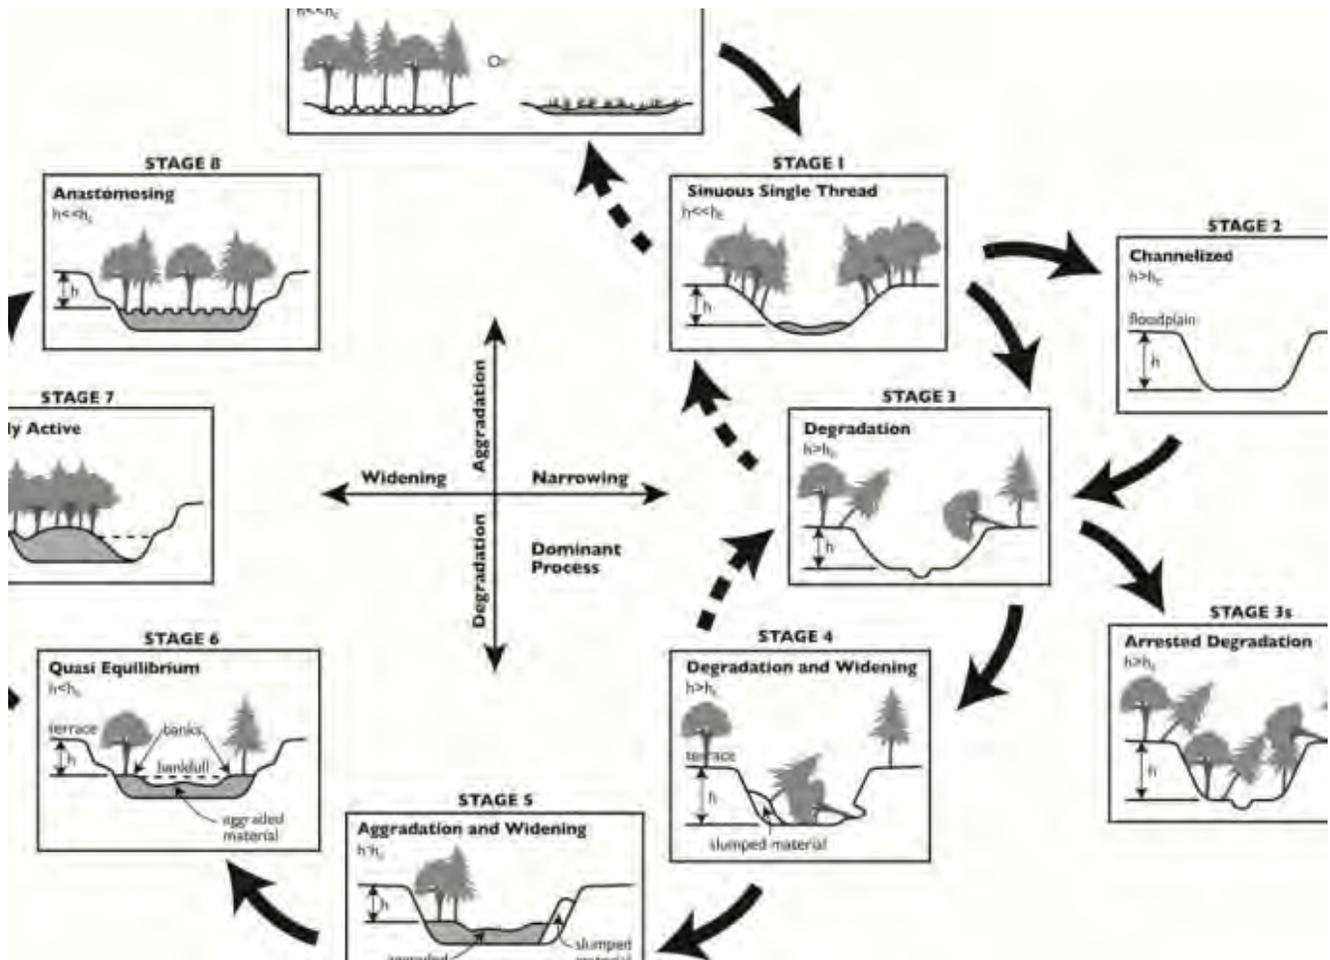
Figure 42. Stream Evolution Model (Cluer and Thorne, 2013)

Otak (2016) used the stream evolution model (SEM) presented in Cluer and Thorne (2013) to define the current stage of stream evolution of each reach along the South St. Vrain. The SEM is a tool to assist with understanding morphological responses to disturbances within a stream system (e.g., base level change, channelization, alterations to the flow/sediment regimes) and can help determine channel trajectories and achievable restoration goals. A graphic showing the stages of the SEM is shown in Figure 42 below and the SEM trajectories identified in Otak (2016) are reproduced in Table 8. Additionally, the table has been updated to incorporate the projected impacts of the proposed design on the channel trajectories.

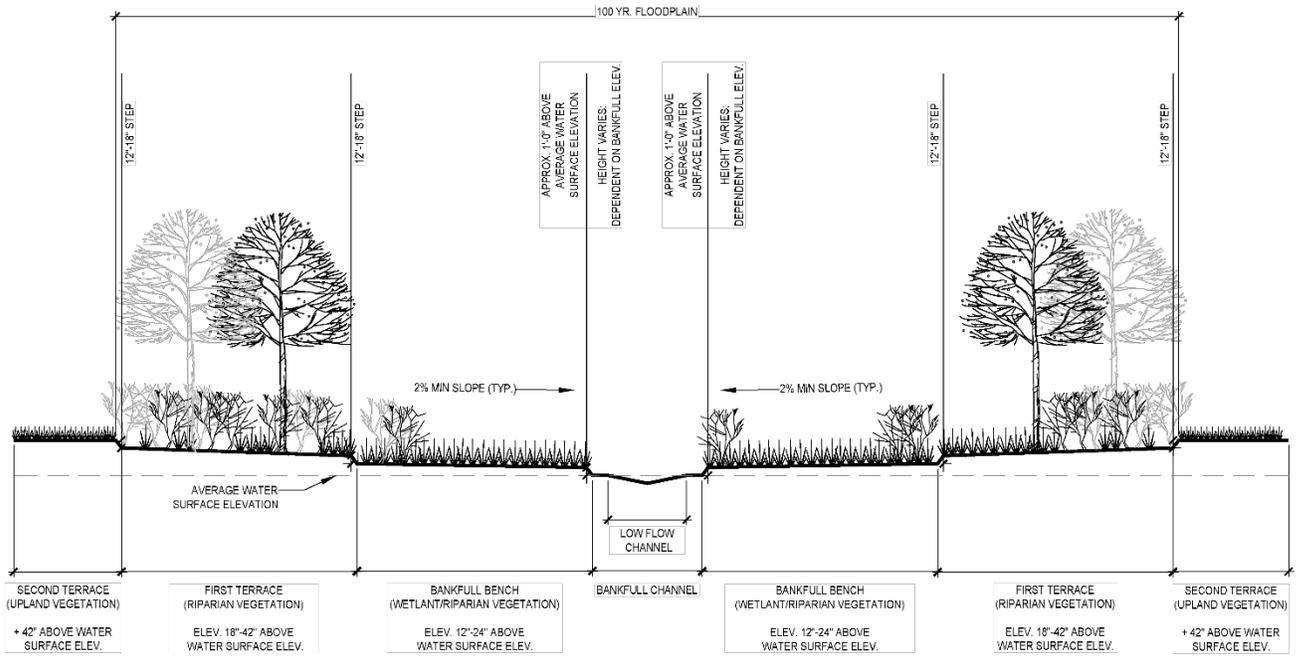
**TYPICAL CREEK ECOSYSTEM SECTION**  
SCALE: 1/8"=1'-0"

Figure 43. Typical Creek Ecosystem Section

Wetland plants will be located closer to the limits of the bankfull height between 0"-24" above the base flow water surface elevation. Riparian plants will be planted at elevation between 18"-42" above the base flow water surface elevation. Upland plants will be planted at elevations greater than 42" above the base flow water surface elevation.

For more information on planting locations and heights, please see Figure 43. Typical Creek Ecosystem Section.

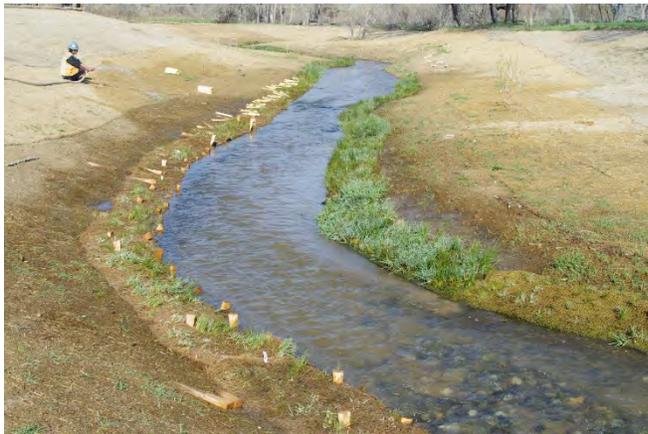
Figure 44. Wetland/Riparian Sod during installation: May 2016

**Wetland Sod and Riparian Sod:** The Design Team will use wetland sod and riparian sod as part of this project. Wetland and riparian sods are made from native plant material grown from local seed in coconut fiber blankets and installed along the creek channel for immediate revegetation. Seed will be harvested from within the project site and grown specifically for this project by a reputable supplier. That will provide an eco-type planting that will have immediate growth and be naturally adapted to this area.

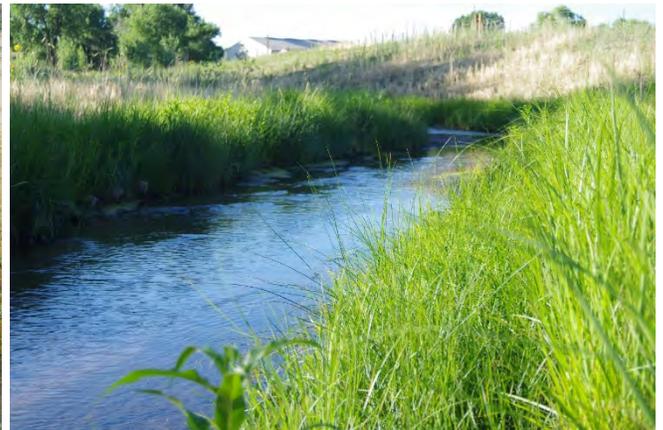
Figure 45. Wetland/Riparian Sod: July 2016

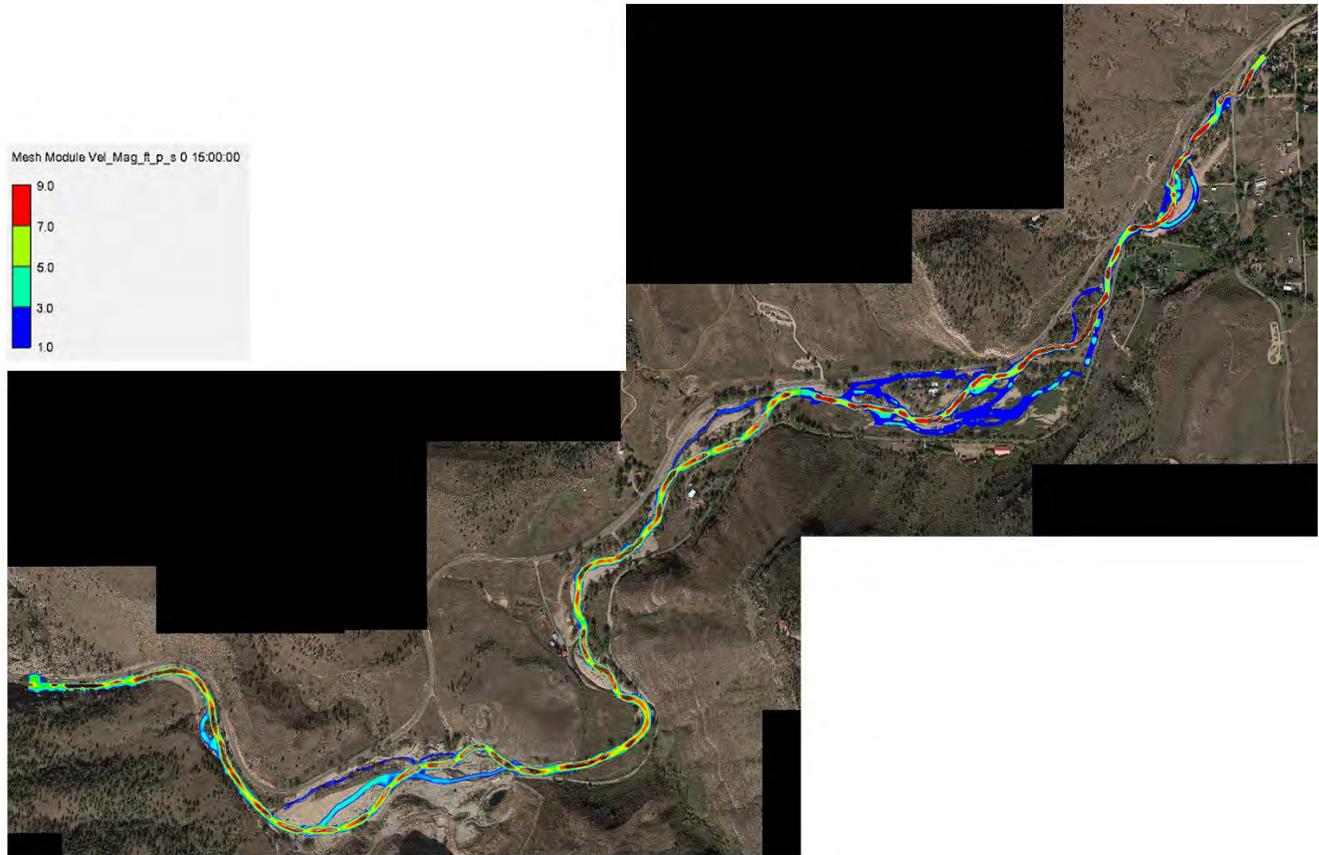
Figure 48. 5-year Peak Discharge Velocities

The velocity map shows creek flows between 1-9+ feet per second (ft/s) at the 5-year peak discharge. Specific locations where velocities were higher and/or infrastructure needed to be protected were selected to receive bioengineering treatments that would resist initial velocities greater than or equal to the 5-year peak discharge ensuring increased protection of vital assets. The bioengineering treatments used are identified per area in Table 17. Bank Stabilization: Bioengineering Treatments.

The Design Team used these design criteria to evaluate the permissible velocities of bioengineering treatments and created a map showing the velocities of the proposed condition during a 5-year peak discharge. This map was then analyzed and used to apply bioengineering treatments in locations that would withstand the “initial” velocities during the 5-year event. See Figure 48 5-year Peak Discharge Velocities.

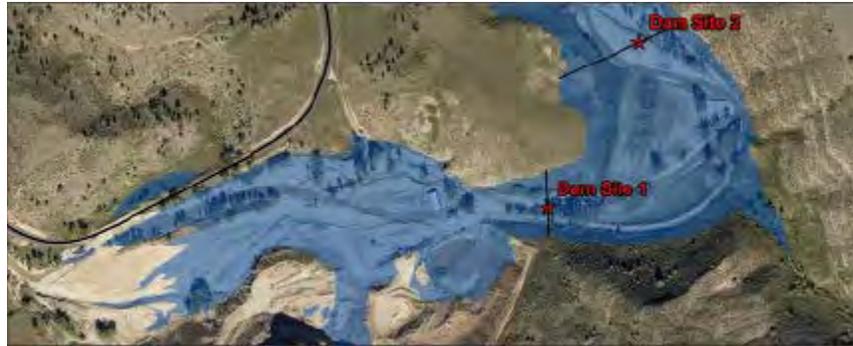
Figure 49. Alternative Dam Locations

The St. Vrain Creek Master Plan evaluated two different dam locations in vicinity of the Andesite Quarry to provide flood storage and peak flow attenuation. For the purposes of their evaluation, the maximum dam height was set to an elevation such that Highway 7 would not be inundated during maximum storage conditions. Highway 7 is a major highway that must remain operable for emergency service vehicles. There is a potential future evaluation that could examine the realignment of Highway 7 so that is located at a higher elevation to provide more storage, but is beyond the scope of this project. The Master Plan (Baker, 2014) evaluated the benefit for flood attenuation by comparing the maximum storage capacity of each dam alternative with the volume of the inflow hydrograph.

It was determined that neither detention alternative would be feasible to implement. Placing a dam at either location would inundate infrastructure upstream and would likely not provide enough peak flow attenuation to alleviate flooding downstream. For each alternative it was determined that only 7% and 18% of the 100-year peak flow would be attenuated at Sites 1 and 2, respectively. The dam at Site 1 would be 320 feet wide and 38 feet tall, while the dam at Site 2 would be 680 feet wide and 56 feet tall.

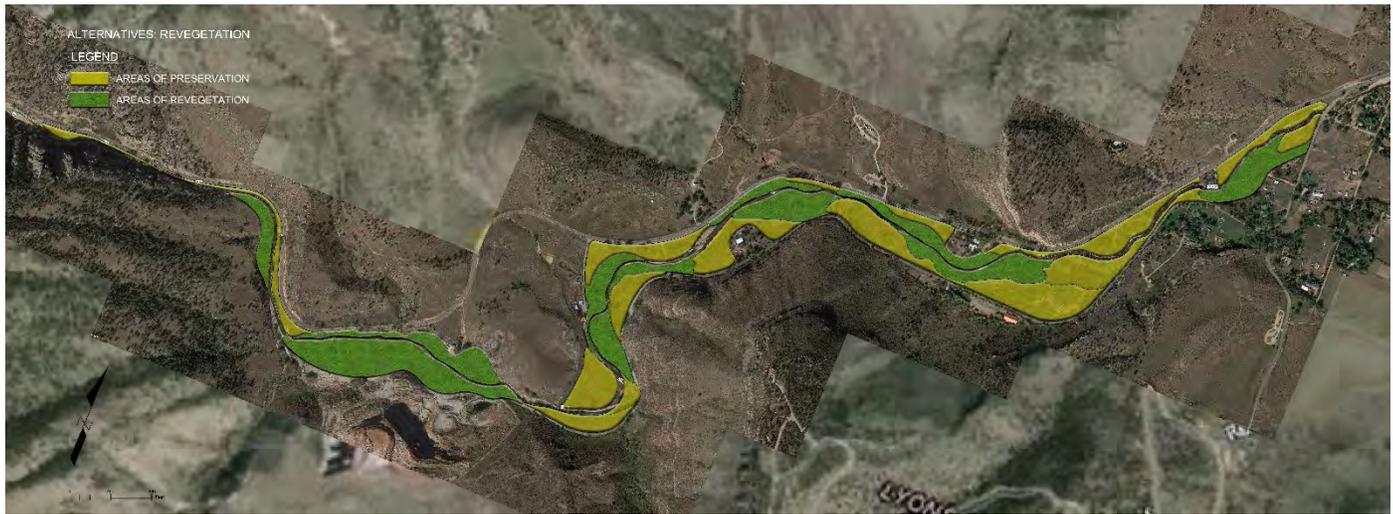
Figure 50. Areas Requiring Revegetation

The revegetation effort for this project will focus on preserving existing stands of mature and healthy vegetation and reconnecting the wetland, riparian and upland ecosystems through additional revegetation for the entire 3.2 miles.
