# Preliminary Basis of Design Report

## For South St. Vrain Creek Restoration at Hall Ranch

**Boulder County, Colorado**

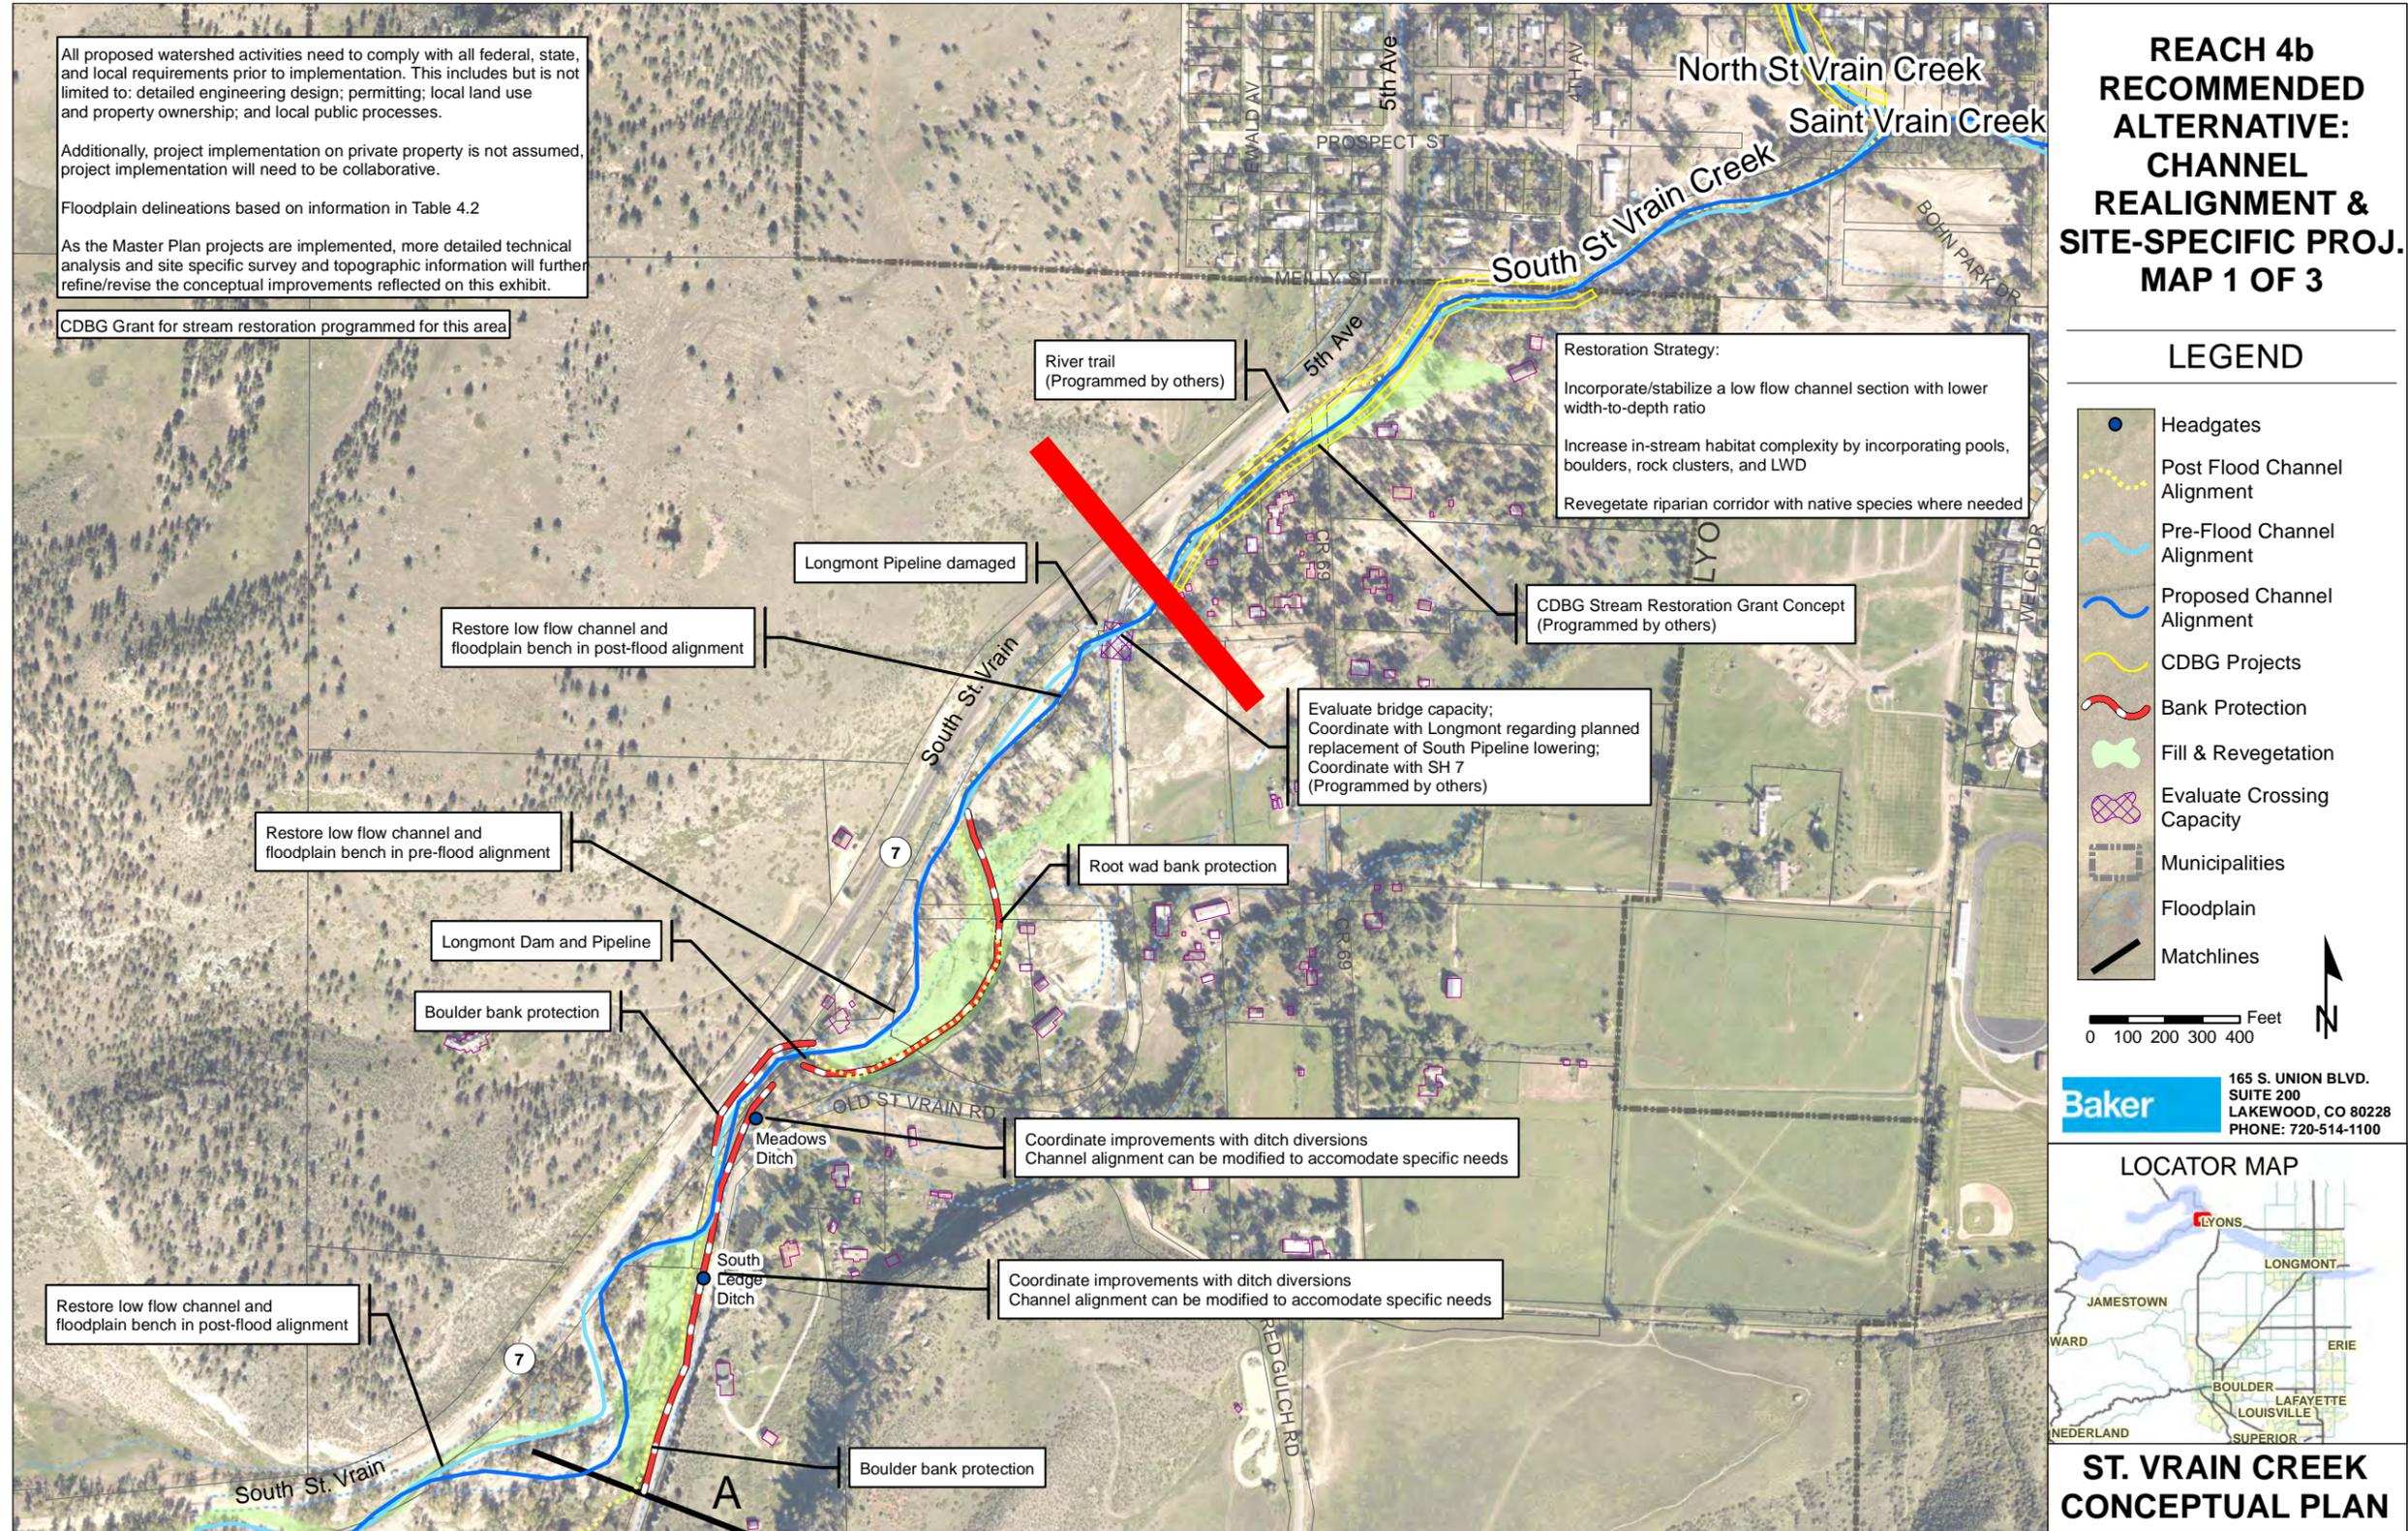
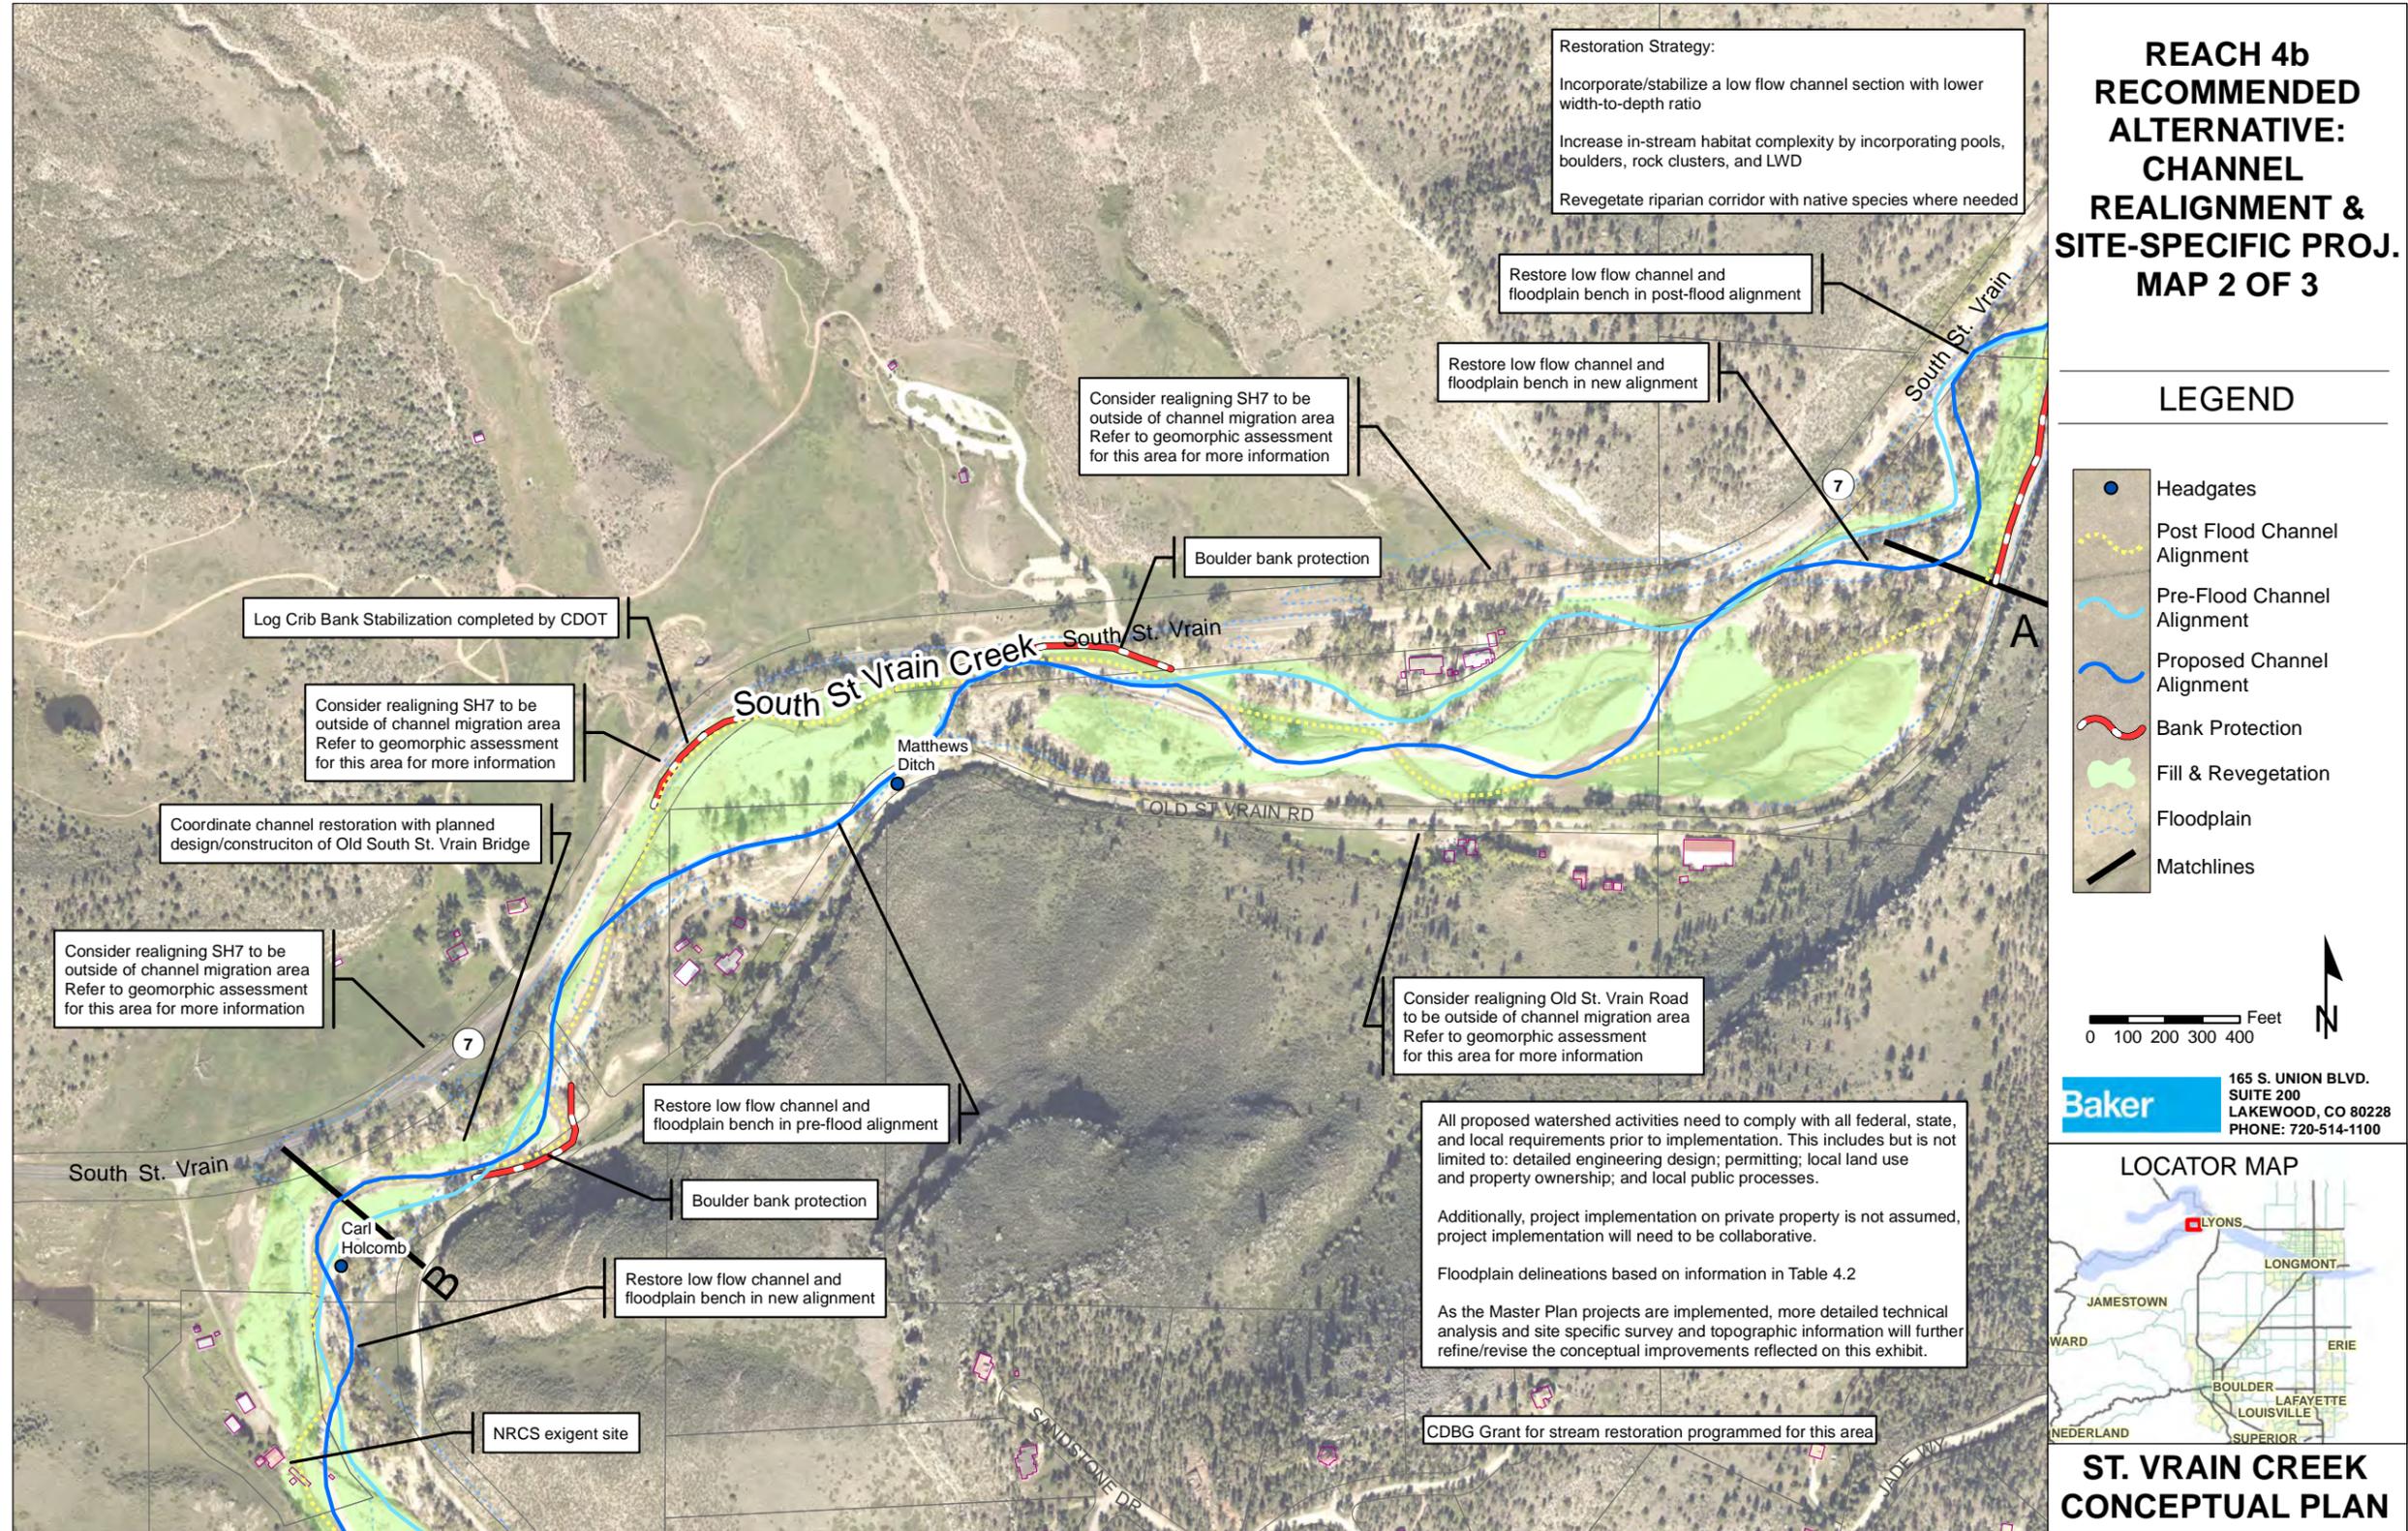
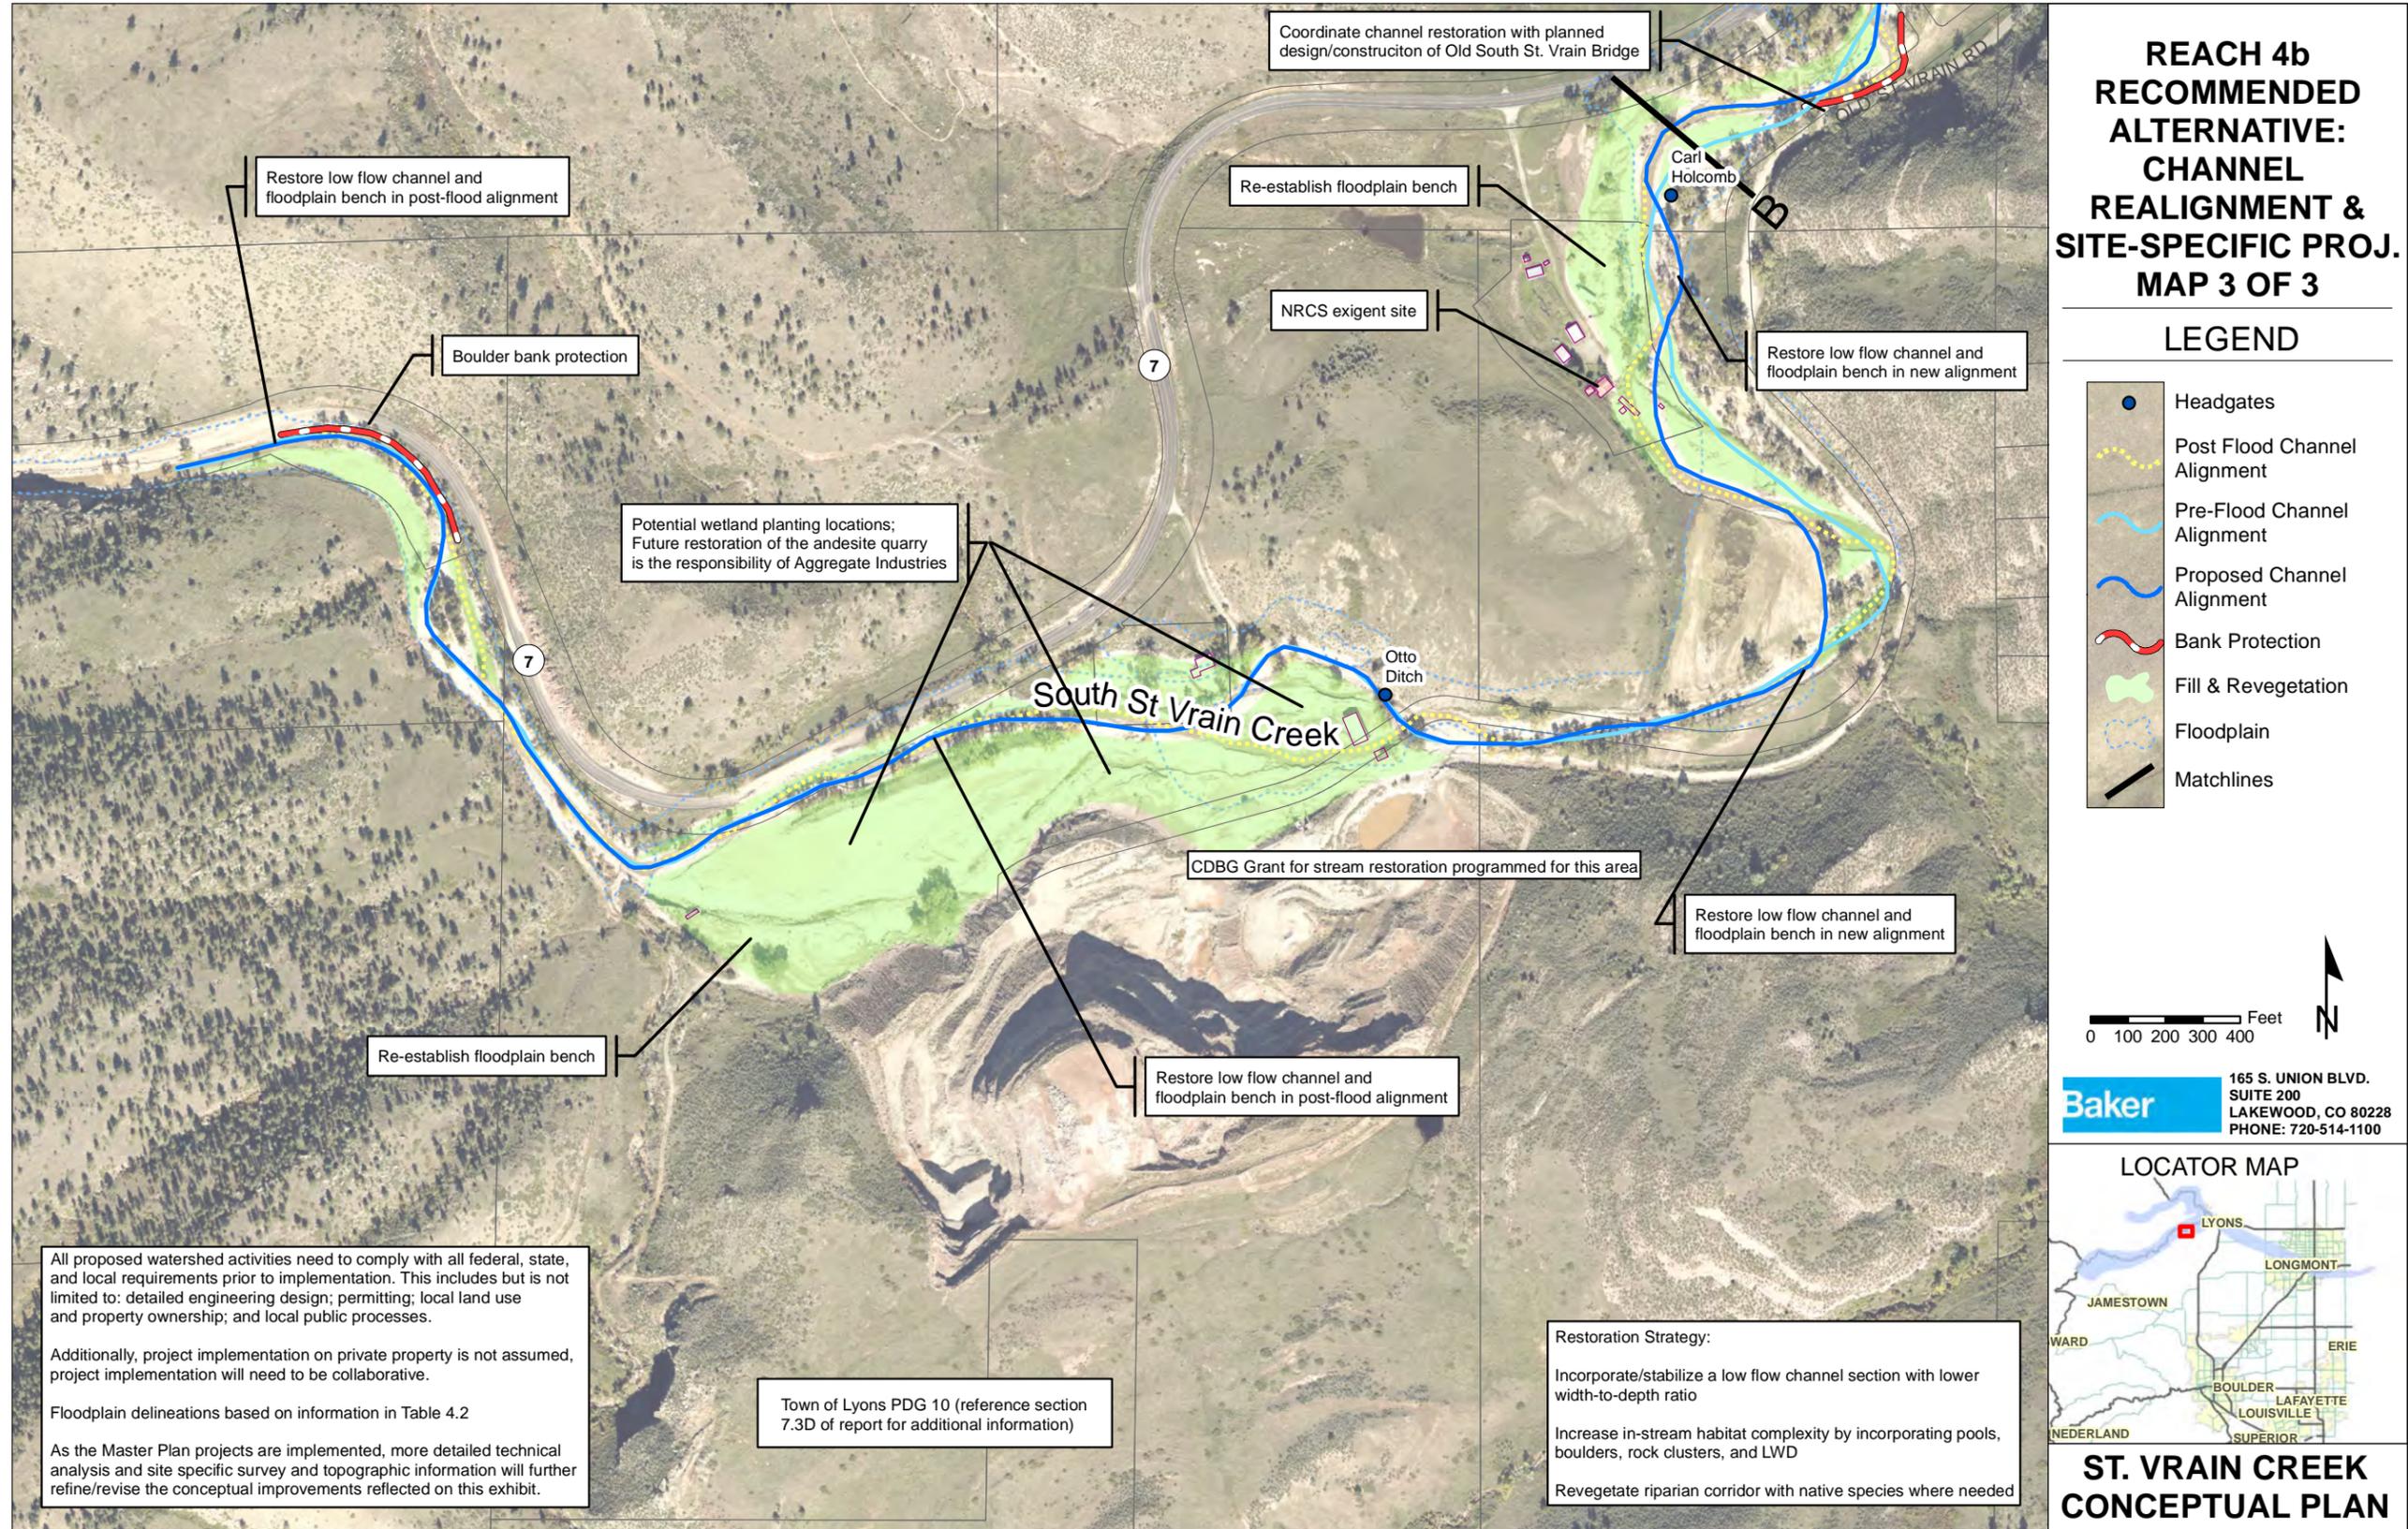
## REACH 4b RECOMMENDED ALTERNATIVE: CHANNEL REALIGNMENT & SITE-SPECIFIC PROJ. MAP 3 OF 3

The recommended plan for Reach 4b is shown on the following Figures. The purpose of this alternative is to implement a channel alignment that will optimize the interaction with completed, ongoing, and funded projects while being sensitive to the constraints presented by the presence of numerous private residences throughout this river corridor. The implementation of this alternative will expedite the maturation of this reach by re-establishing a natural channel, repairing erosion scars, re-establishing floodplain benches, building point-bars and excavating pools, re-vegetating denuded areas, and stabilizing channel banks. The Baker Team conducted a feasibility analysis during the planning process to evaluate the potential for detention in the vicinity of Andesite Quarry as outlined in PDG 10. The analysis showed a lack of significant reduction in downstream flood risk and concluded that such a facility would not be cost beneficial as a result of the large cost of designing, building, maintaining, and operating such a facility with limited public benefit. Thus, the study did not recommend this flood control measure. If desired by the Town of Lyons and others, additional analysis could be undertaken to further evaluate the feasibility of detention at this location and whether it could be made more cost beneficial. Any further analysis would require additional engineering studies, cost-benefit analysis, and environmental investigations including an evaluation of the potential impacts to in-stream and riparian habitats that such a facility would create both upstream and downstream. See Appendix D and G for more information.

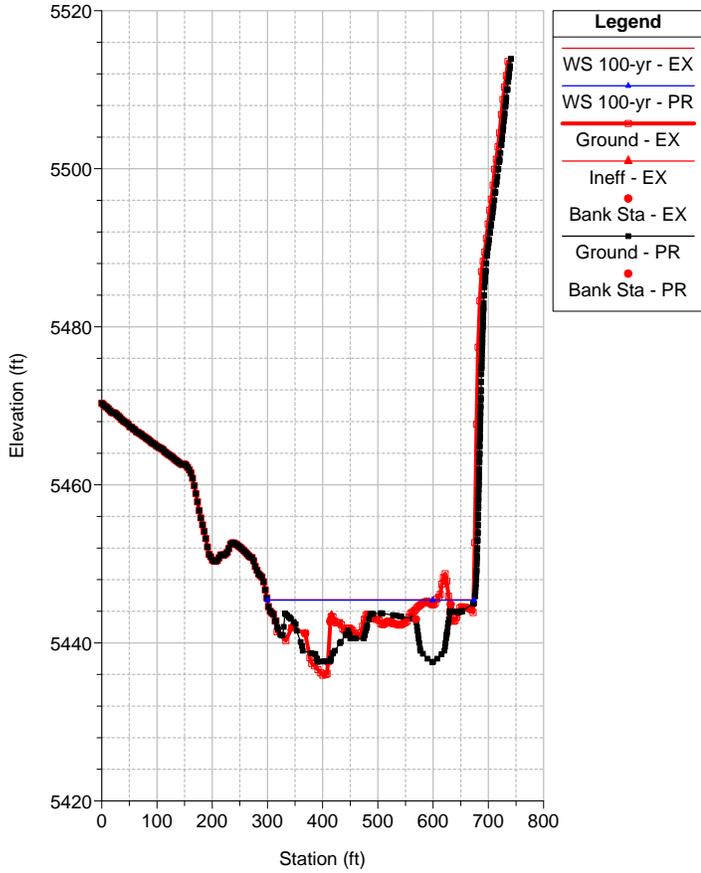
South St Vrain Creek Plan: 1) PR 2) EX  
River = South St Vrain Reach = South Fork RS = 19965

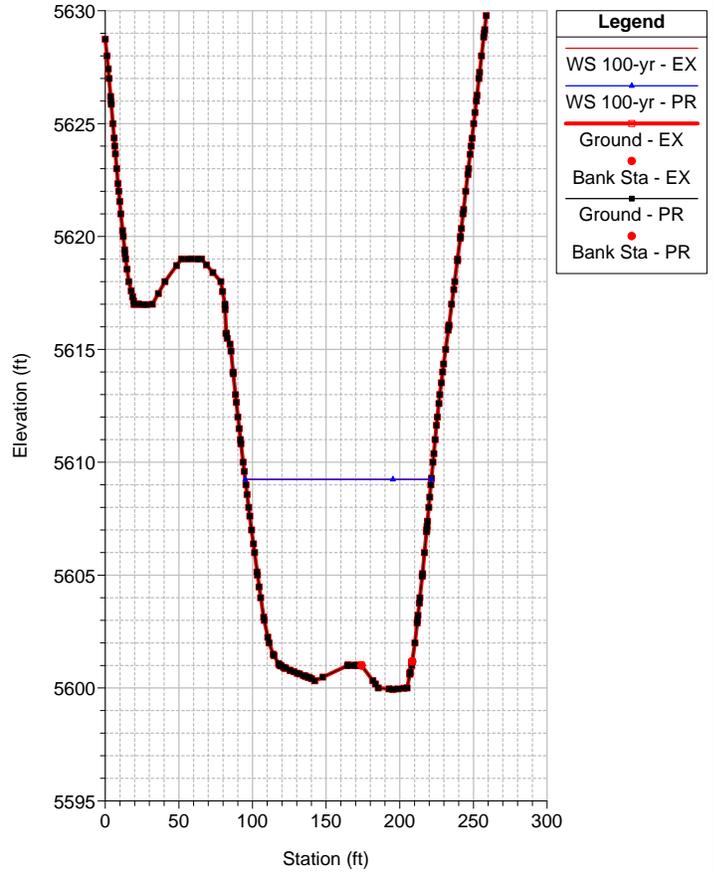
South St Vrain Creek Plan: 1) PR 2) EX  
River = South St Vrain Reach = South Fork RS = 19694

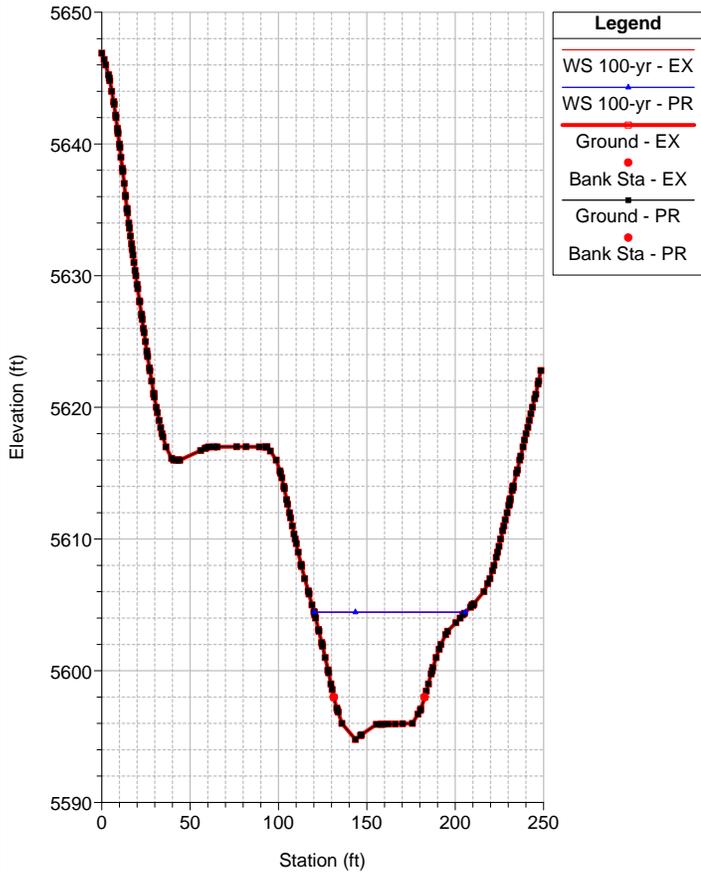
South St Vrain Creek Plan: 1) PR 2) EX  
River = South St Vrain Reach = South Fork RS = 19365

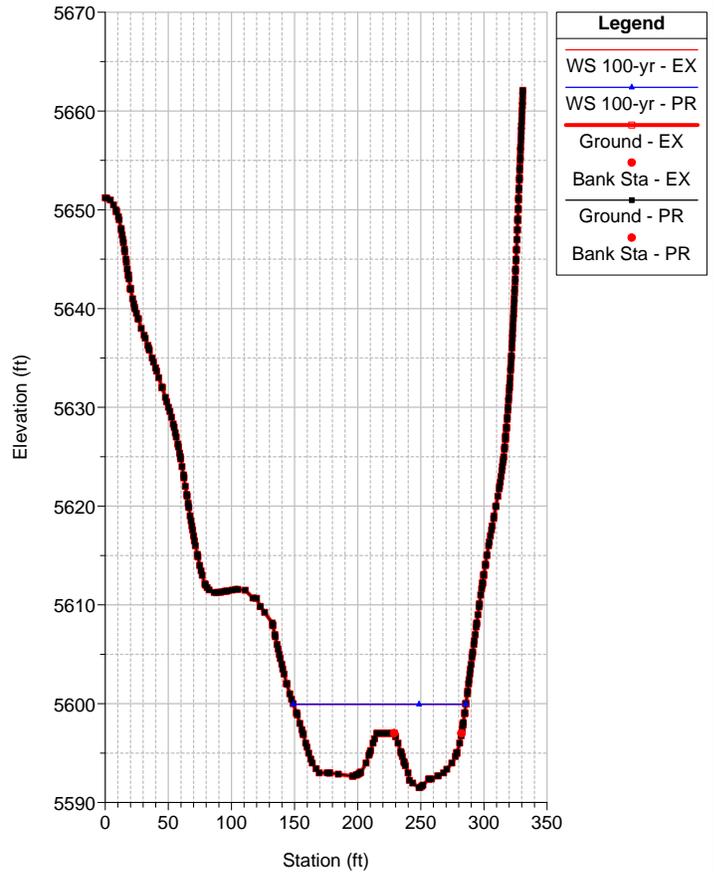
South St Vrain Creek Plan: 1) PR 2) EX  
 River = South St Vrain Reach = South Fork RS = 19078

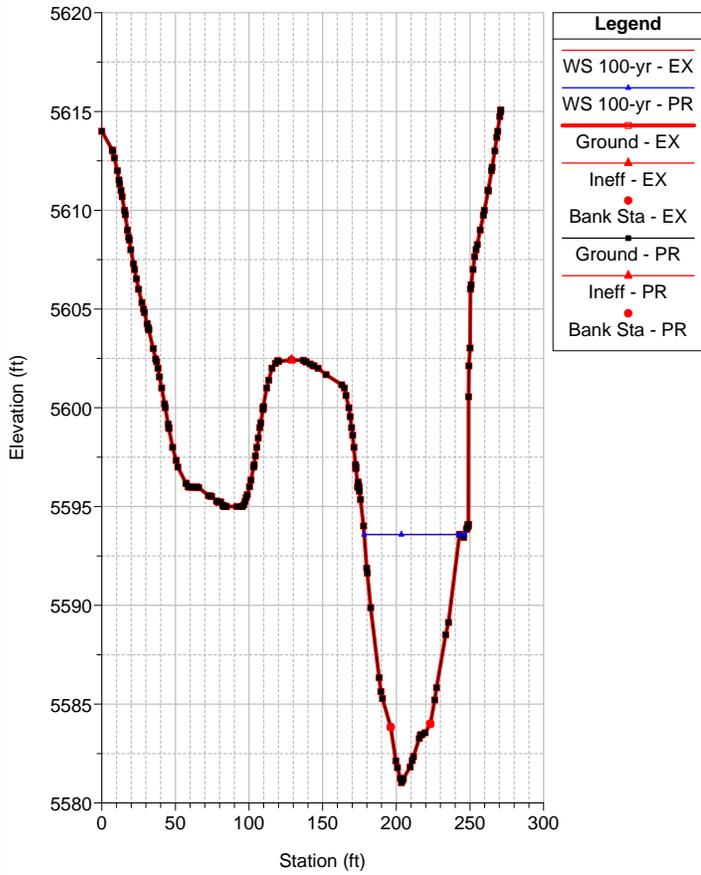
South St Vrain Creek Plan: 1) PR 2) EX  
 River = South St Vrain Reach = South Fork RS = 18811

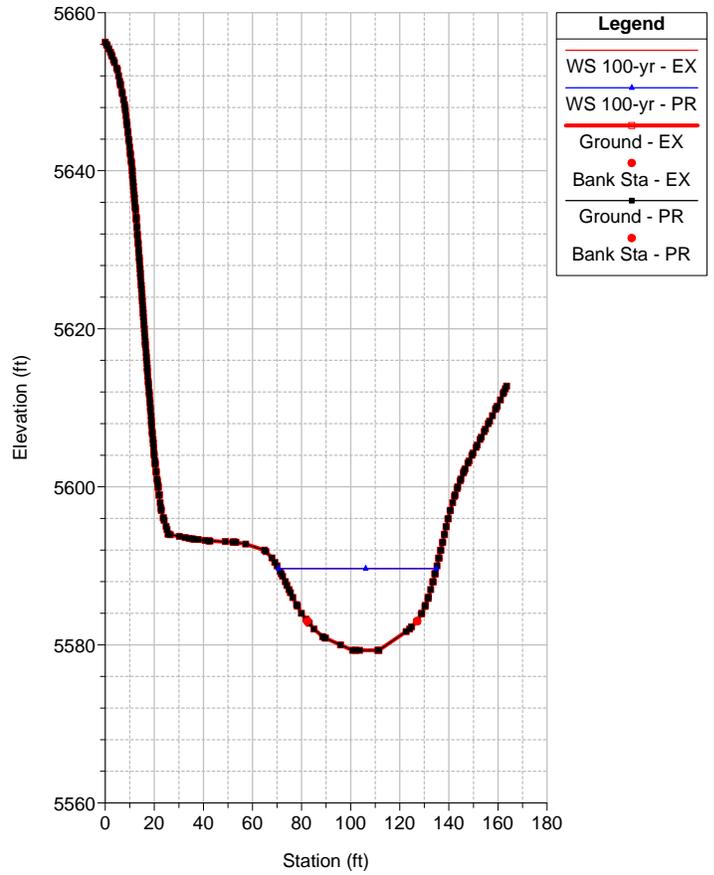
South St Vrain Creek Plan: 1) PR 2) EX  
 River = South St Vrain Reach = South Fork RS = 18529

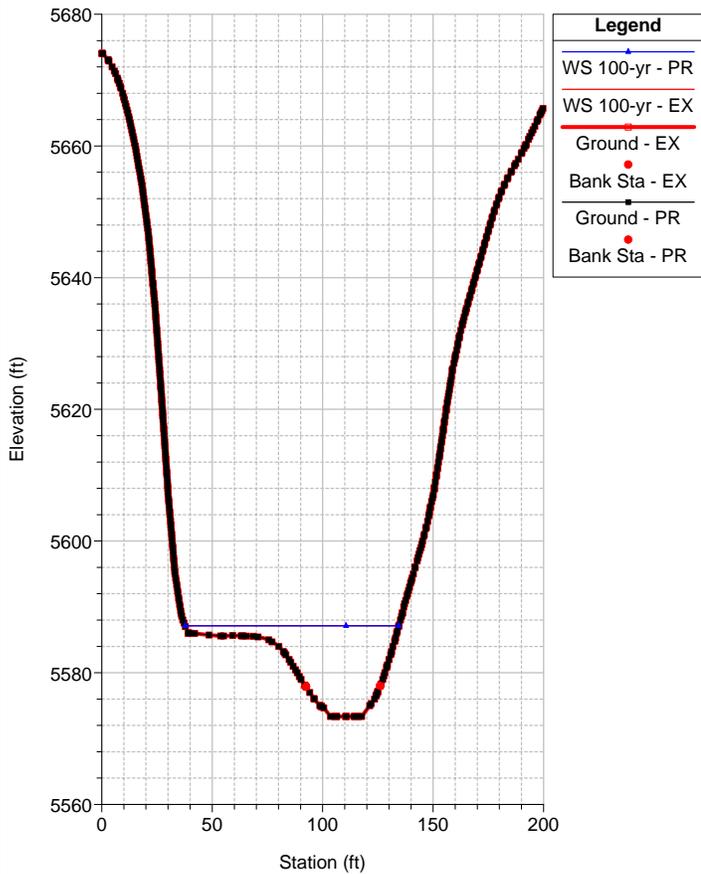
South St Vrain Creek Plan: 1) PR 2) EX  
 River = South St Vrain Reach = South Fork RS = 18274

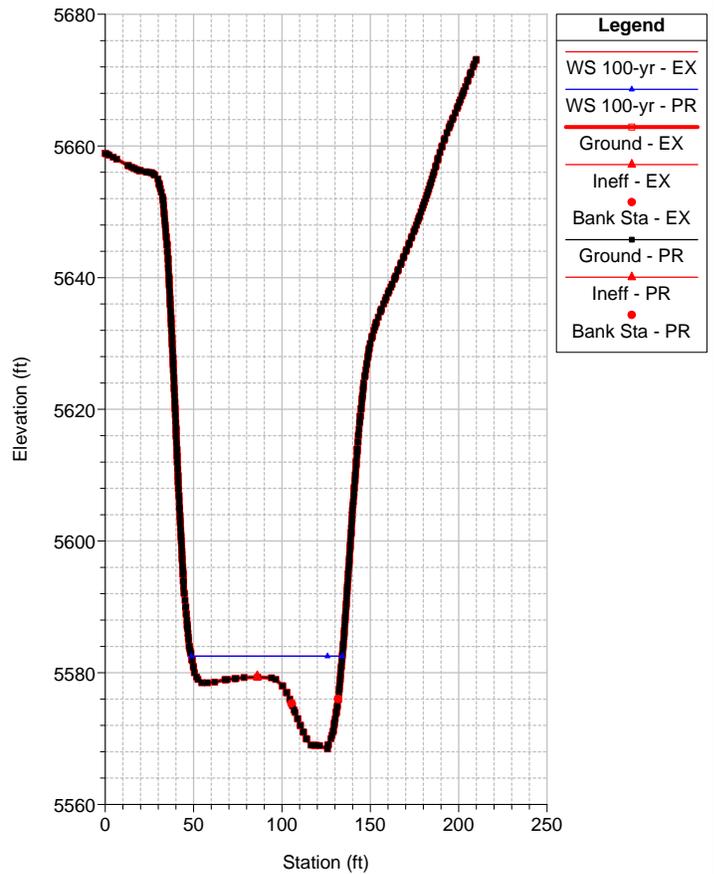
South St Vrain Creek Plan: 1) PR 2) EX  
 River = South St Vrain Reach = South Fork RS = 18017

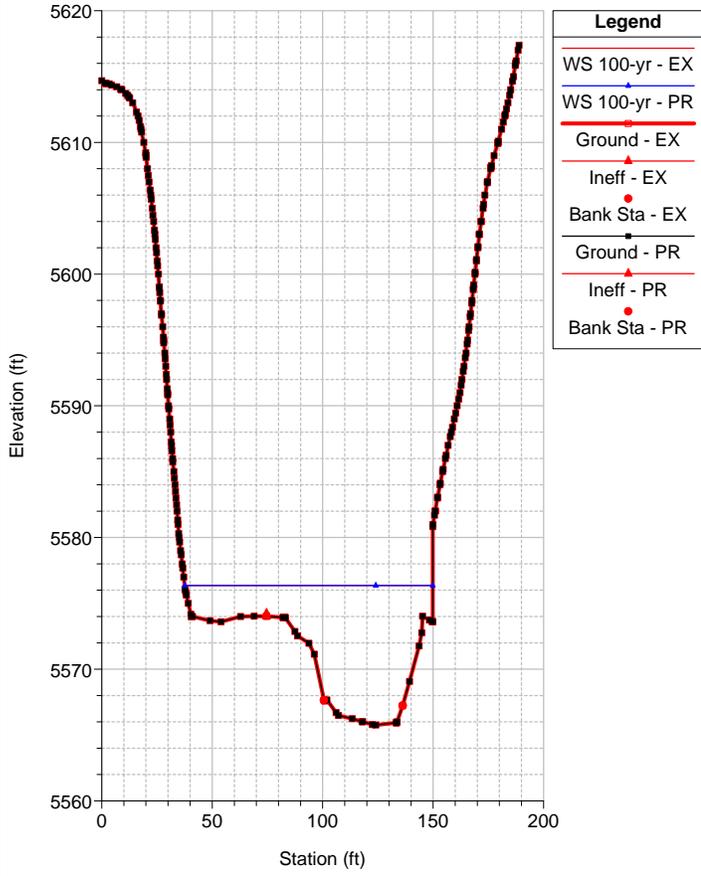
South St Vrain Creek Plan: 1) PR 2) EX  
 River = South St Vrain Reach = South Fork RS = 17767

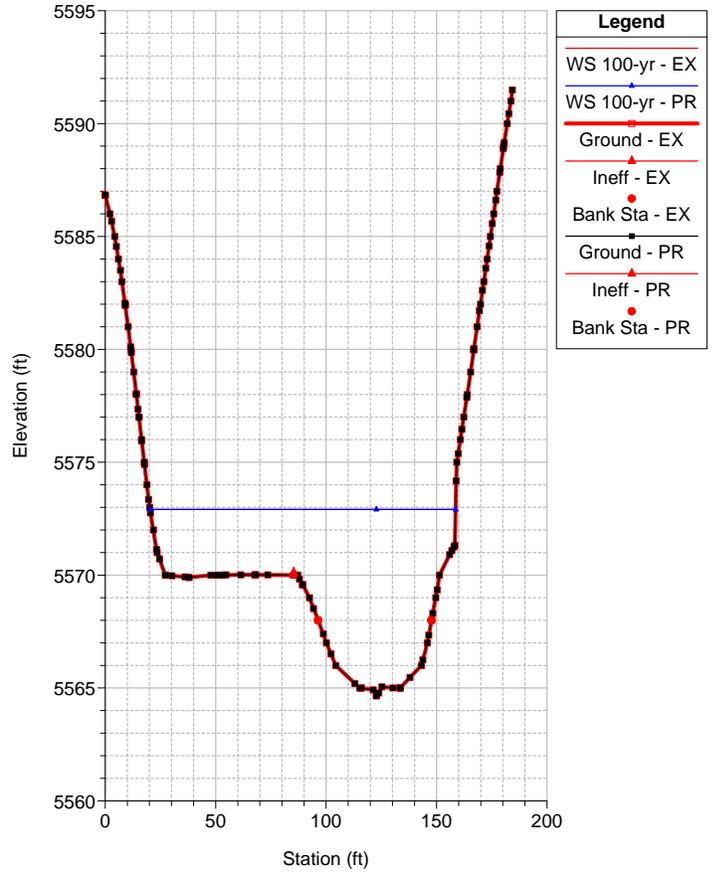
South St Vrain Creek Plan: 1) PR 2) EX  
 River = South St Vrain Reach = South Fork RS = 17519 SSVc\_06XS

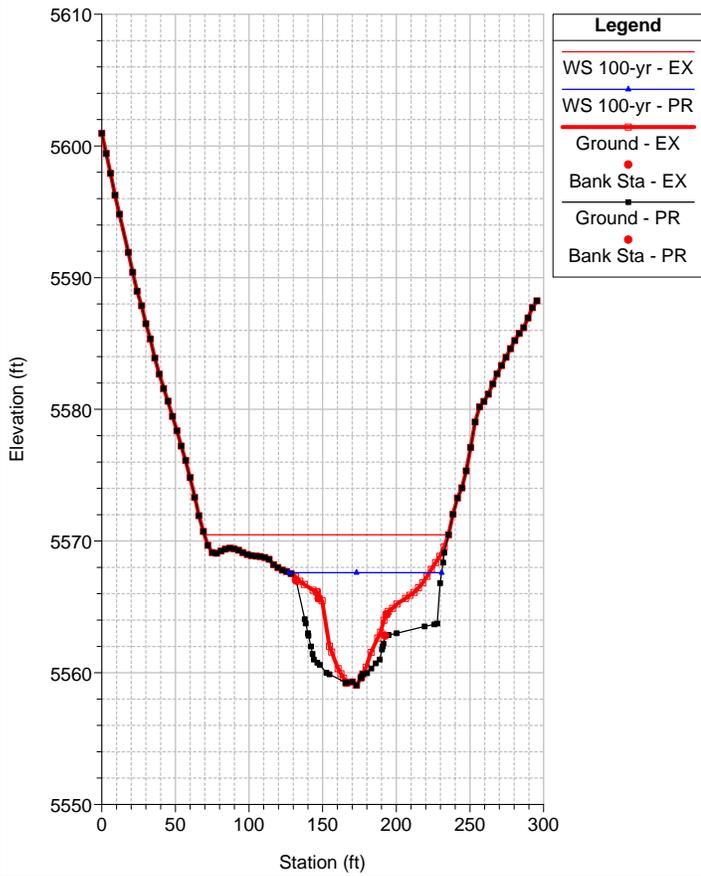
South St Vrain Creek Plan: 1) PR 2) EX  
 River = South St Vrain Reach = South Fork RS = 17202 Civil Arts 4/26/16

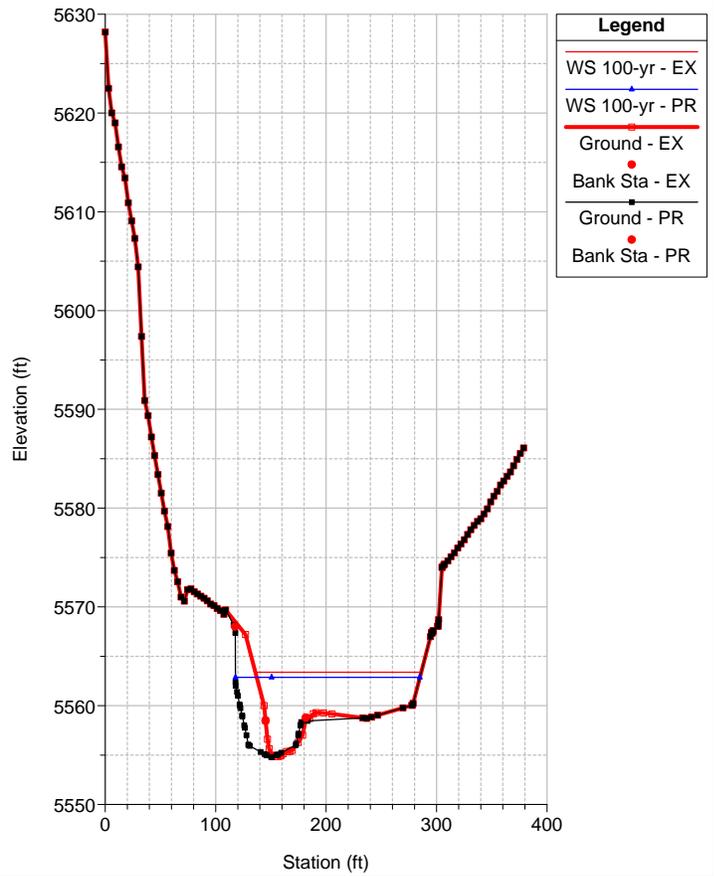
South St Vrain Creek Plan: 1) PR 2) EX  
 River = South St Vrain Reach = South Fork RS = 16961 2014 Lidar

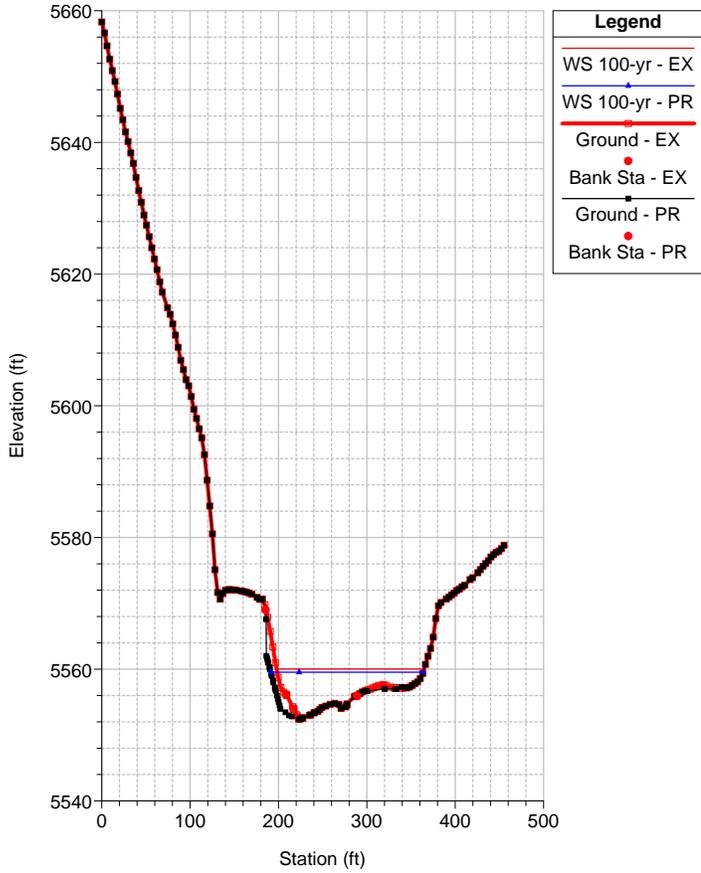
South St Vrain Creek Plan: 1) PR 2) EX  
 River = South St Vrain Reach = South Fork RS = 16757 Civil Arts 4/26/2016

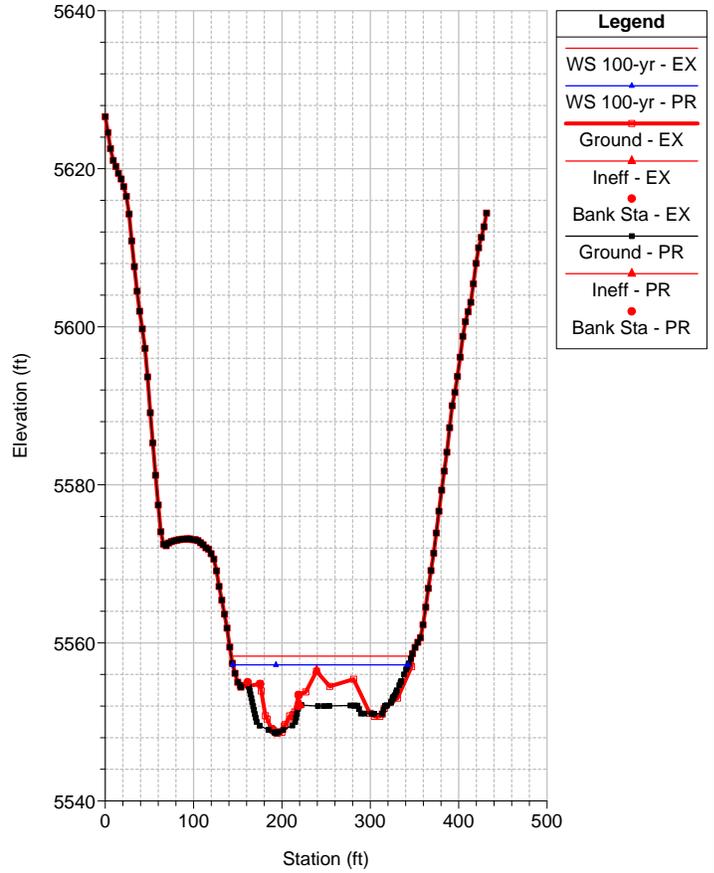
South St Vrain Creek Plan: 1) PR 2) EX  
 River = South St Vrain Reach = South Fork RS = 16437 Civil Arts 4/26/16

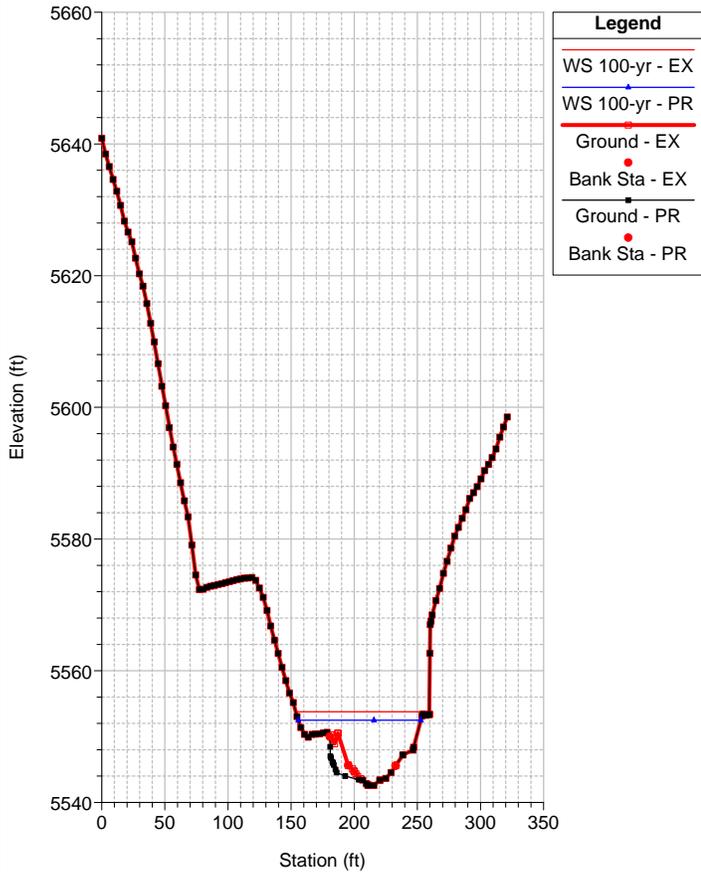
South St Vrain Creek Plan: 1) PR 2) EX  
 River = South St Vrain Reach = South Fork RS = 15910 Civil Arts 4/26/16

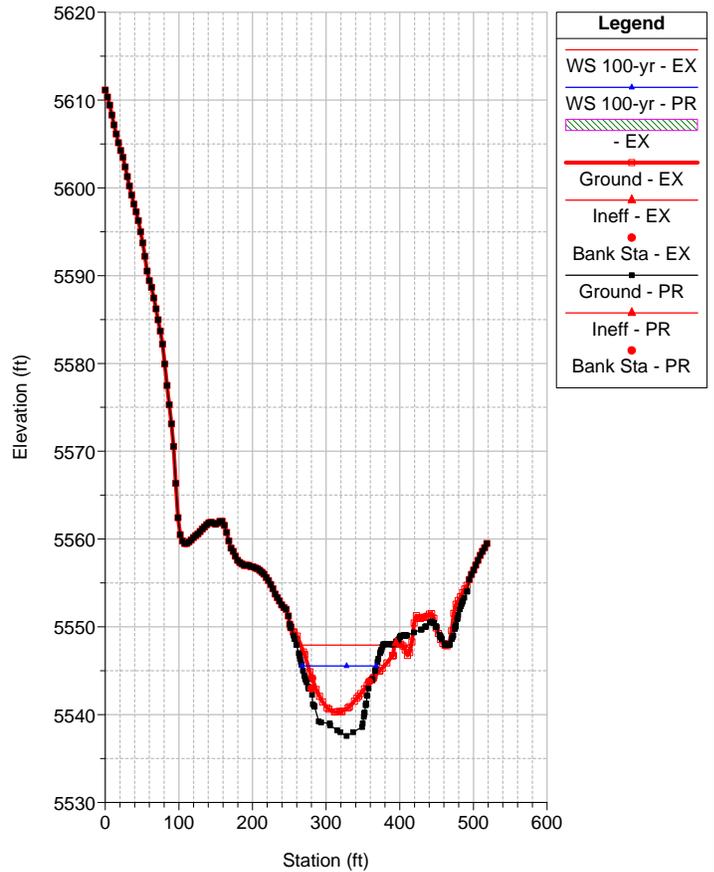
South St Vrain Creek Plan: 1) PR 2) EX  
 River = South St Vrain Reach = South Fork RS = 15543 Civil Arts 4/26/16

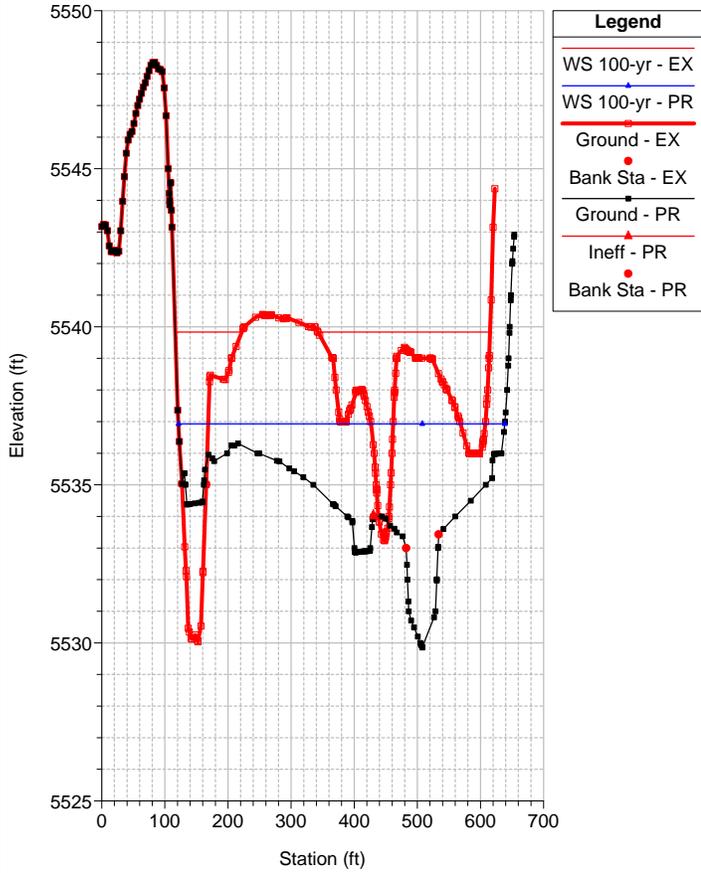
South St Vrain Creek Plan: 1) PR 2) EX  
 River = South St Vrain Reach = South Fork RS = 15044 Civil Arts 4/26/16
