# Preliminary Basis of Design Report

## For South St. Vrain Creek Restoration at Hall Ranch

**Boulder County, Colorado**

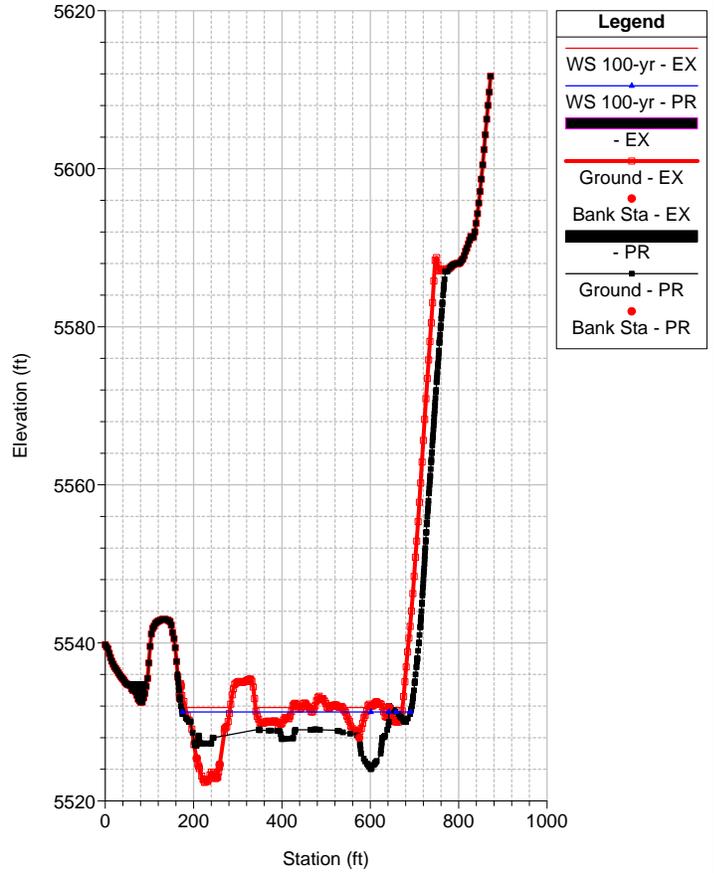
South St Vrain Creek Plan: 1) PR 2) EX  
 River = South St Vrain Reach = South Fork RS = 14567 Civil Arts 4/26/16

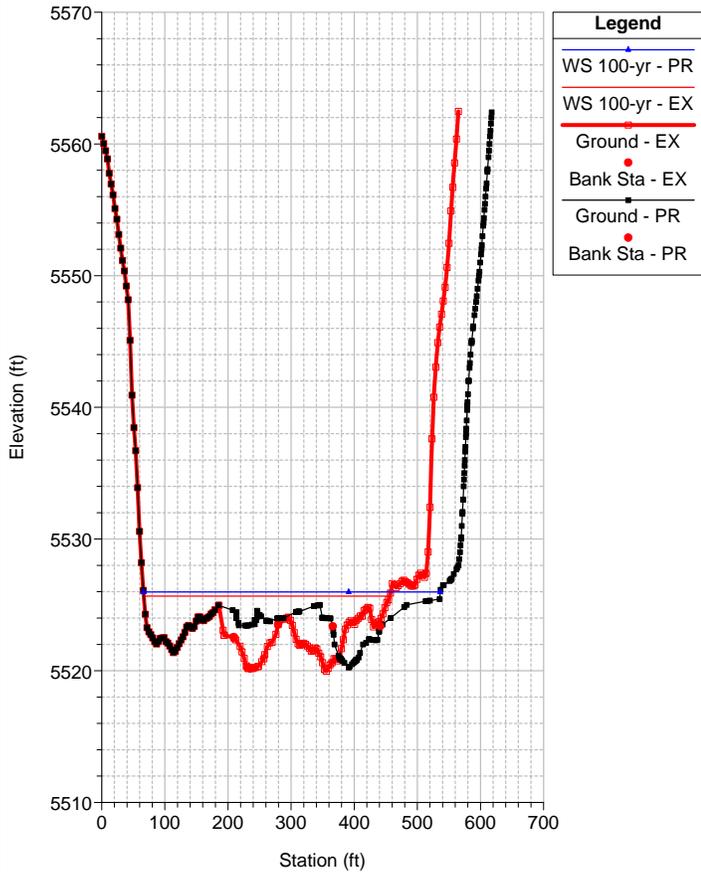
South St Vrain Creek Plan: 1) PR 2) EX  
 River = South St Vrain Reach = South Fork RS = 14423 2014 Lidar

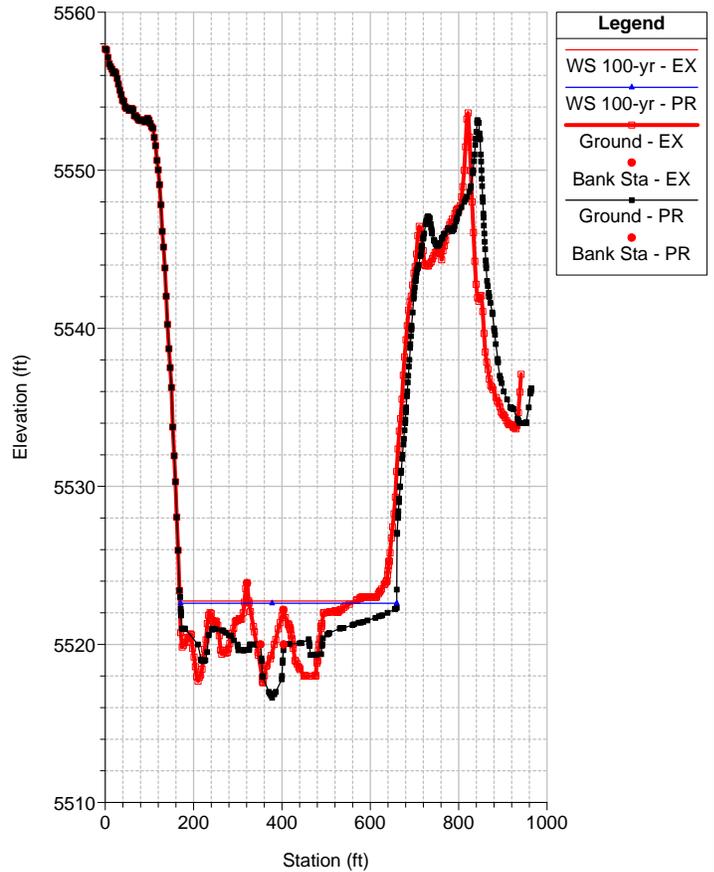
South St Vrain Creek Plan: 1) PR 2) EX  
 River = South St Vrain Reach = South Fork RS = 14143 AECOM SSVV\_05XS

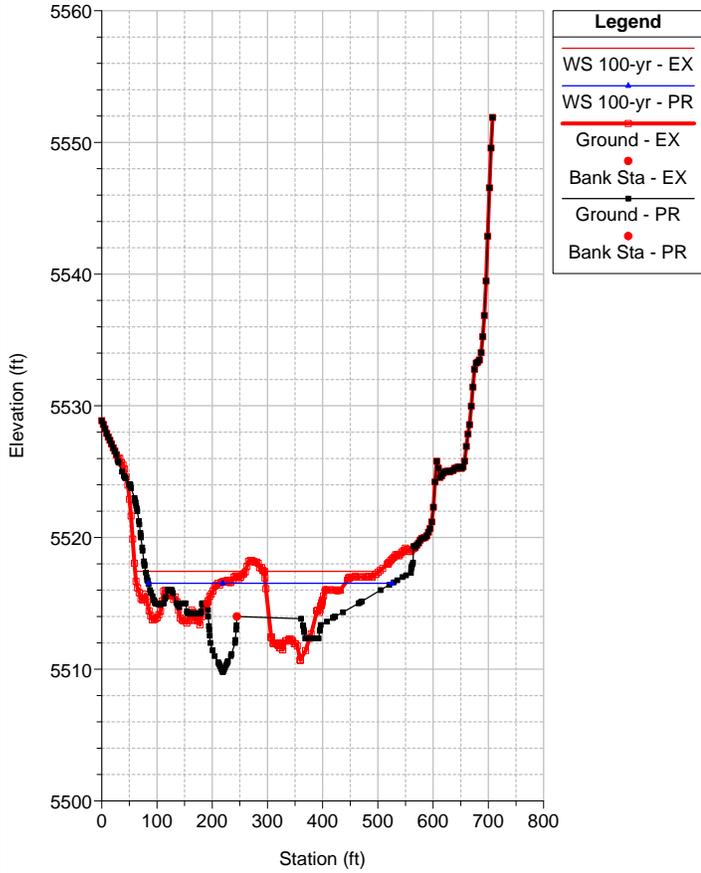
South St Vrain Creek Plan: 1) PR 2) EX  
 River = South St Vrain Reach = South Fork RS = 13669 Civil Arts 4/26/16

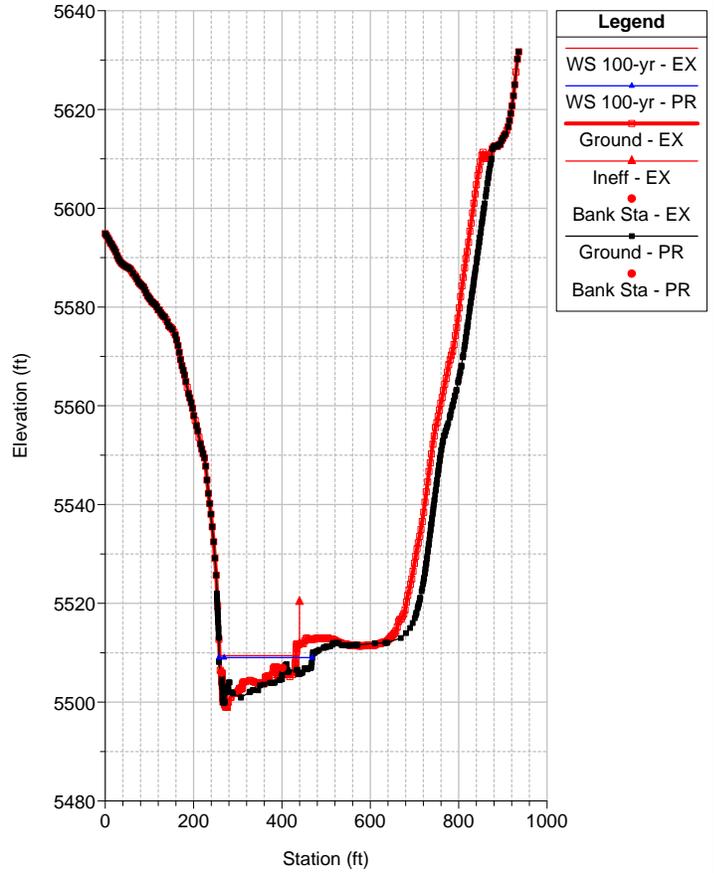
South St Vrain Creek Plan: 1) PR 2) EX  
 River = South St Vrain Reach = South Fork RS = 13290 Civil Arts 4/26/2016

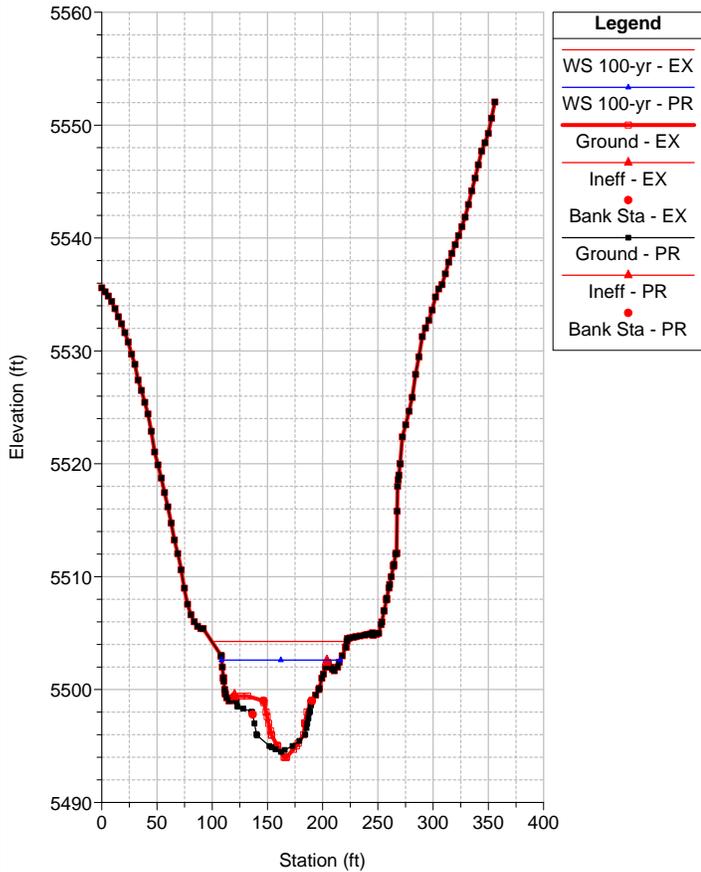
South St Vrain Creek Plan: 1) PR 2) EX  
 River = South St Vrain Reach = South Fork RS = 12768 Civil Arts 4/26/16

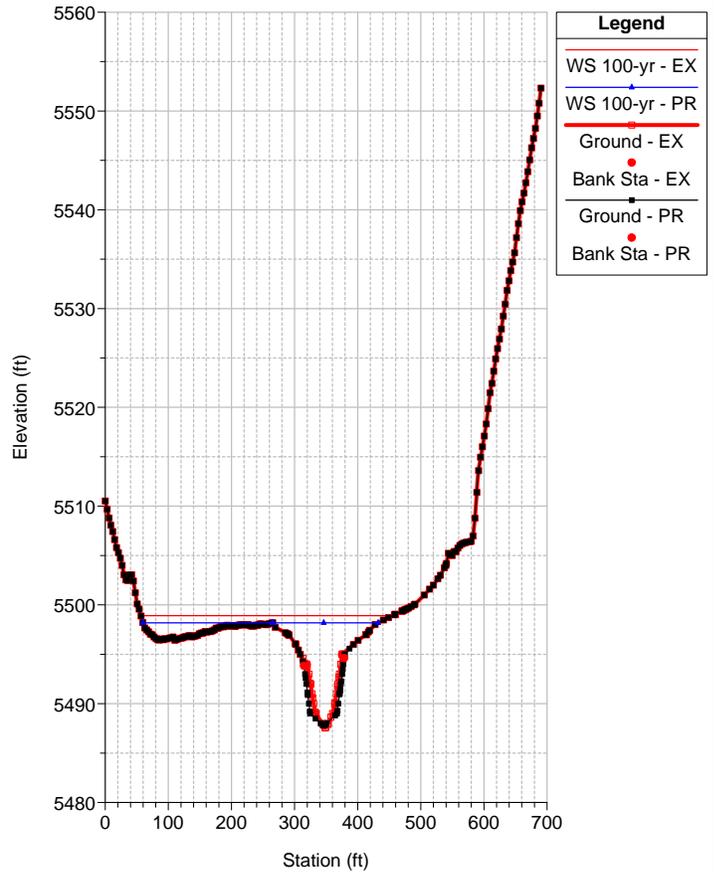
South St Vrain Creek Plan: 1) PR 2) EX  
 River = South St Vrain Reach = South Fork RS = 12220 Civil Arts 4/25/16

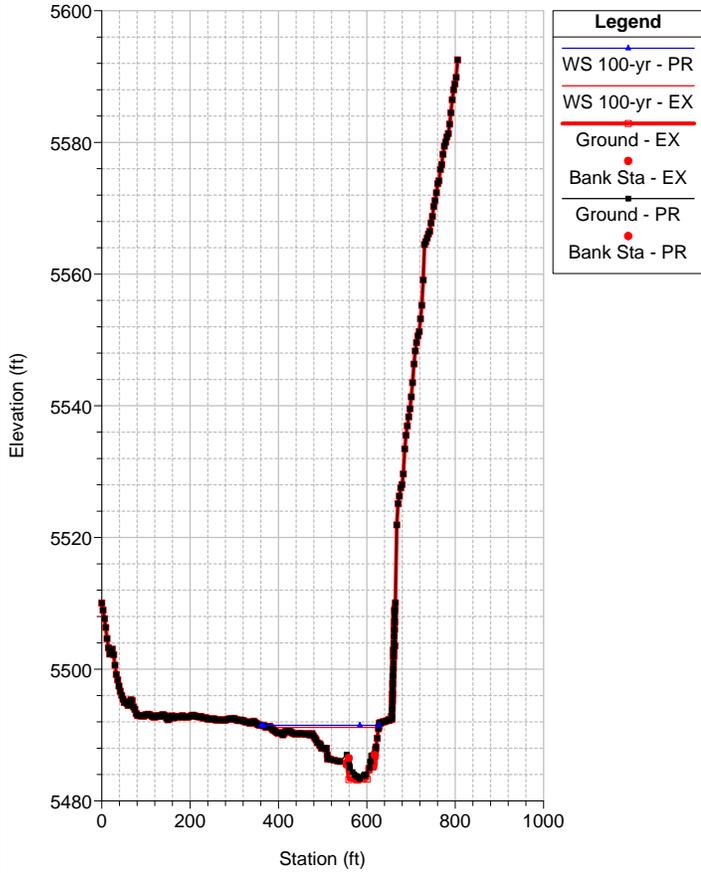
South St Vrain Creek Plan: 1) PR 2) EX  
 River = South St Vrain Reach = South Fork RS = 11851 Civil Arts 4/25/16

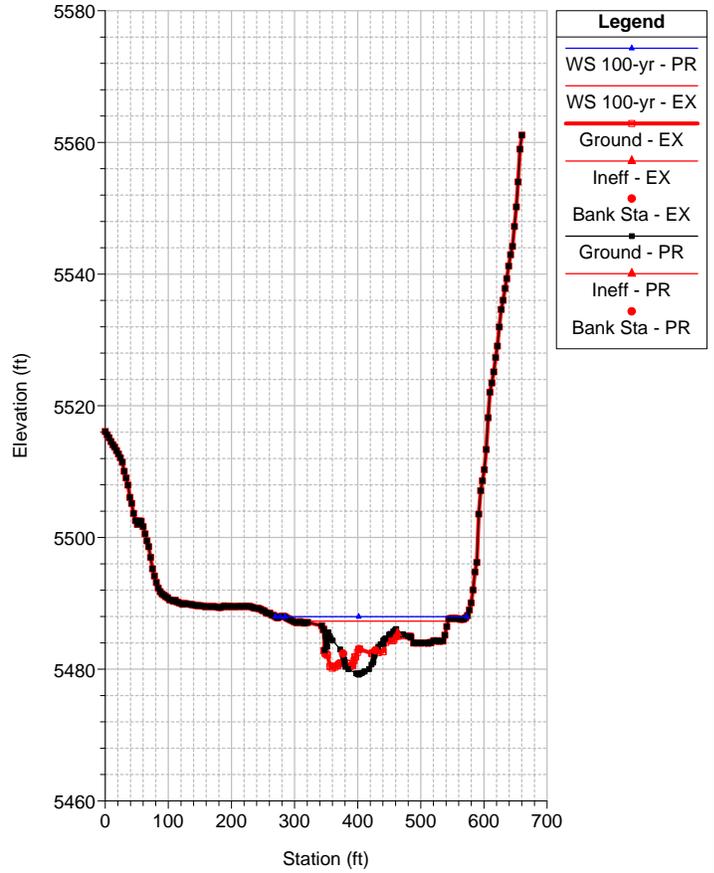
South St Vrain Creek Plan: 1) PR 2) EX  
 River = South St Vrain Reach = South Fork RS = 11459 Civil Arts 4/25/16

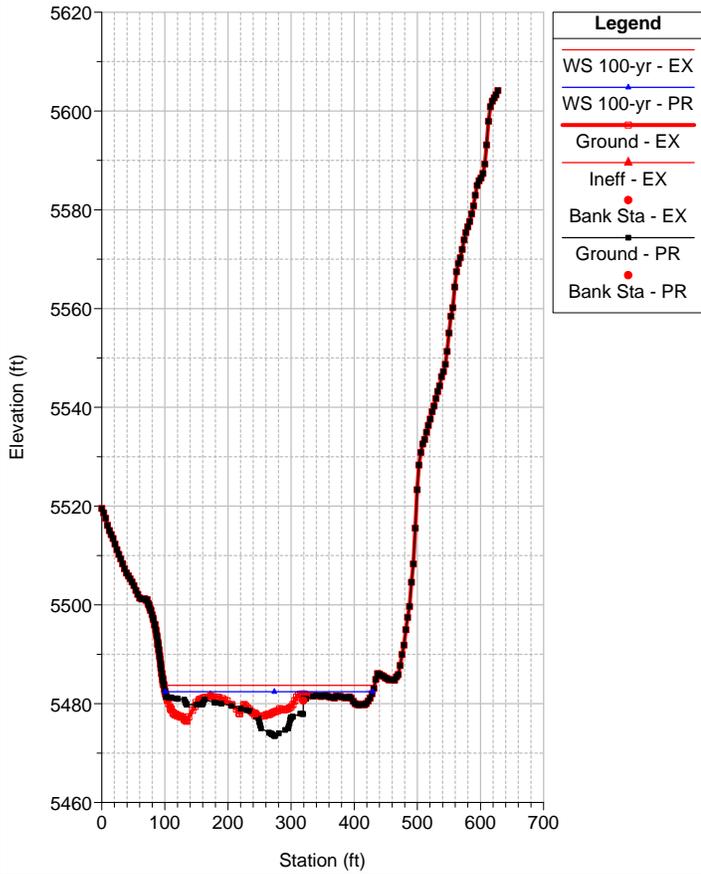
South St Vrain Creek Plan: 1) PR 2) EX  
 River = South St Vrain Reach = South Fork RS = 11090 Civil Arts 4/25/16

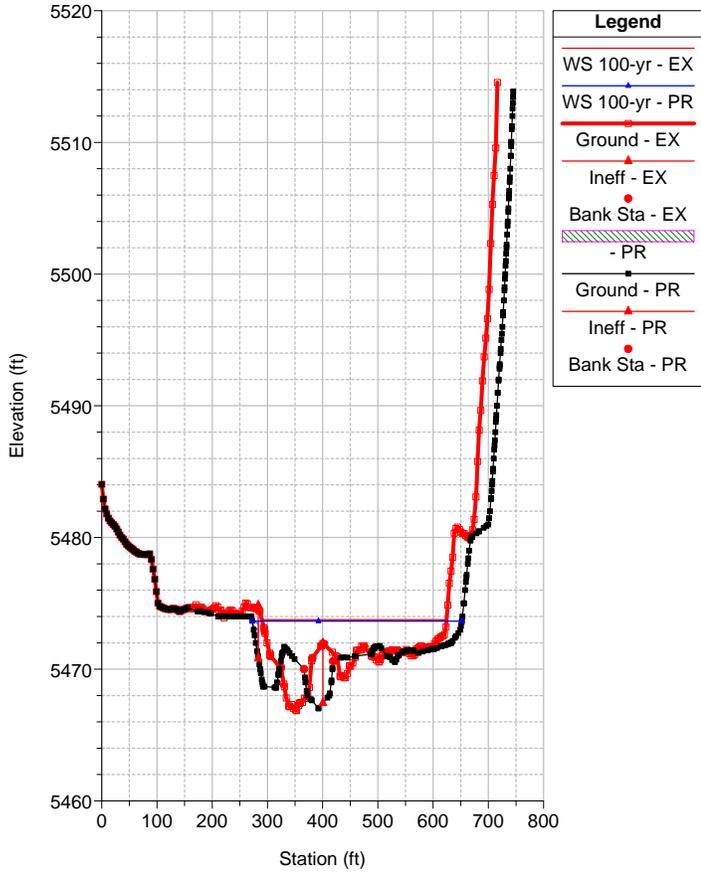
South St Vrain Creek Plan: 1) PR 2) EX  
 River = South St Vrain Reach = South Fork RS = 10660 Civil Arts 4/25/16

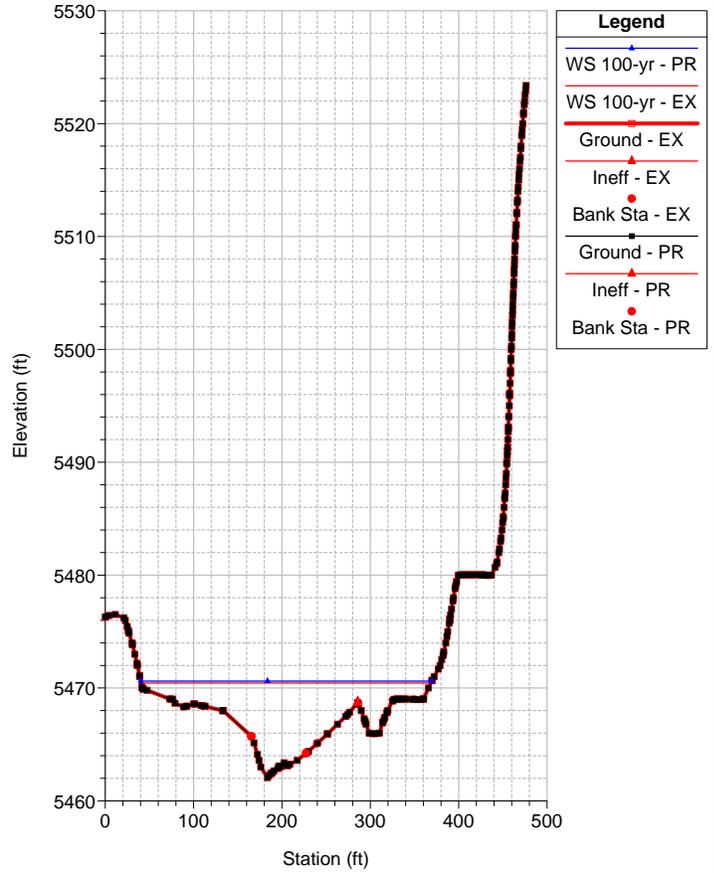
South St Vrain Creek Plan: 1) PR 2) EX  
 River = South St Vrain Reach = South Fork RS = 10427

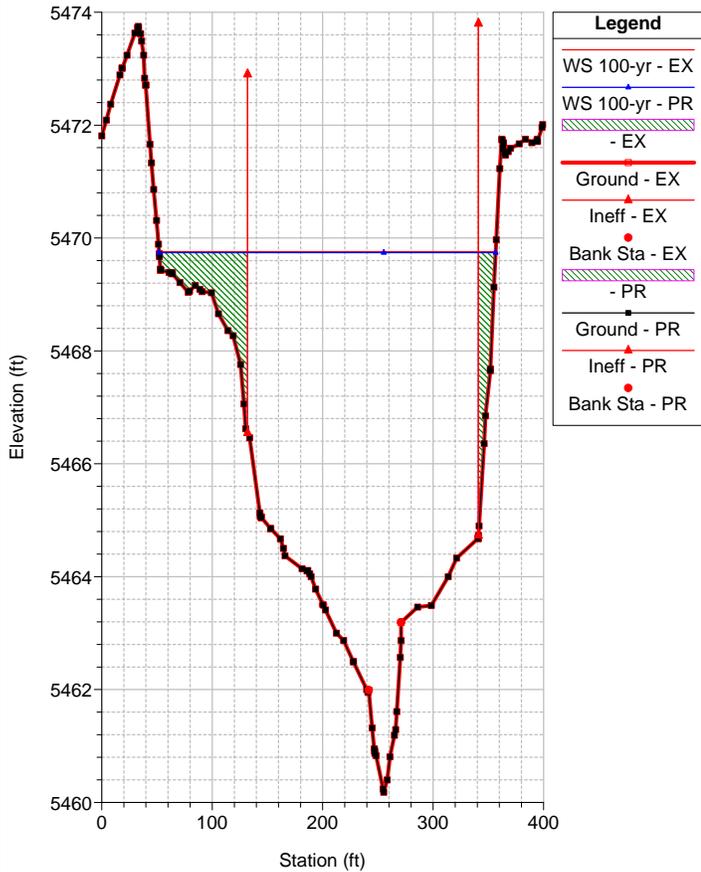
South St Vrain Creek Plan: 1) PR 2) EX  
 River = South St Vrain Reach = South Fork RS = 10239 AECOM SSSVC\_04XS

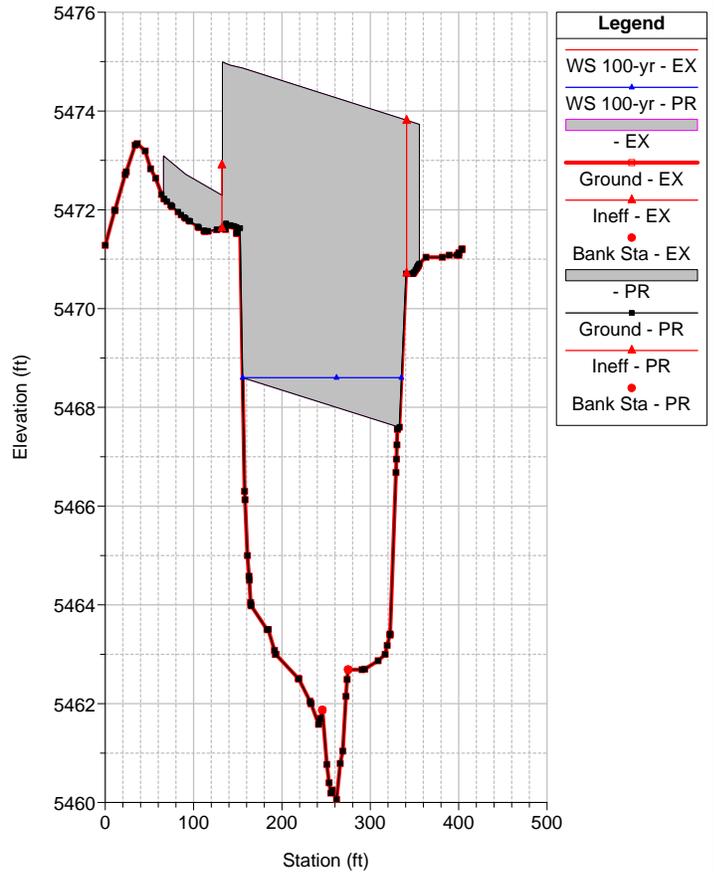
South St Vrain Creek Plan: 1) PR 2) EX  
 River = South St Vrain Reach = South Fork RS = 10212 BR Andesite Bridge

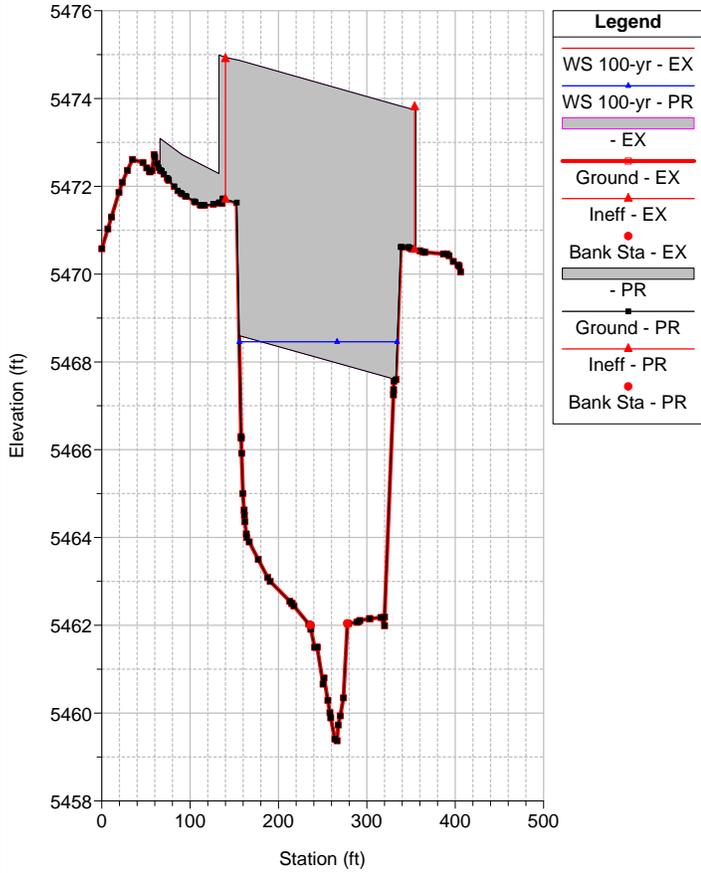
South St Vrain Creek Plan: 1) PR 2) EX  
 River = South St Vrain Reach = South Fork RS = 10212 BR Andesite Bridge

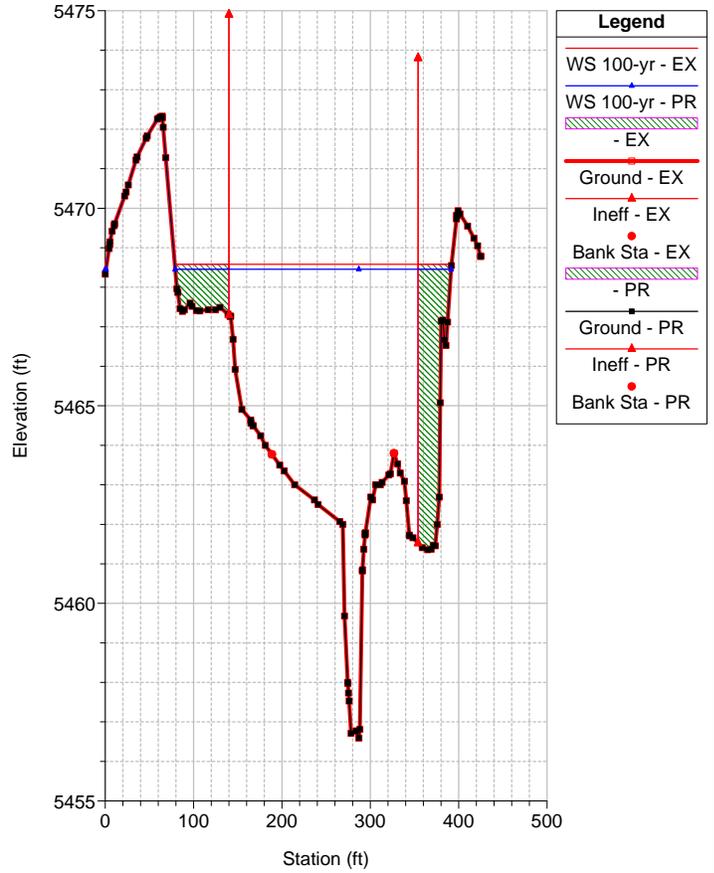
South St Vrain Creek Plan: 1) PR 2) EX  
 River = South St Vrain Reach = South Fork RS = 10134 2014 Lidar

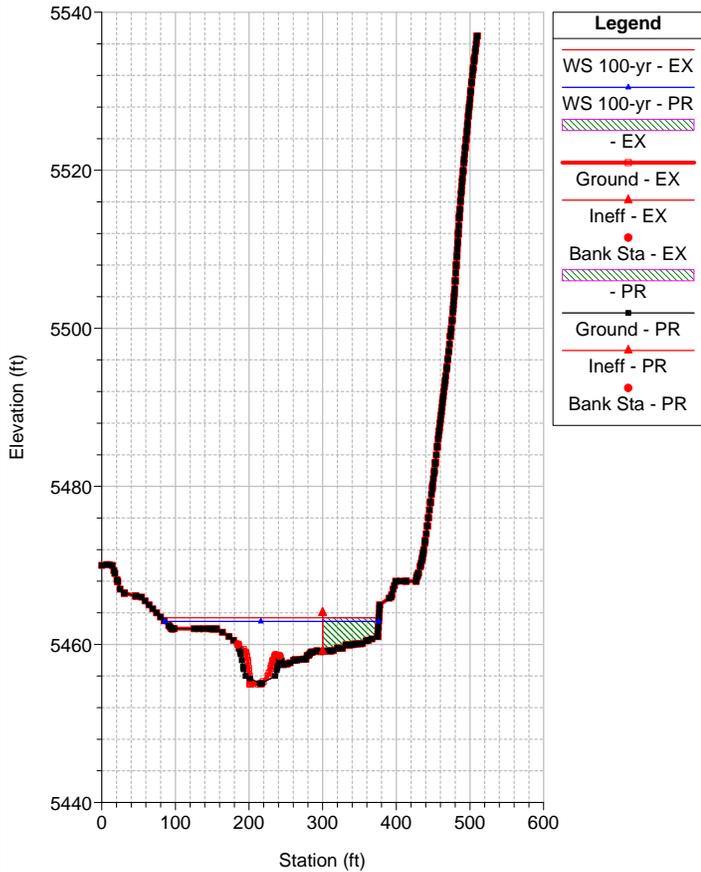
South St Vrain Creek Plan: 1) PR 2) EX  
 River = South St Vrain Reach = South Fork RS = 9963

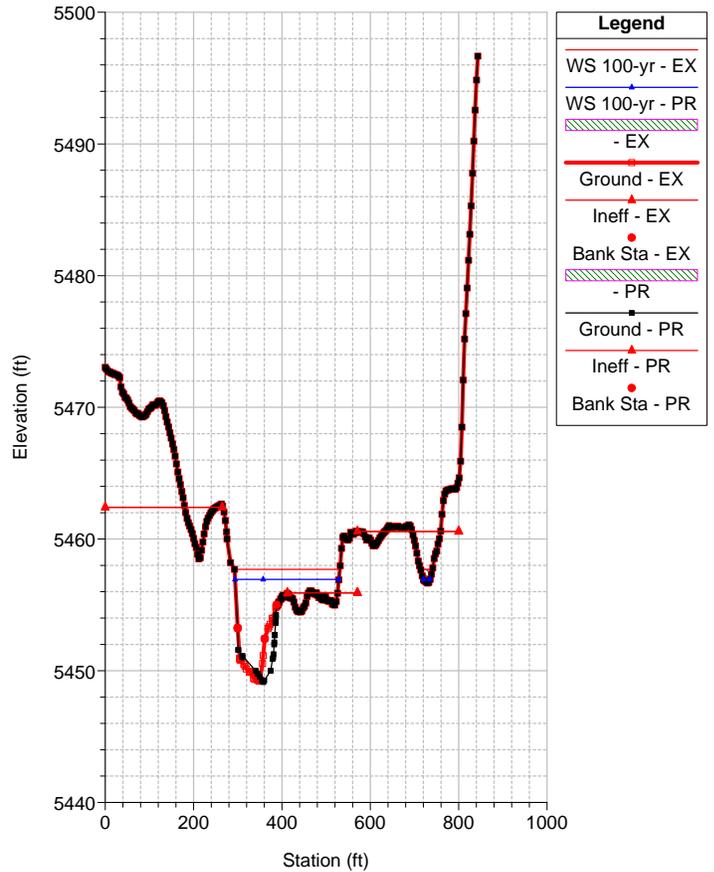
South St Vrain Creek Plan: 1) PR 2) EX  
 River = South St Vrain Reach = South Fork RS = 9454 Civil Arts 4/25/16

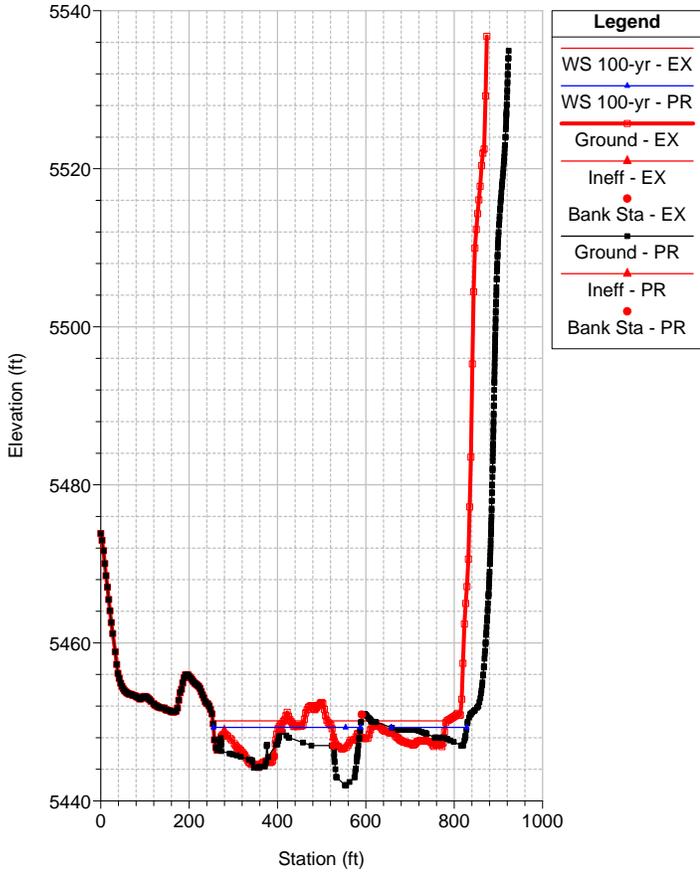
South St Vrain Creek Plan: 1) PR 2) EX  
 River = South St Vrain Reach = South Fork RS = 8975 2014 Lidar

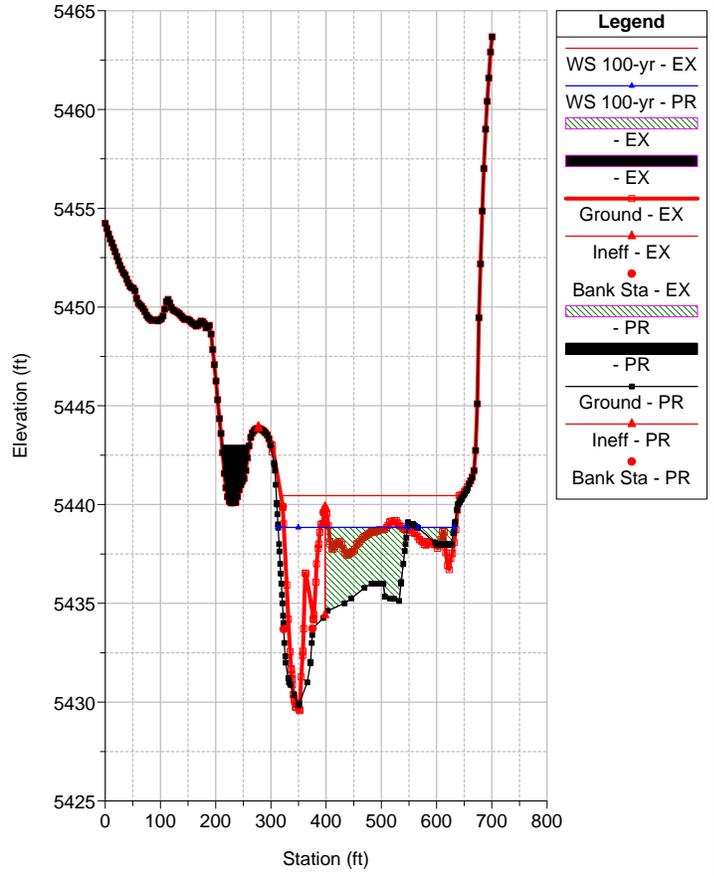
South St Vrain Creek Plan: 1) PR 2) EX  
 River = South St Vrain Reach = South Fork RS = 8021 Civil Arts 4/25/16

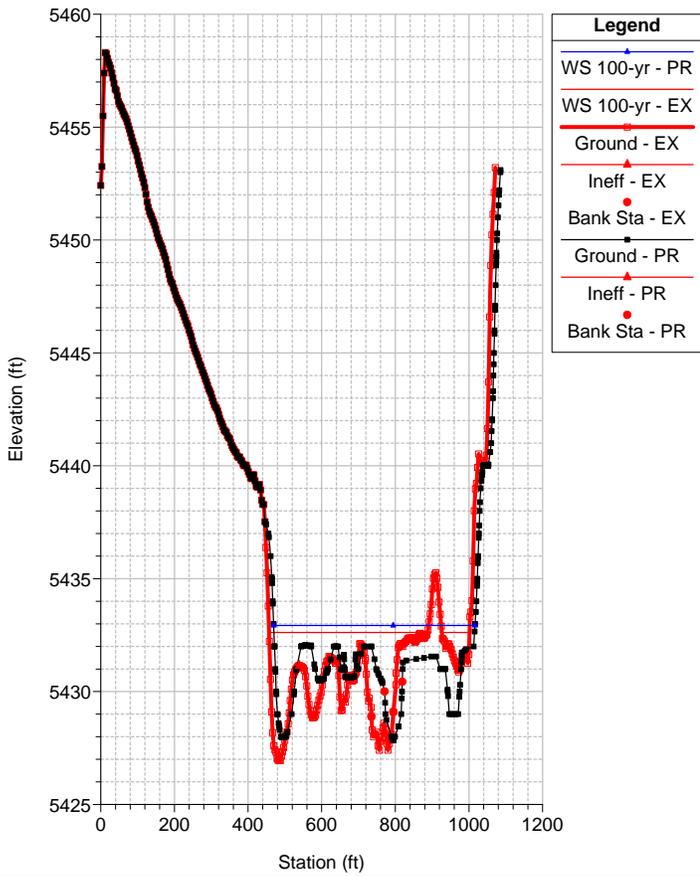
South St Vrain Creek Plan: 1) PR 2) EX  
 River = South St Vrain Reach = South Fork RS = 7529 Civil Arts 4/25/16

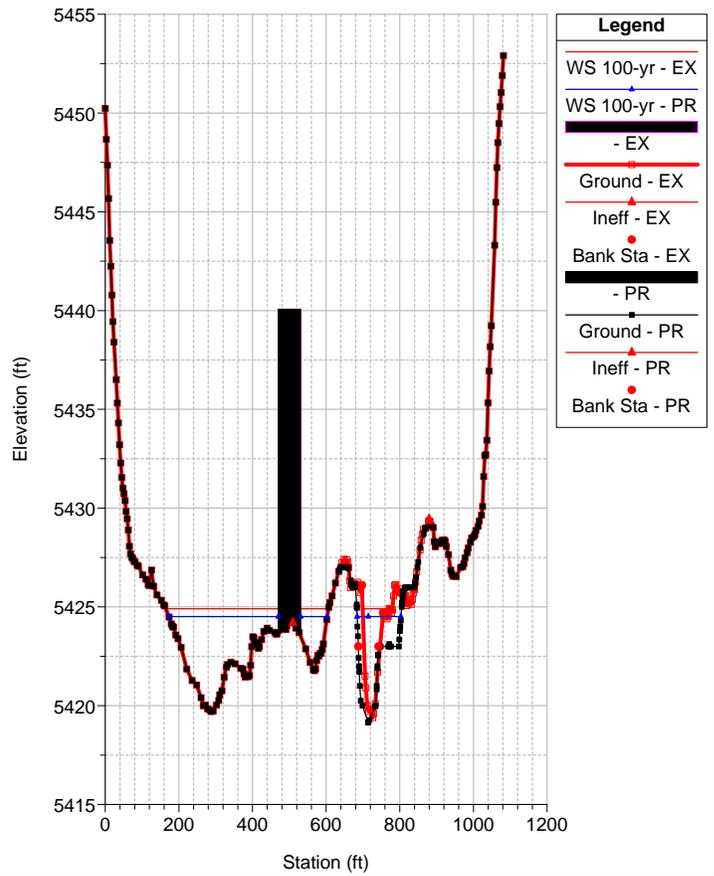
South St Vrain Creek Plan: 1) PR 2) EX  
 River = South St Vrain Reach = South Fork RS = 7041 Civil Arts 4/25/16

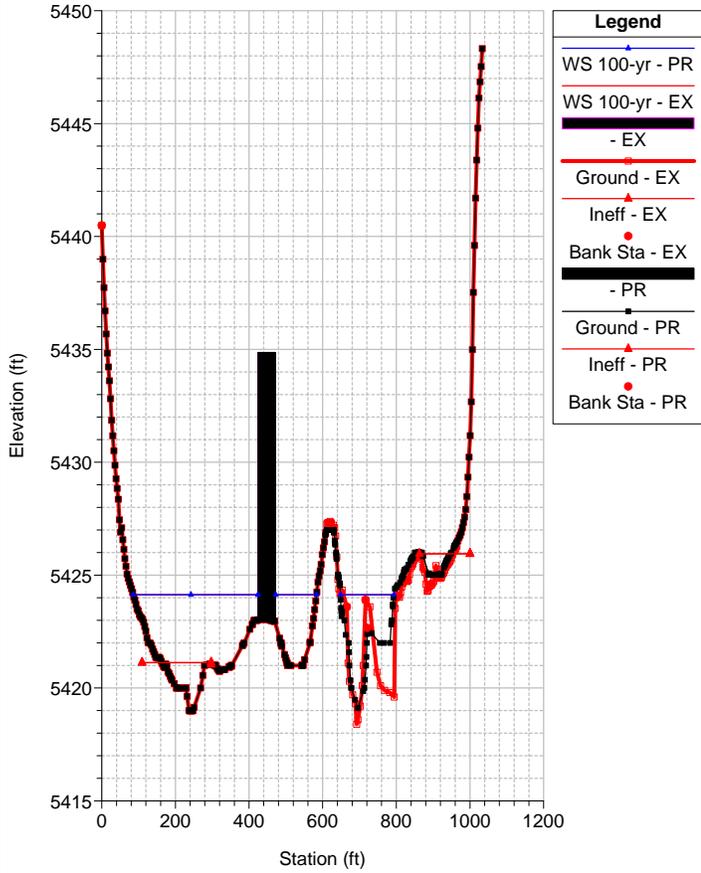
South St Vrain Creek Plan: 1) PR 2) EX  
 River = South St Vrain Reach = South Fork RS = 6941 Civil Arts 4/25/16

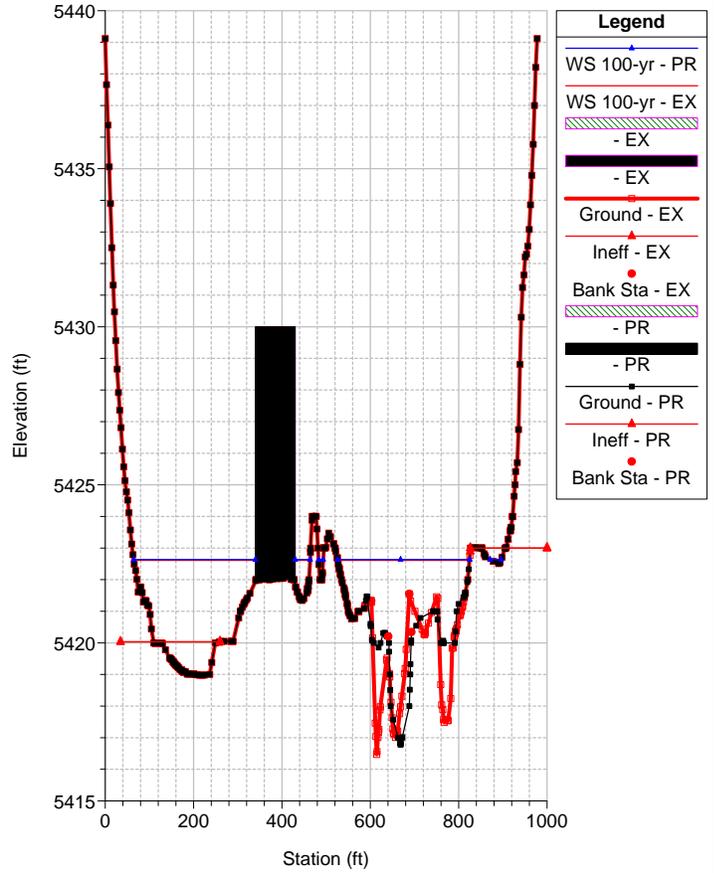
South St Vrain Creek Plan: 1) PR 2) EX  
 River = South St Vrain Reach = South Fork RS = 6797 Civil Arts 4/21/16

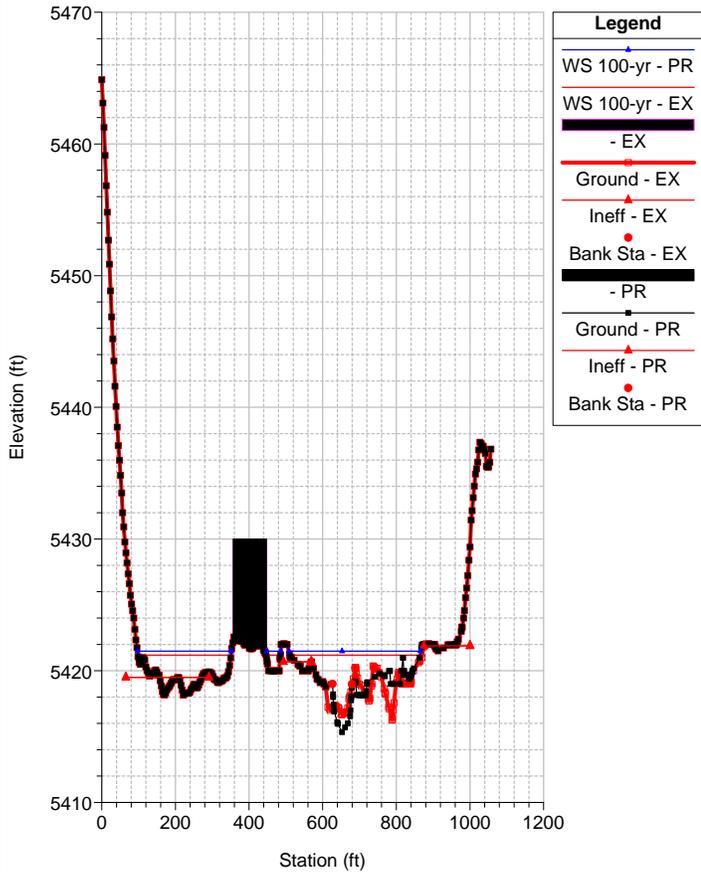
South St Vrain Creek Plan: 1) PR 2) EX  
 River = South St Vrain Reach = South Fork RS = 6707 2014 Lidar

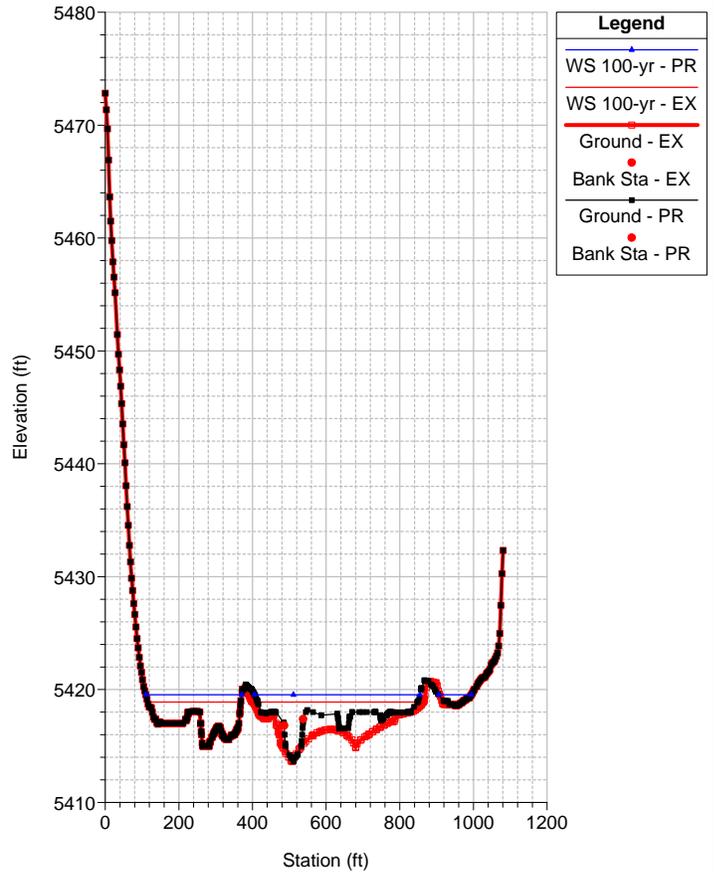
South St Vrain Creek Plan: 1) PR 2) EX  
 River = South St Vrain Reach = South Fork RS = 6536 2014 Lidar

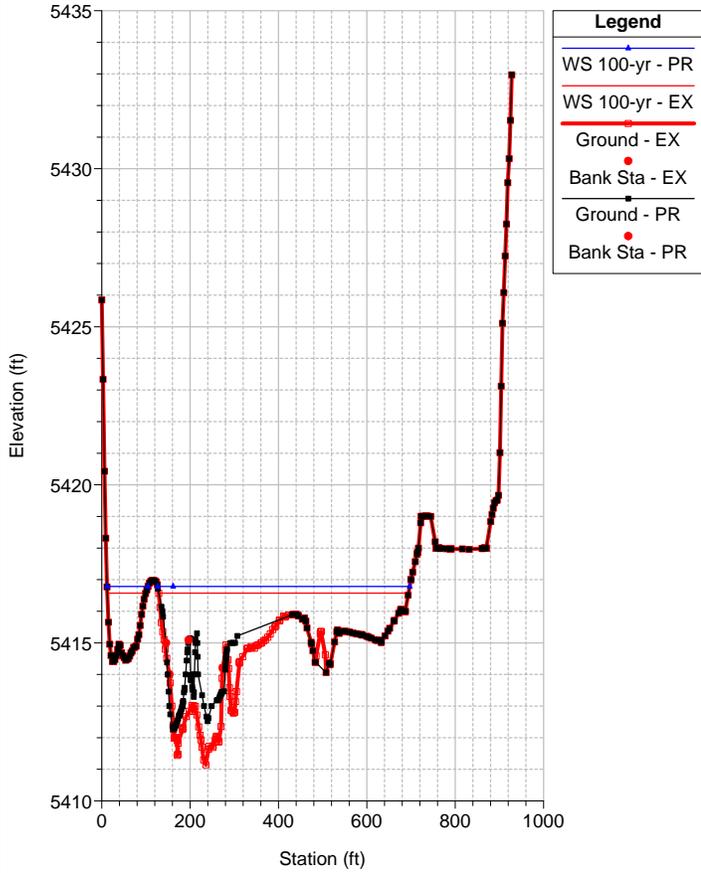
South St Vrain Creek Plan: 1) PR 2) EX  
 River = South St Vrain Reach = South Fork RS = 6344 AECOM SSSVC\_03XS

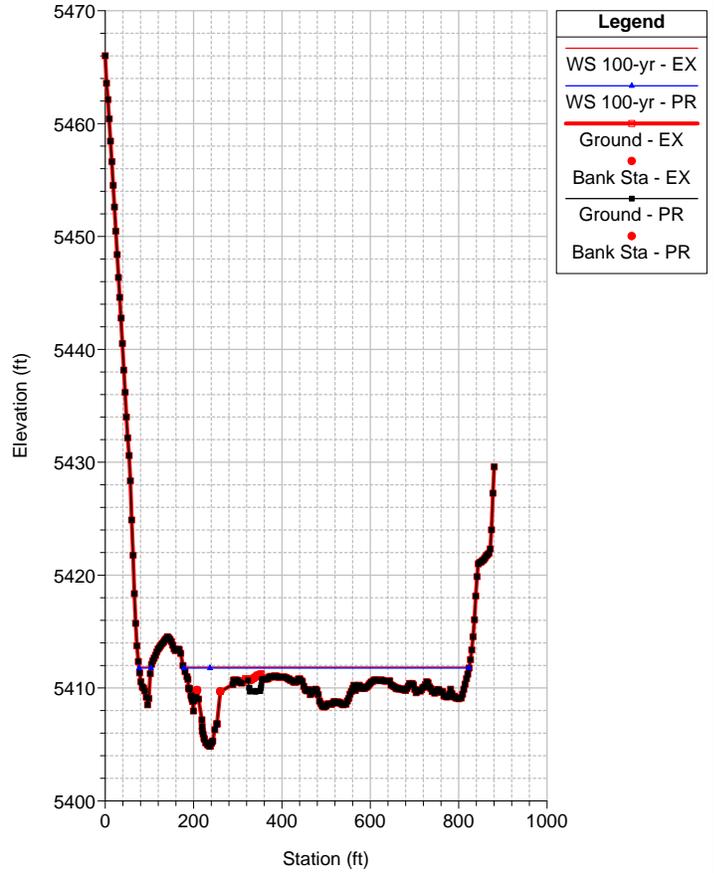
South St Vrain Creek Plan: 1) PR 2) EX  
 River = South St Vrain Reach = South Fork RS = 6033 Civil Arts 4/21/16

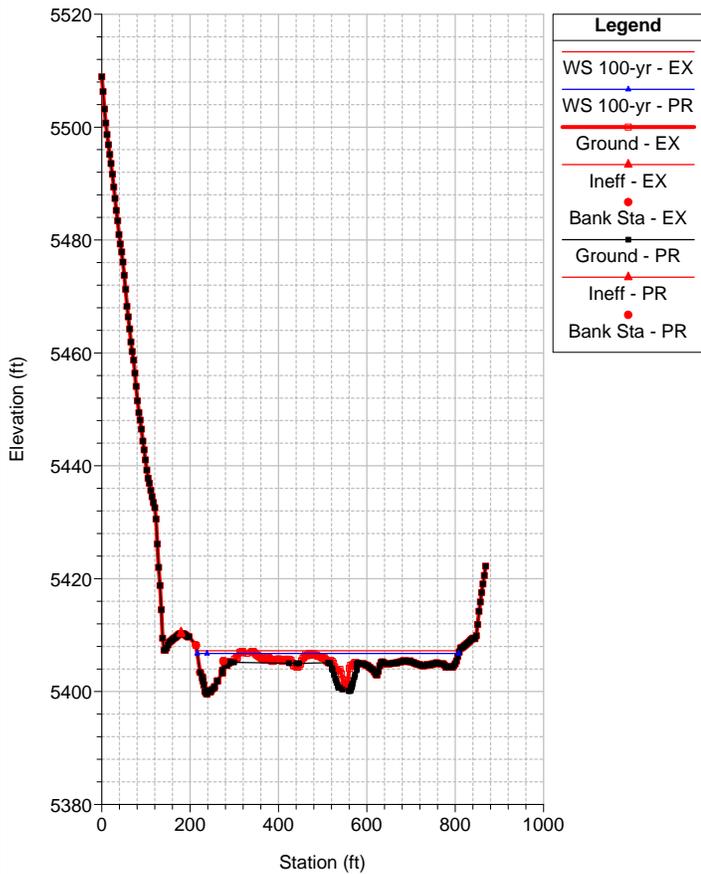
South St Vrain Creek Plan: 1) PR 2) EX  
 River = South St Vrain Reach = South Fork RS = 5668 Civil Arts 4/25/16

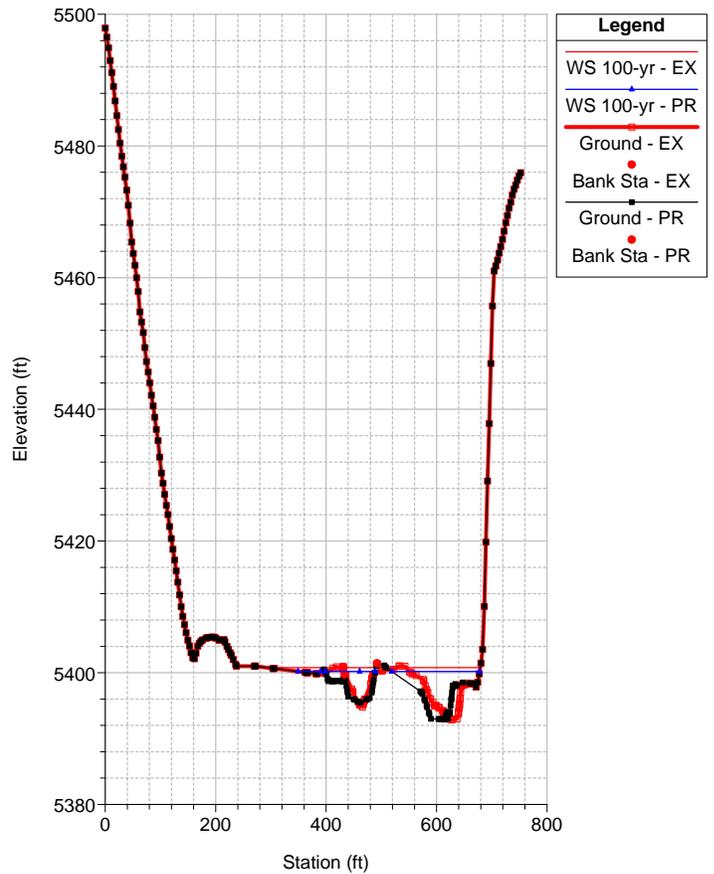
South St Vrain Creek Plan: 1) PR 2) EX  
 River = South St Vrain Reach = South Fork RS = 5329 2014 Lidar

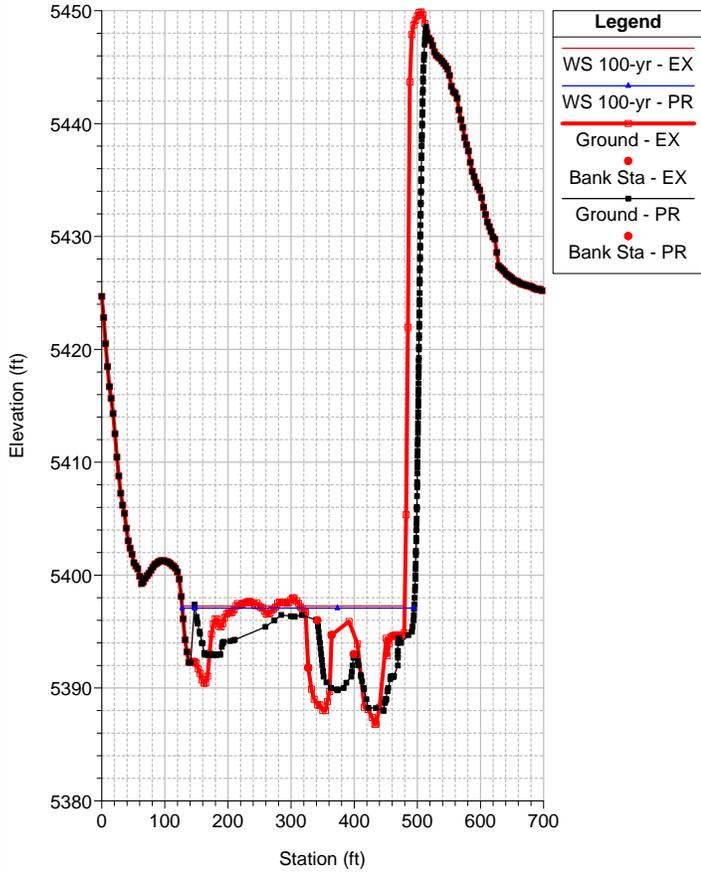
South St Vrain Creek Plan: 1) PR 2) EX  
 River = South St Vrain Reach = South Fork RS = 5056 Civil Arts 4/21/16

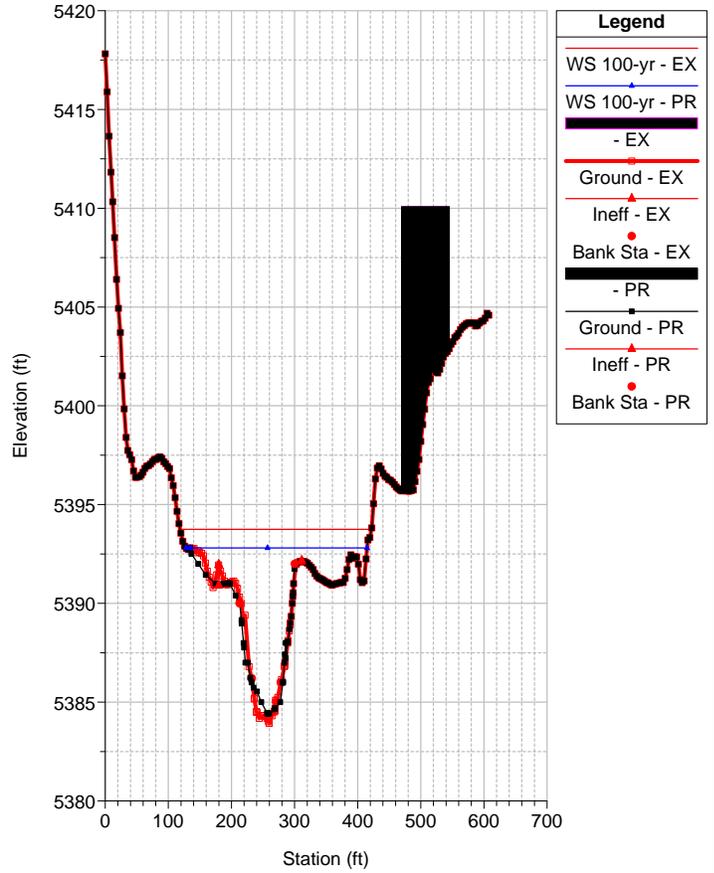
South St Vrain Creek Plan: 1) PR 2) EX  
 River = South St Vrain Reach = South Fork RS = 4703 Civil Arts 4/21/16

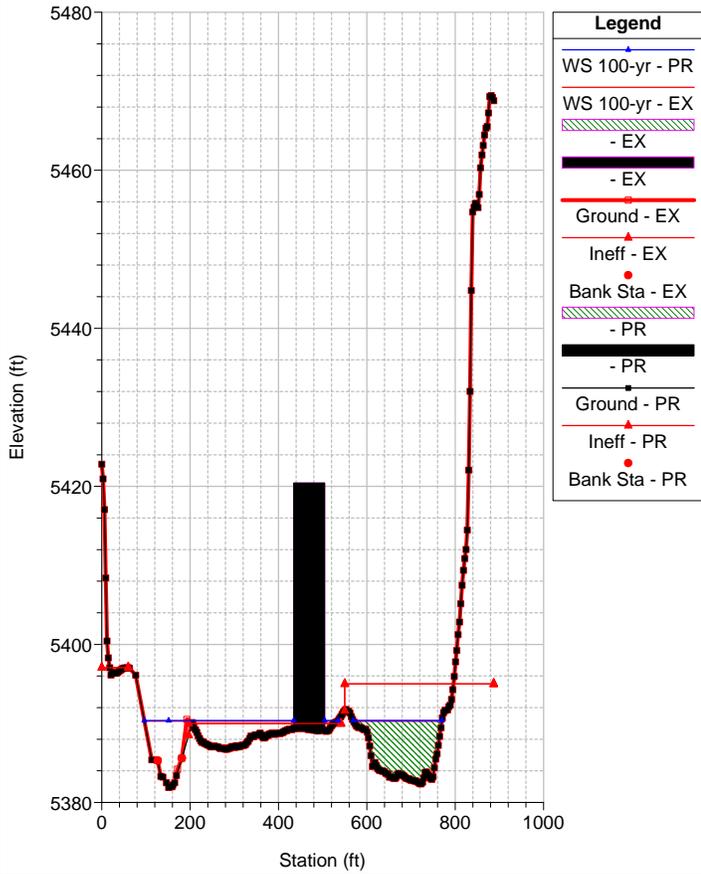
South St Vrain Creek Plan: 1) PR 2) EX  
 River = South St Vrain Reach = South Fork RS = 4480 Civil Arts 4/21/16

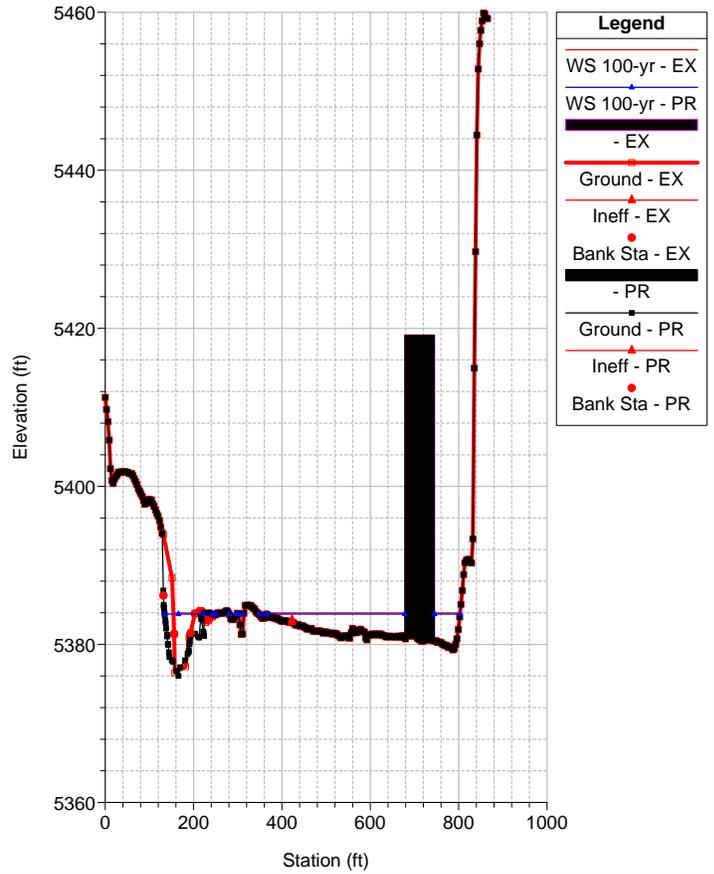
South St Vrain Creek Plan: 1) PR 2) EX  
 River = South St Vrain Reach = South Fork RS = 4154 Civil Arts 4/21/16

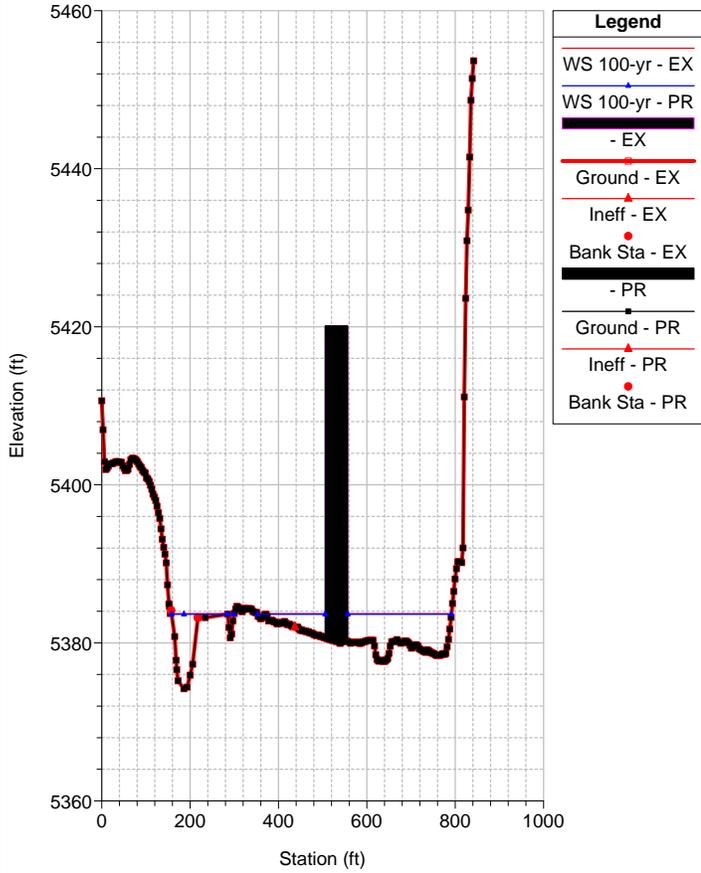
South St Vrain Creek Plan: 1) PR 2) EX  
 River = South St Vrain Reach = South Fork RS = 4107 Civil Arts 4/21/16
