# Preliminary Basis of Design Report

## For South St. Vrain Creek Restoration at Hall Ranch

**Boulder County, Colorado**

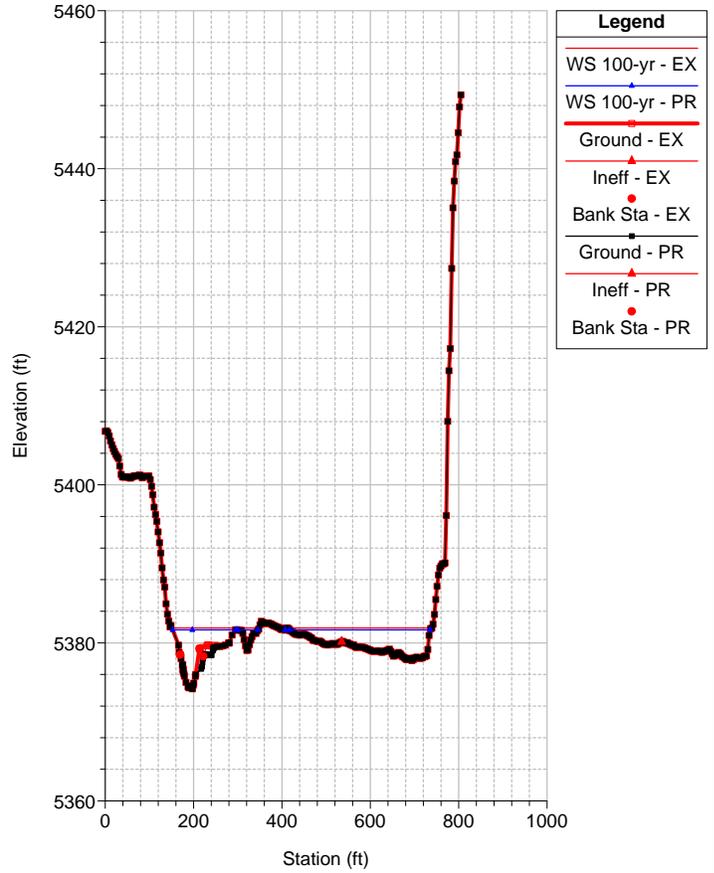
South St Vrain Creek Plan: 1) PR 2) EX  
 River = South St Vrain Reach = South Fork RS = 3985 Civil Arts 4/21/16

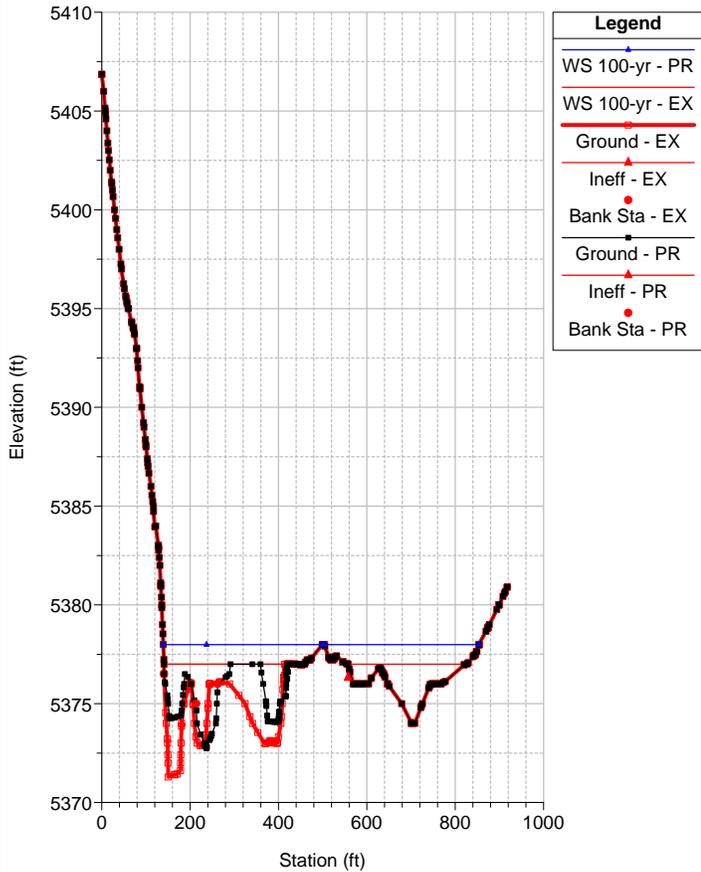
South St Vrain Creek Plan: 1) PR 2) EX  
 River = South St Vrain Reach = South Fork RS = 3763 Civil Arts 4/21/16

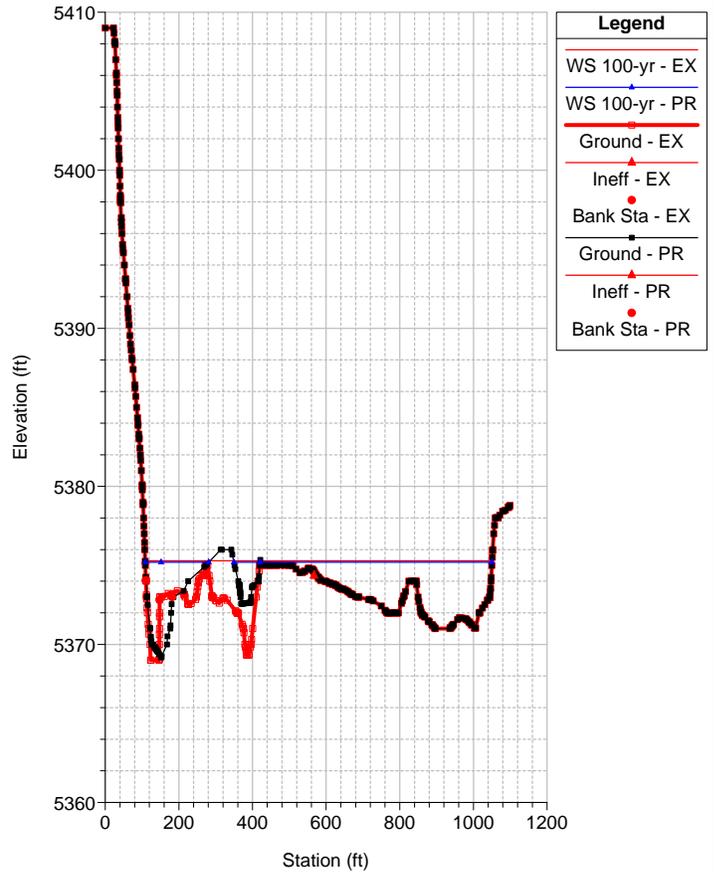
South St Vrain Creek Plan: 1) PR 2) EX  
 River = South St Vrain Reach = South Fork RS = 3602

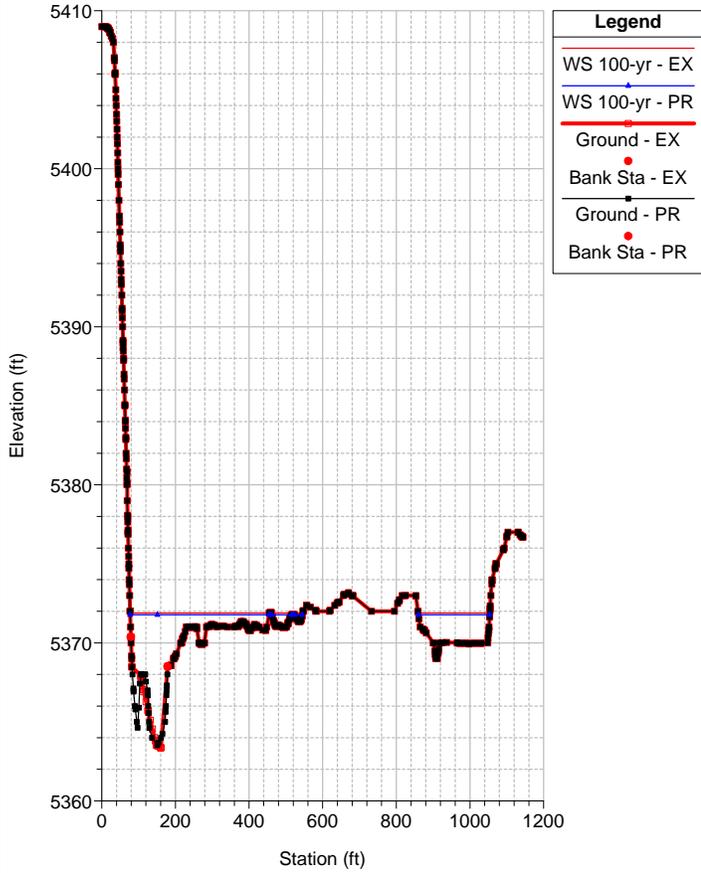
South St Vrain Creek Plan: 1) PR 2) EX  
 River = South St Vrain Reach = South Fork RS = 3260 Civil Arts 4/21/16

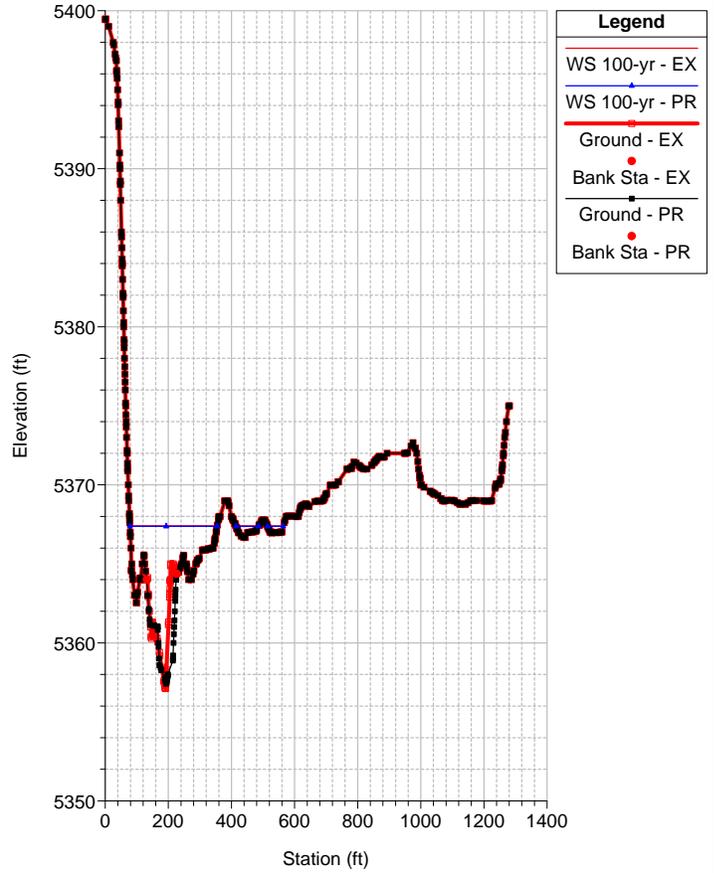
South St Vrain Creek Plan: 1) PR 2) EX  
 River = South St Vrain Reach = South Fork RS = 2888 Civil Arts XS-S13

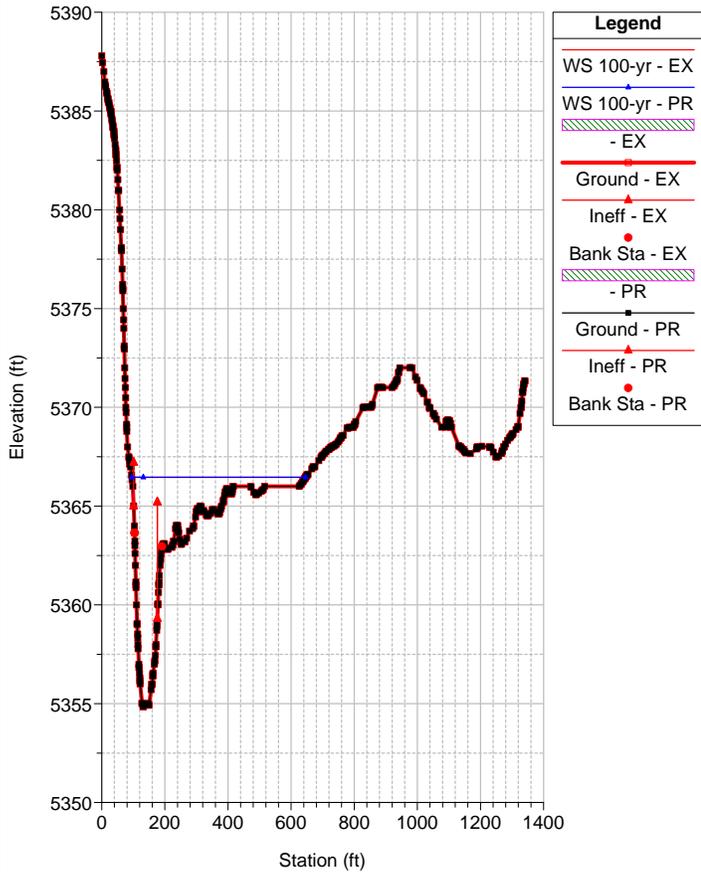
South St Vrain Creek Plan: 1) PR 2) EX  
 River = South St Vrain Reach = South Fork RS = 2651

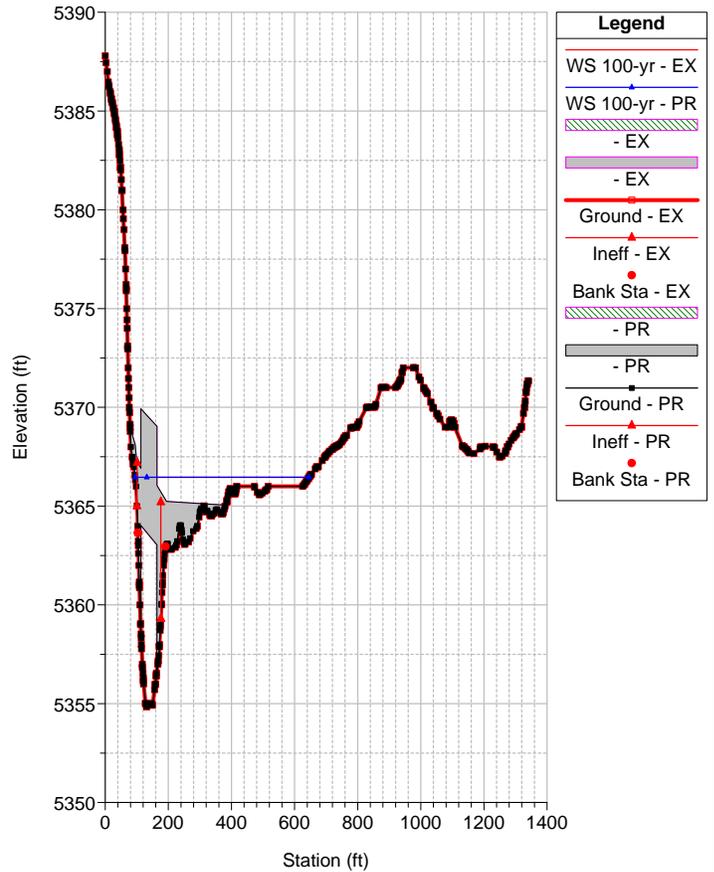
South St Vrain Creek Plan: 1) PR 2) EX  
 River = South St Vrain Reach = South Fork RS = 2620 BR Old South St Vrain Road Downstream

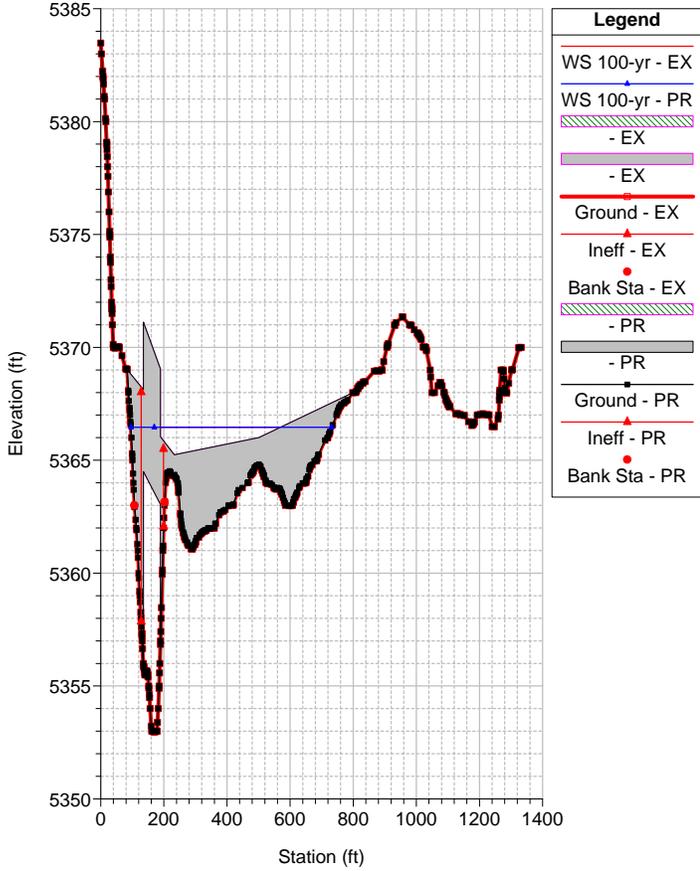
South St Vrain Creek Plan: 1) PR 2) EX  
 River = South St Vrain Reach = South Fork RS = 2620 BR Old South St Vrain Road Downstream

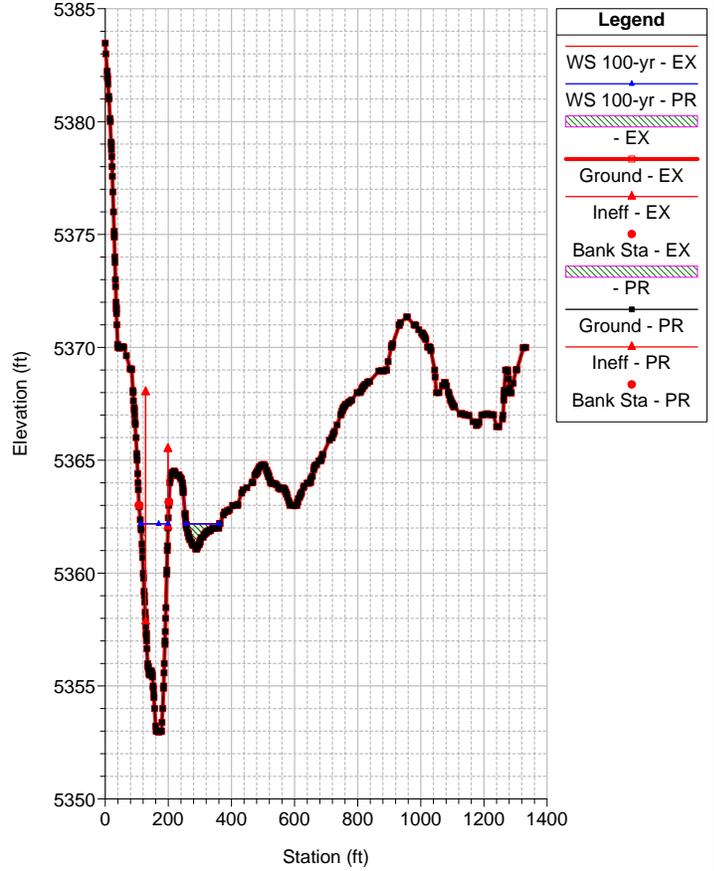
South St Vrain Creek Plan: 1) PR 2) EX  
 River = South St Vrain Reach = South Fork RS = 2588 DS Bridge

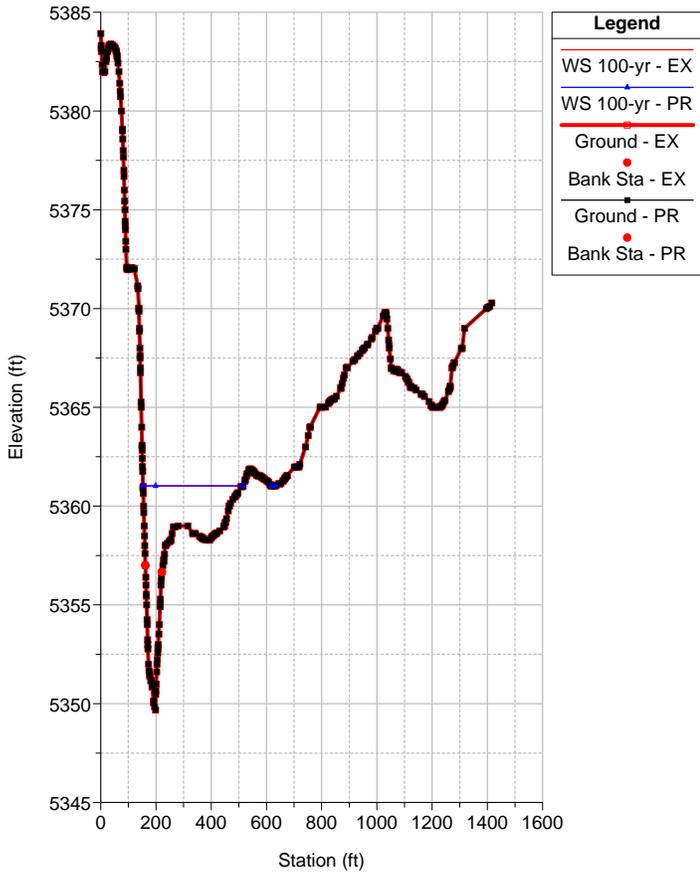
South St Vrain Creek Plan: 1) PR 2) EX  
 River = South St Vrain Reach = South Fork RS = 2458 AECOM SSSVC 01

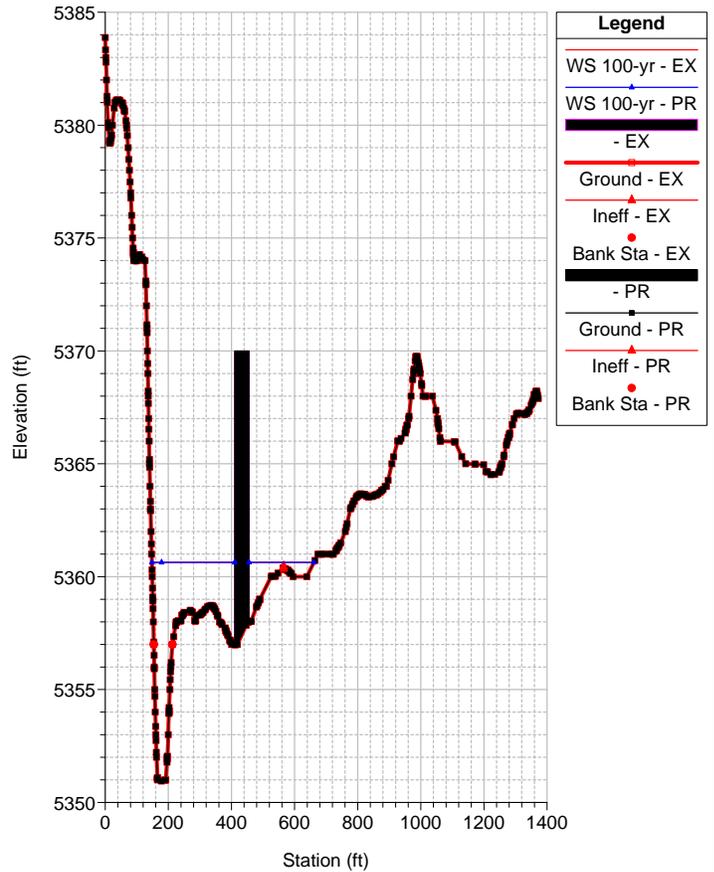
South St Vrain Creek Plan: 1) PR 2) EX  
 River = South St Vrain Reach = South Fork RS = 2396 Civil Arts XS-S12

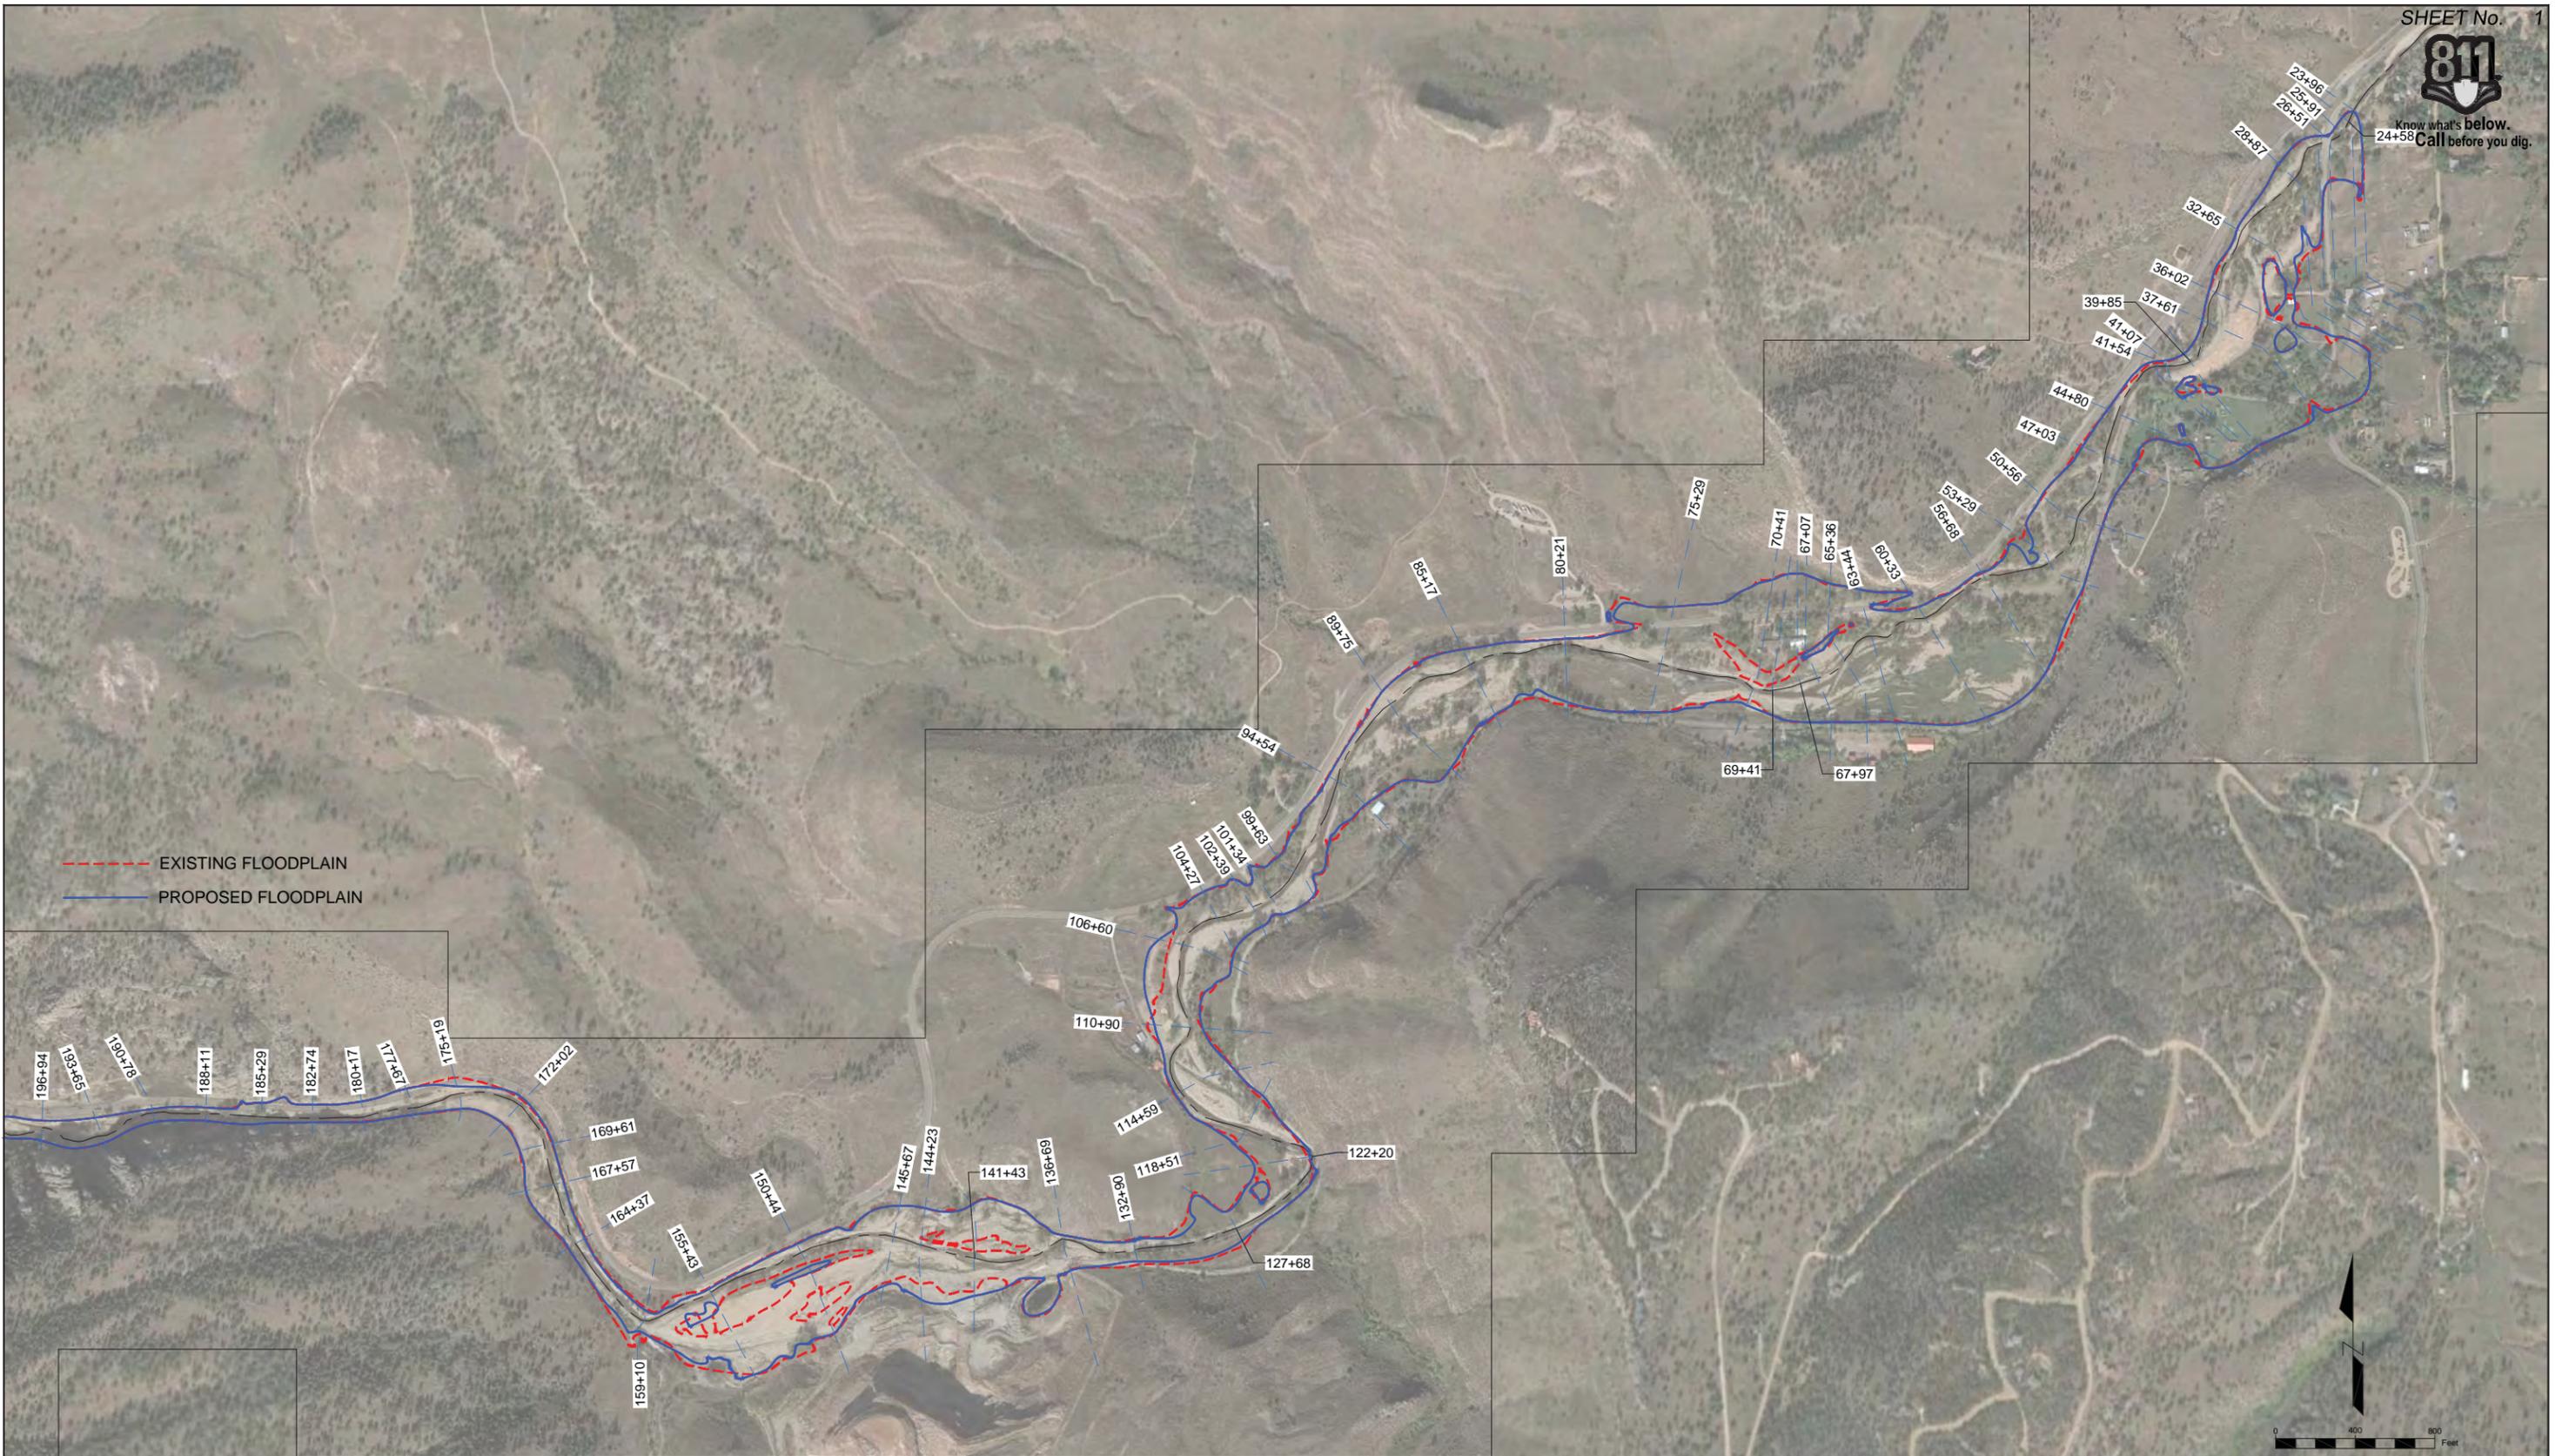
--- EXISTING FLOODPLAIN  
— PROPOSED FLOODPLAIN

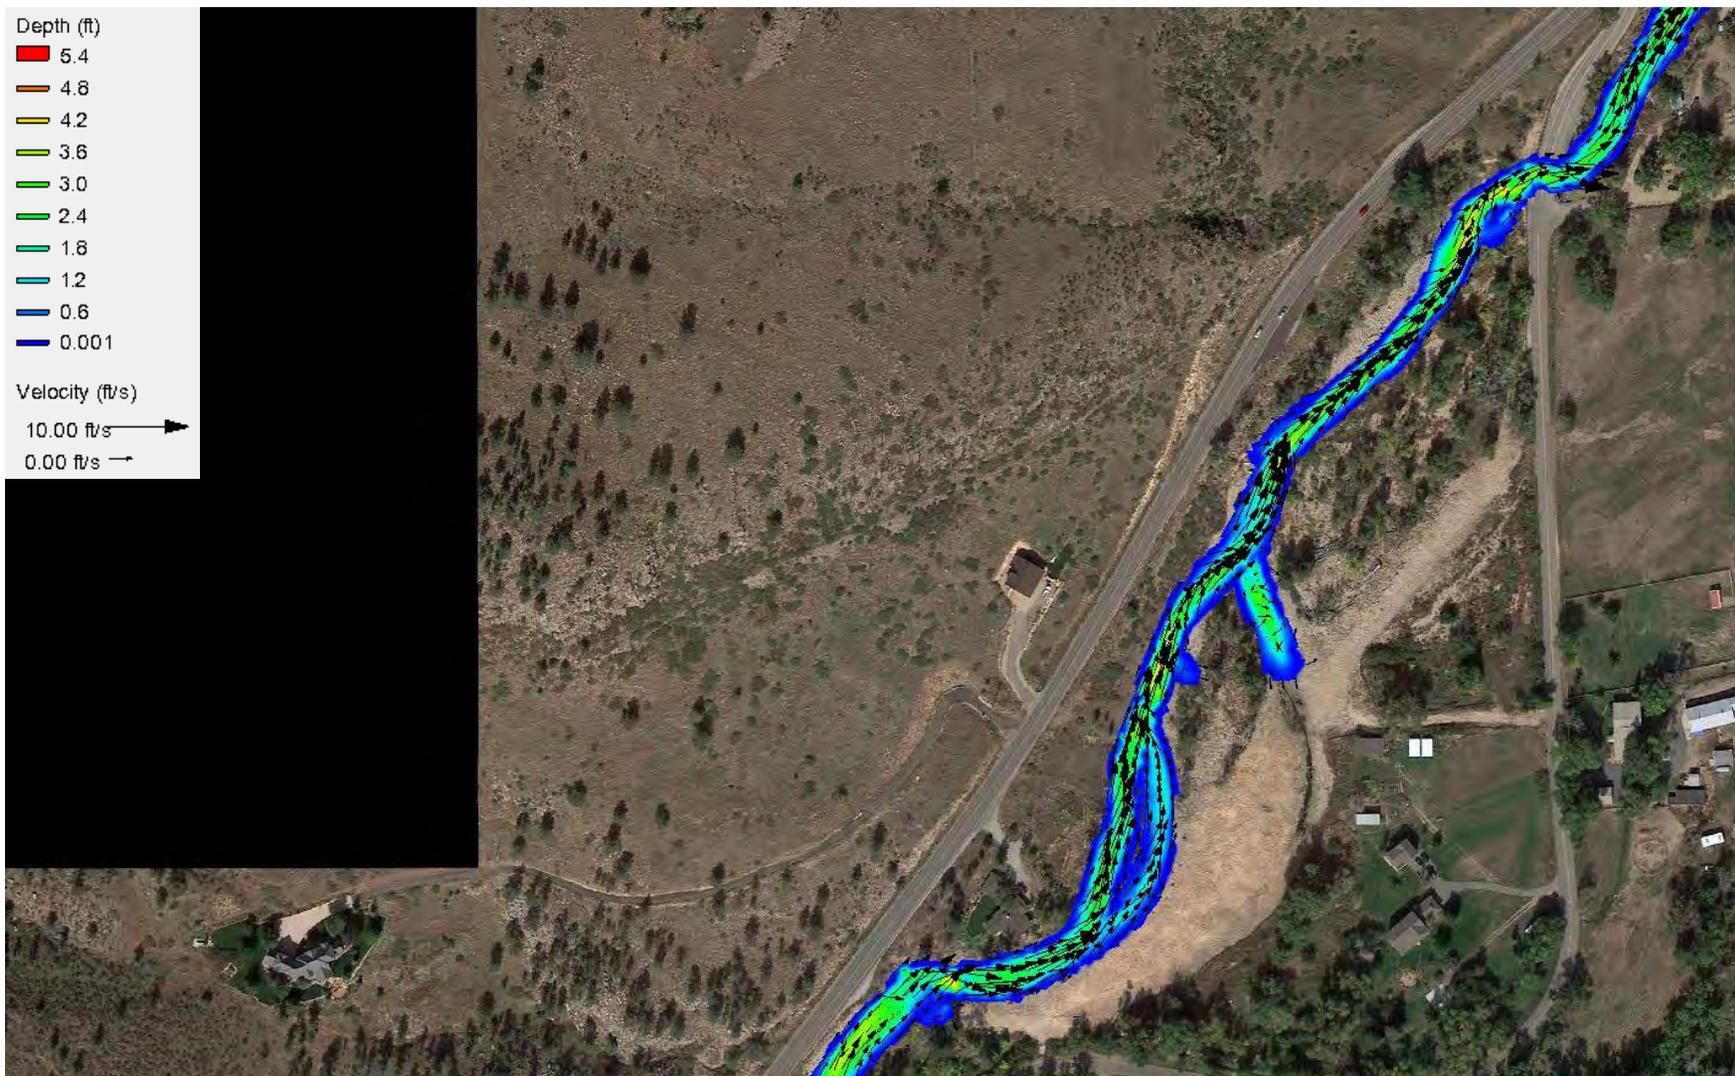
**Existing Conditions –  $Q_{1.5}$  – Lower Section (Map 1)**

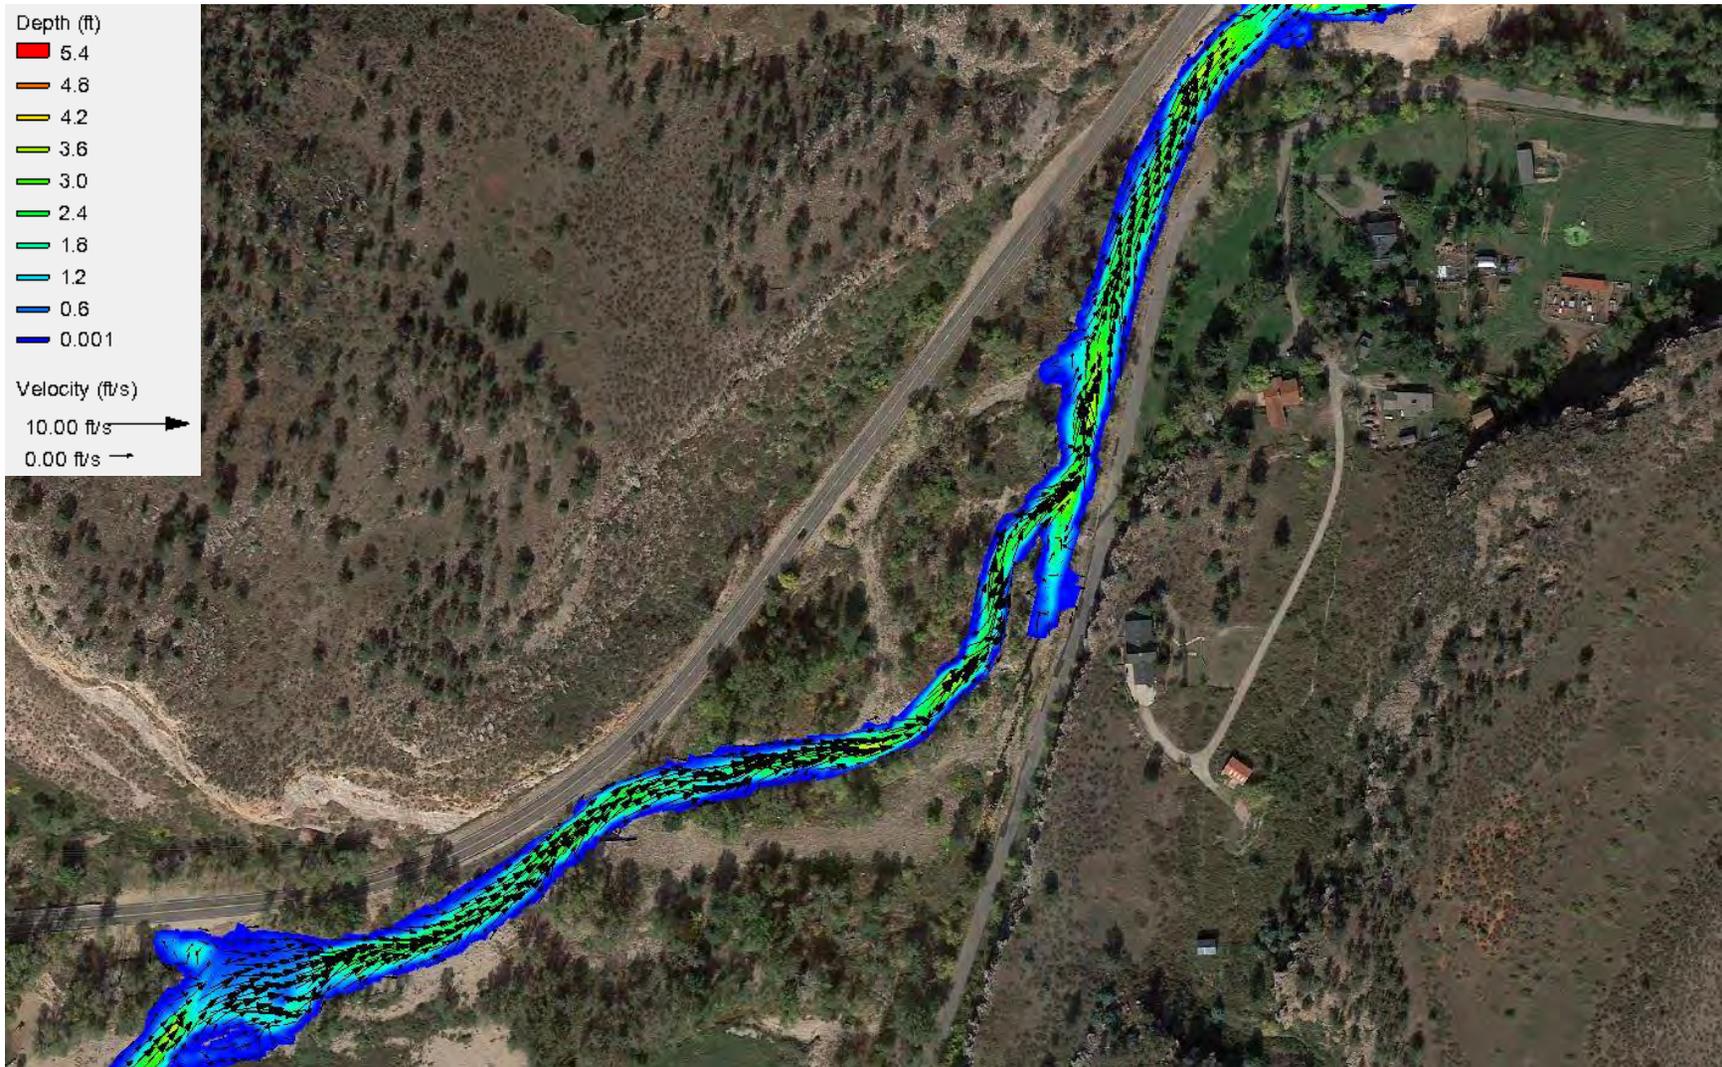
**Existing Conditions –  $Q_{1.5}$  – Lower Section (Map 2)**

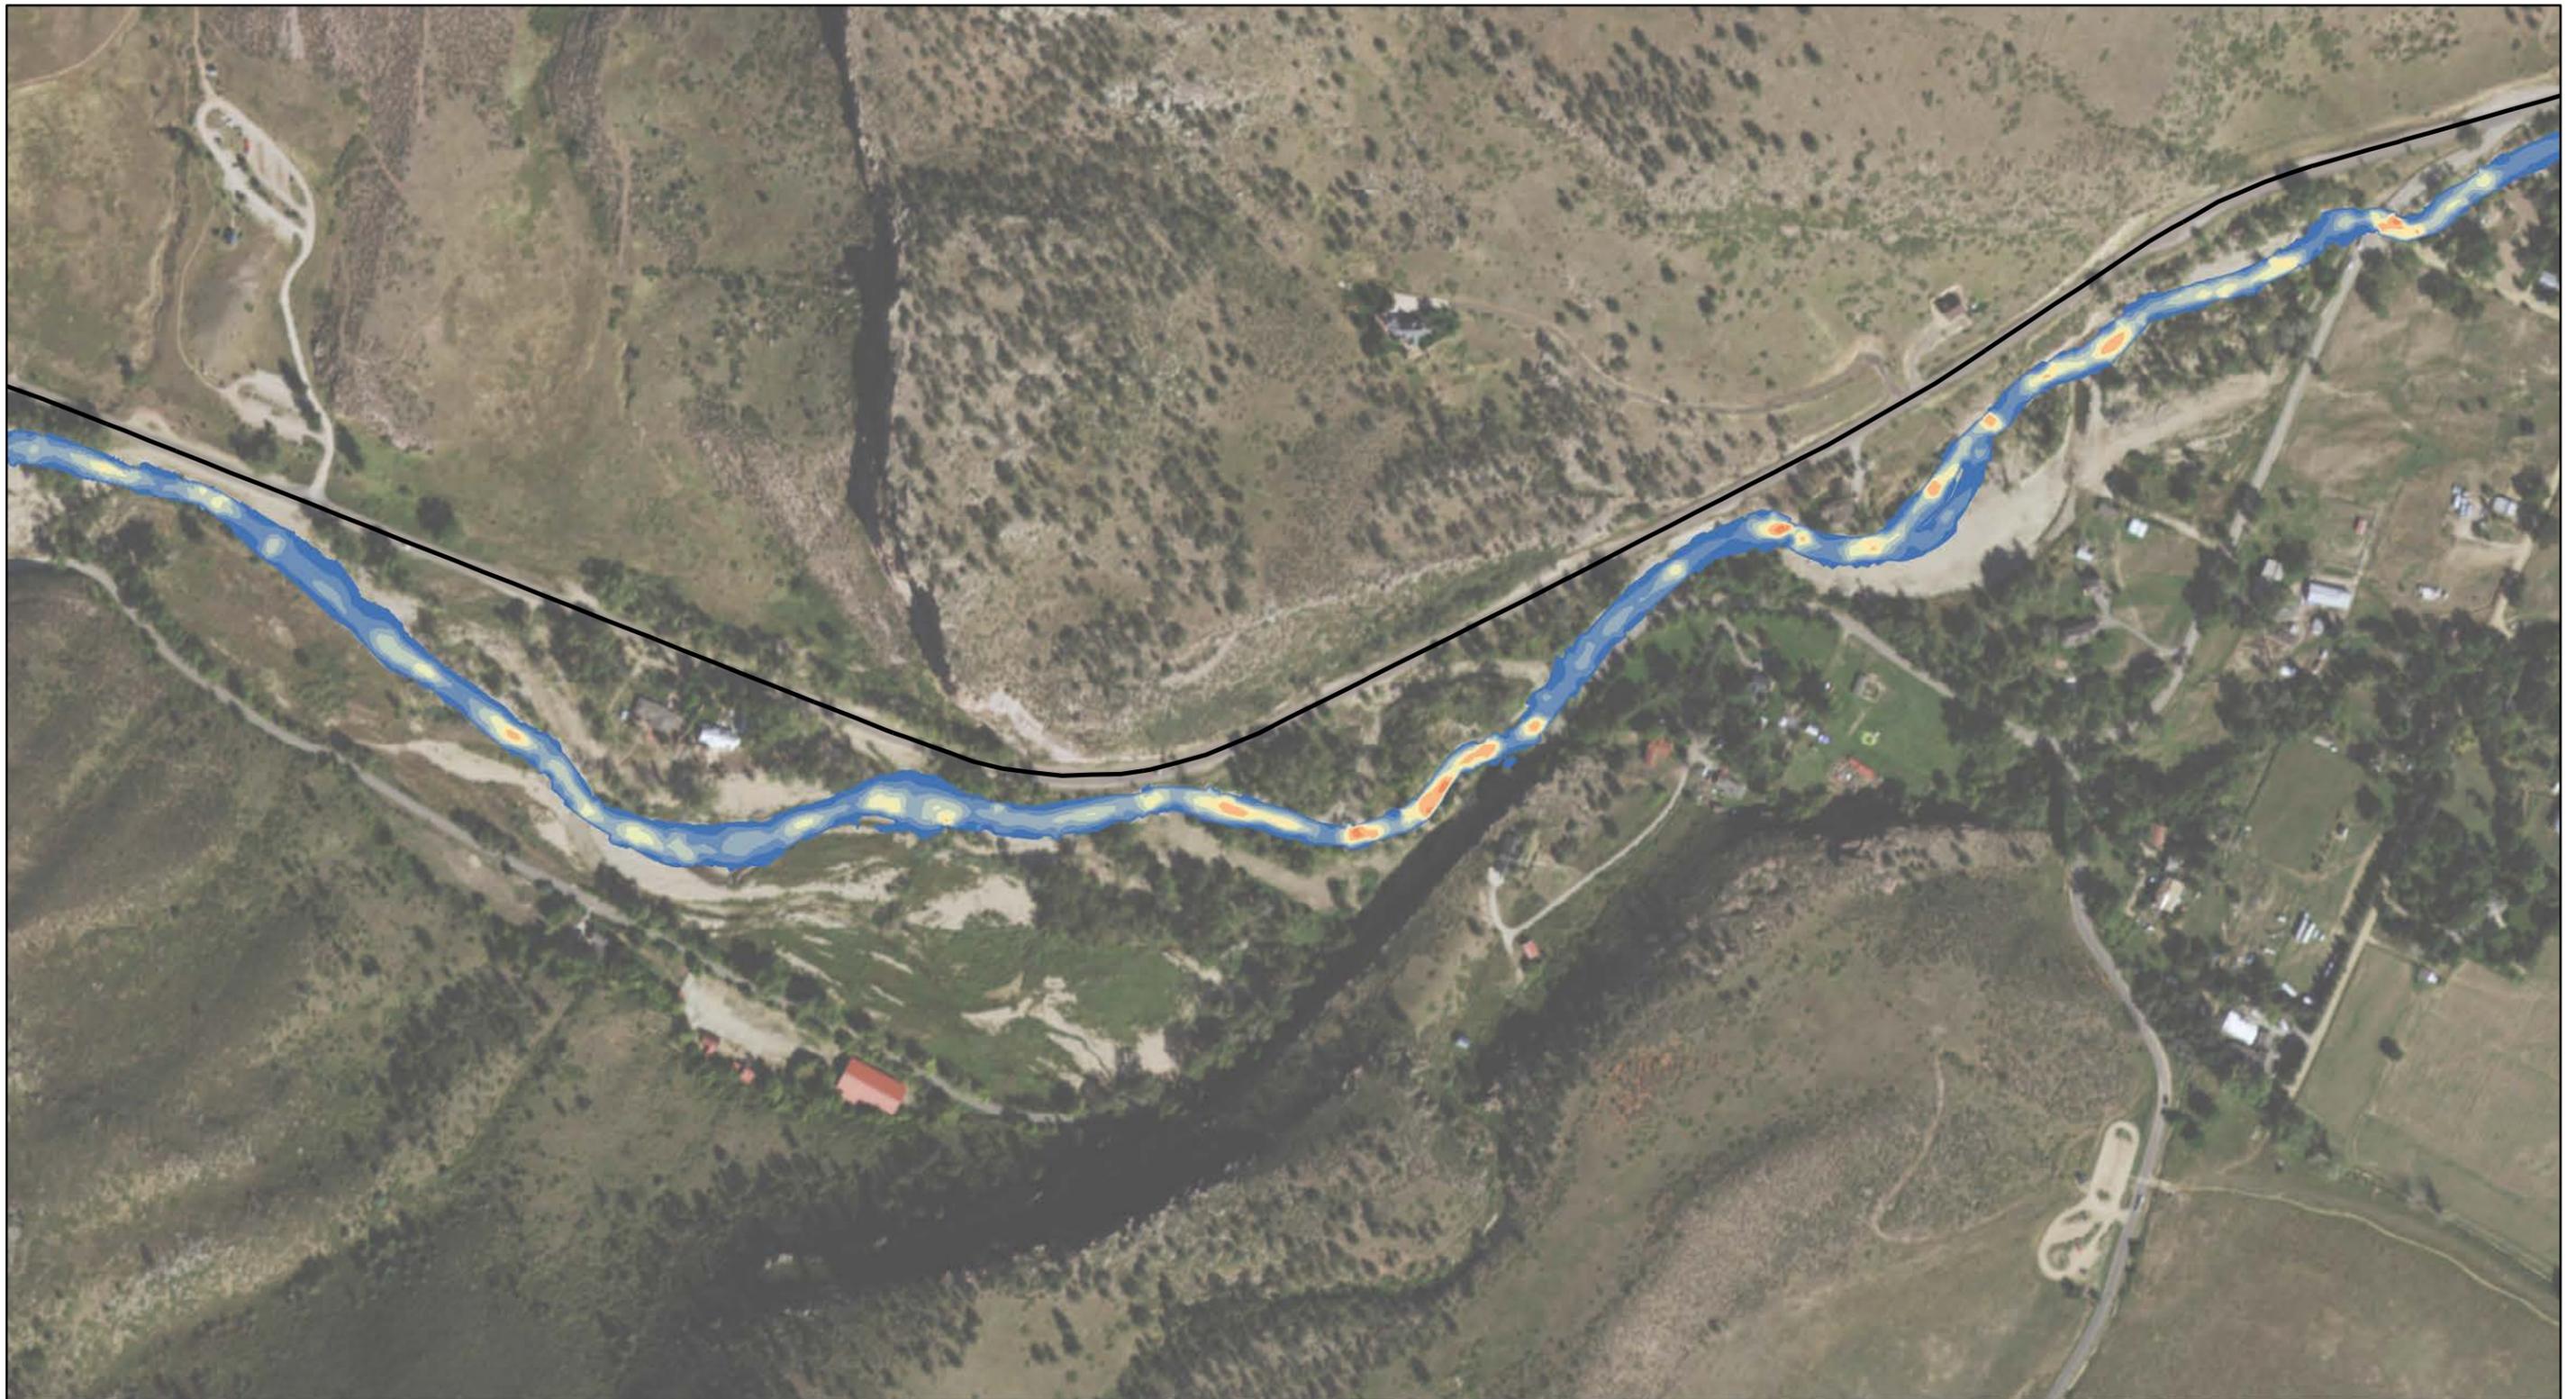
1.5 YEAR FLOW  
**MAP  
1**

**1.5yr Stream Power**

**EXISTING CONDITIONS  
STREAM POWER MAPBOOK  
1.5 YEAR FLOW**

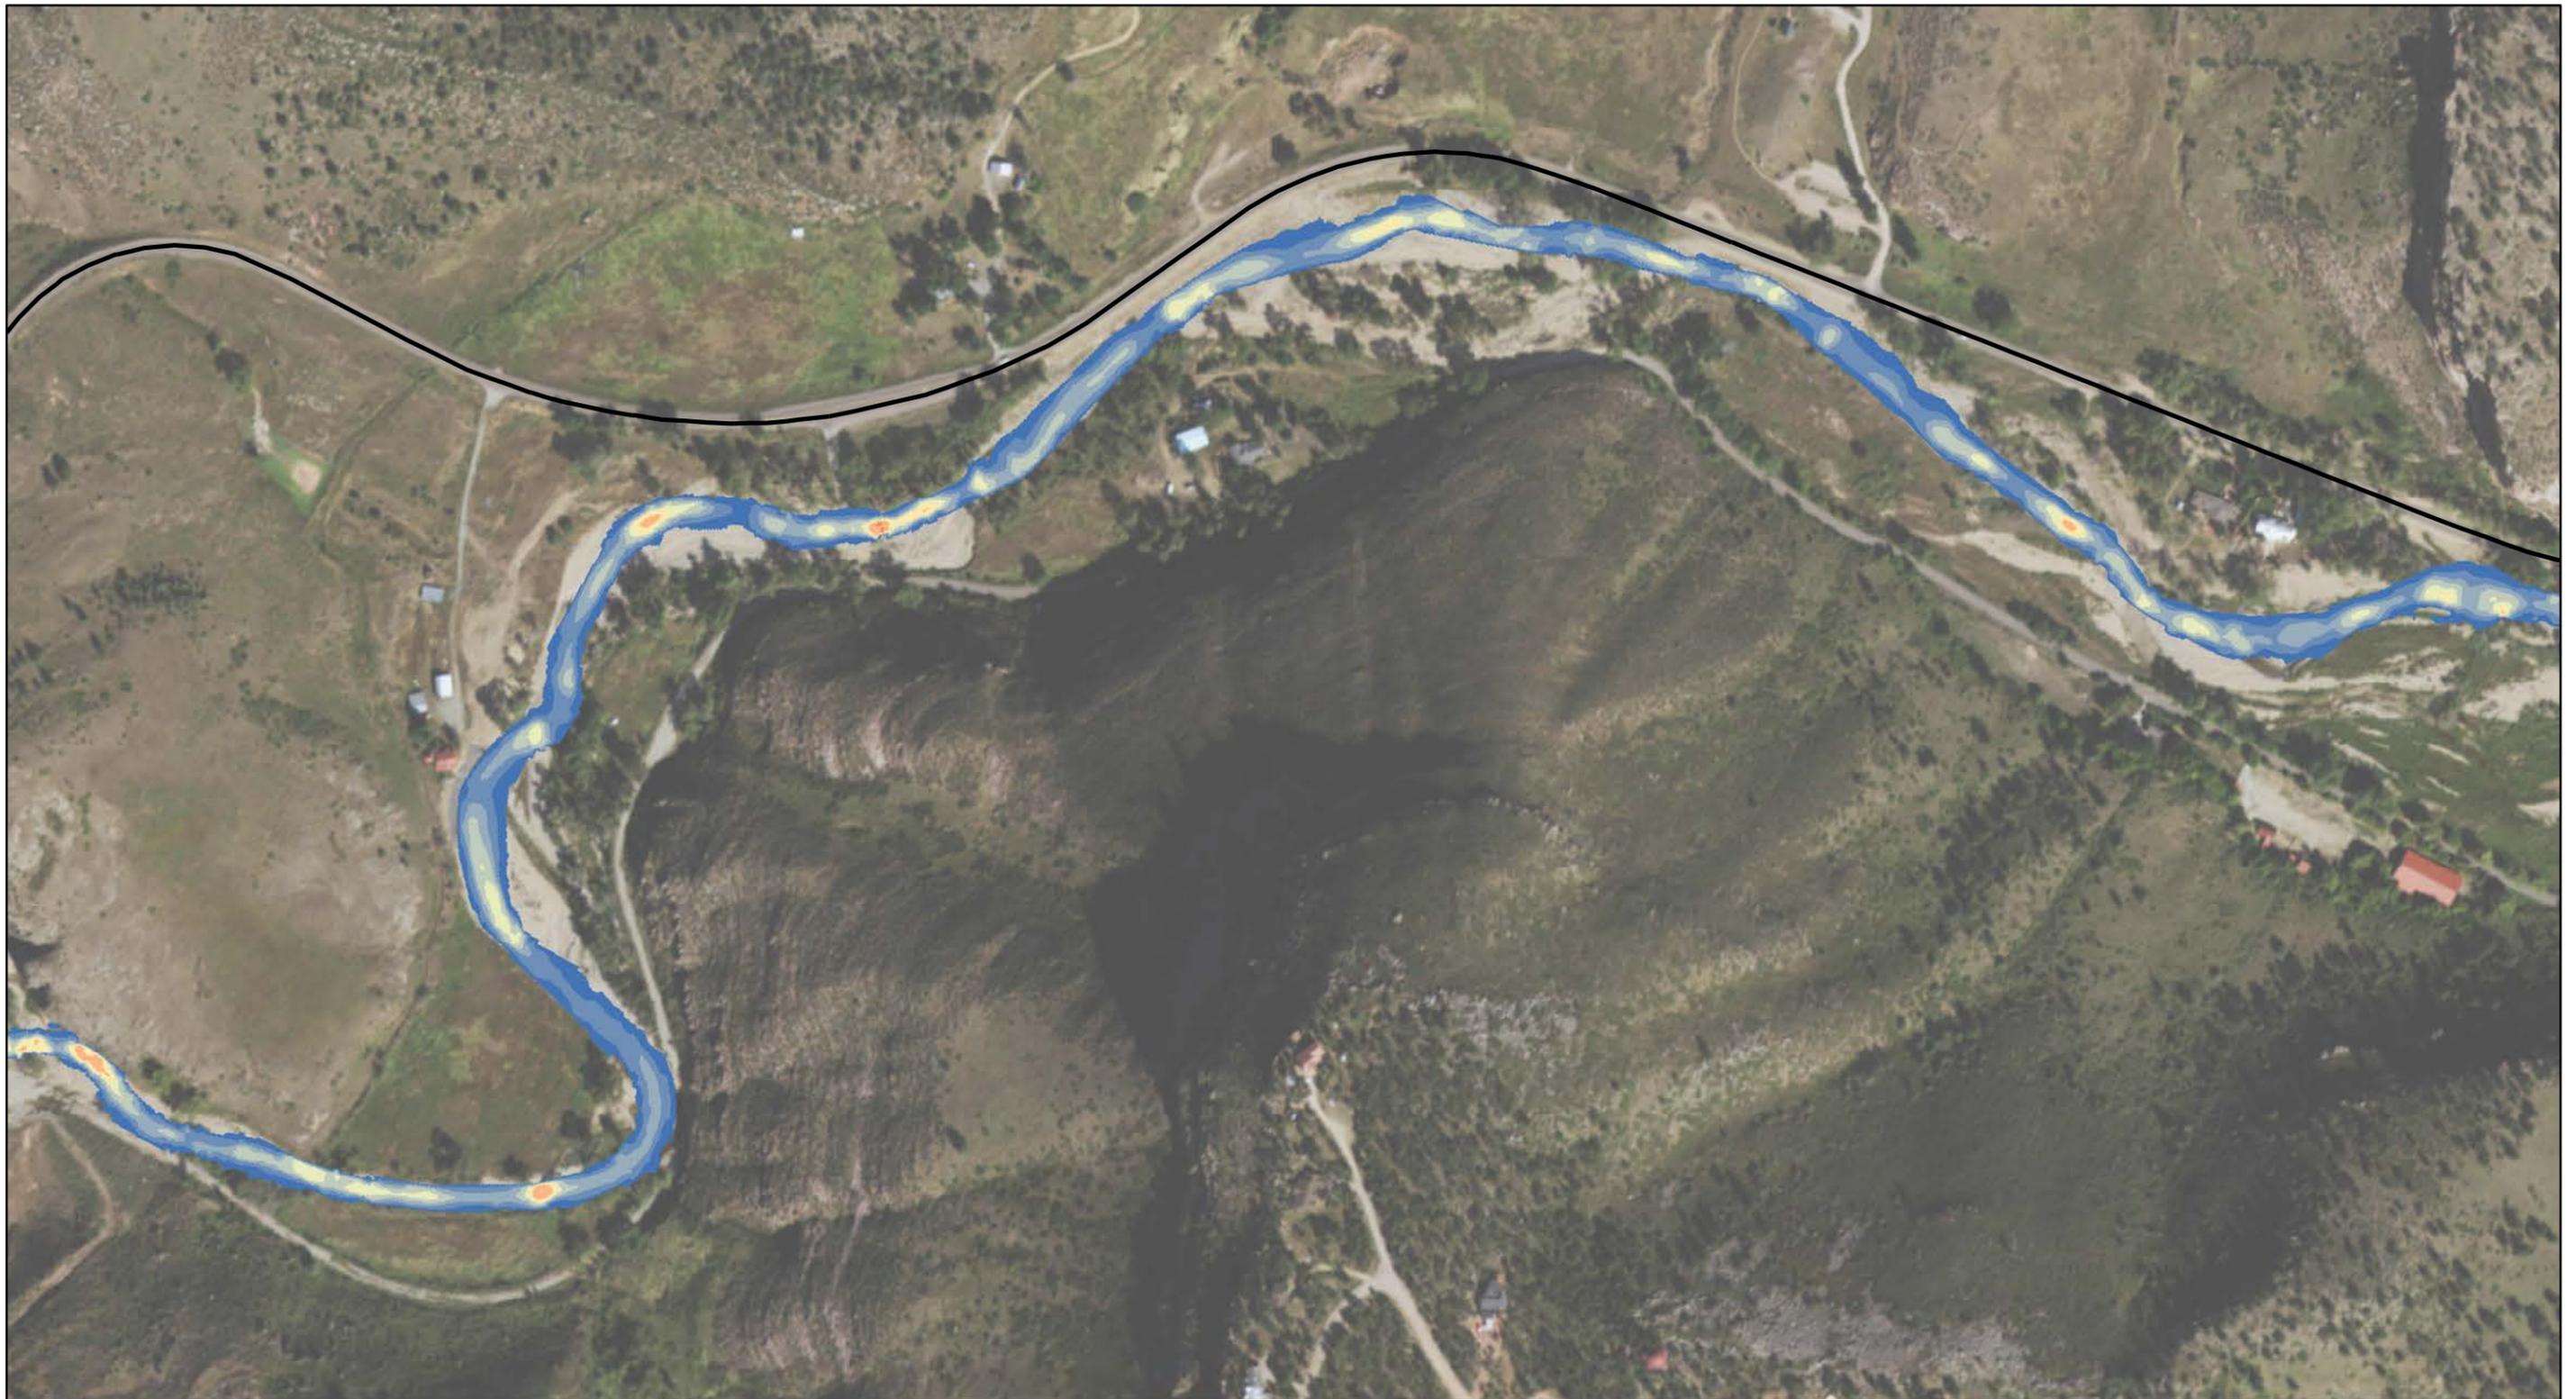
1.5 YEAR FLOW  
**MAP  
2**

**1.5yr Stream Power**

**EXISTING CONDITIONS  
STREAM POWER MAPBOOK  
1.5 YEAR FLOW**
