# Preliminary Basis of Design Report

## For South St. Vrain Creek Restoration at Hall Ranch

**Boulder County, Colorado**

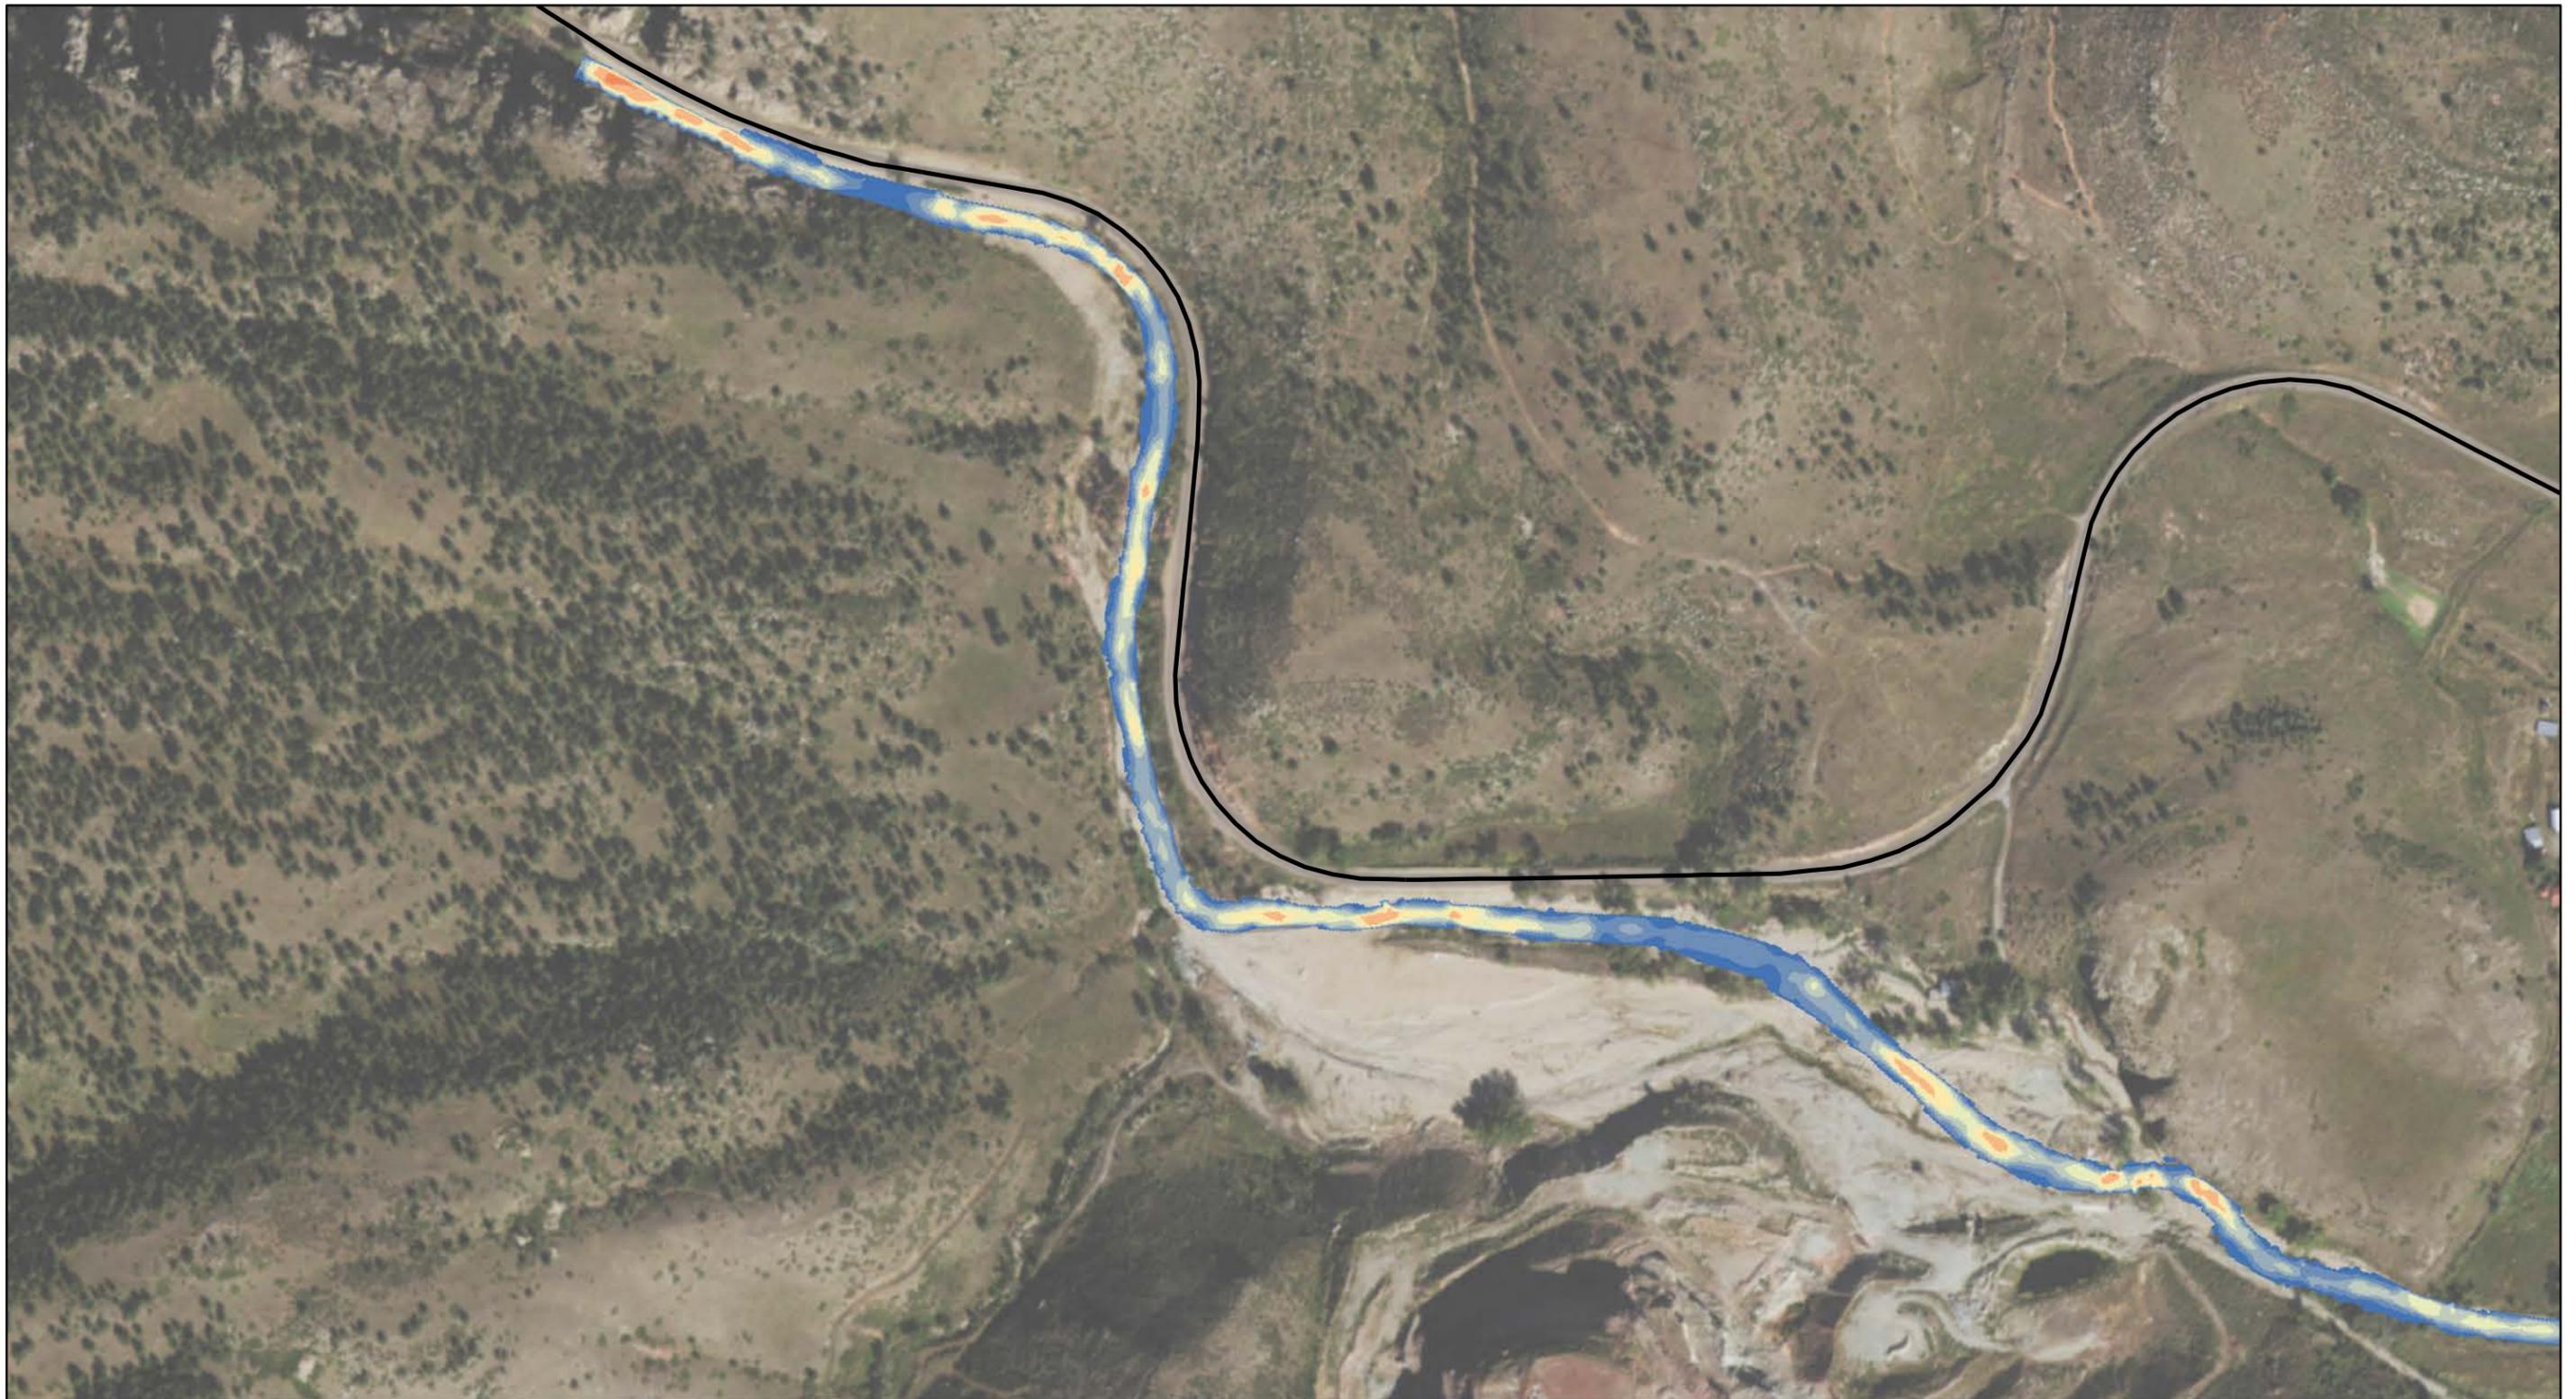
1.5 YEAR FLOW  
**MAP  
3**

**1.5yr Stream Power**

**EXISTING CONDITIONS  
STREAM POWER MAPBOOK  
1.5 YEAR FLOW**

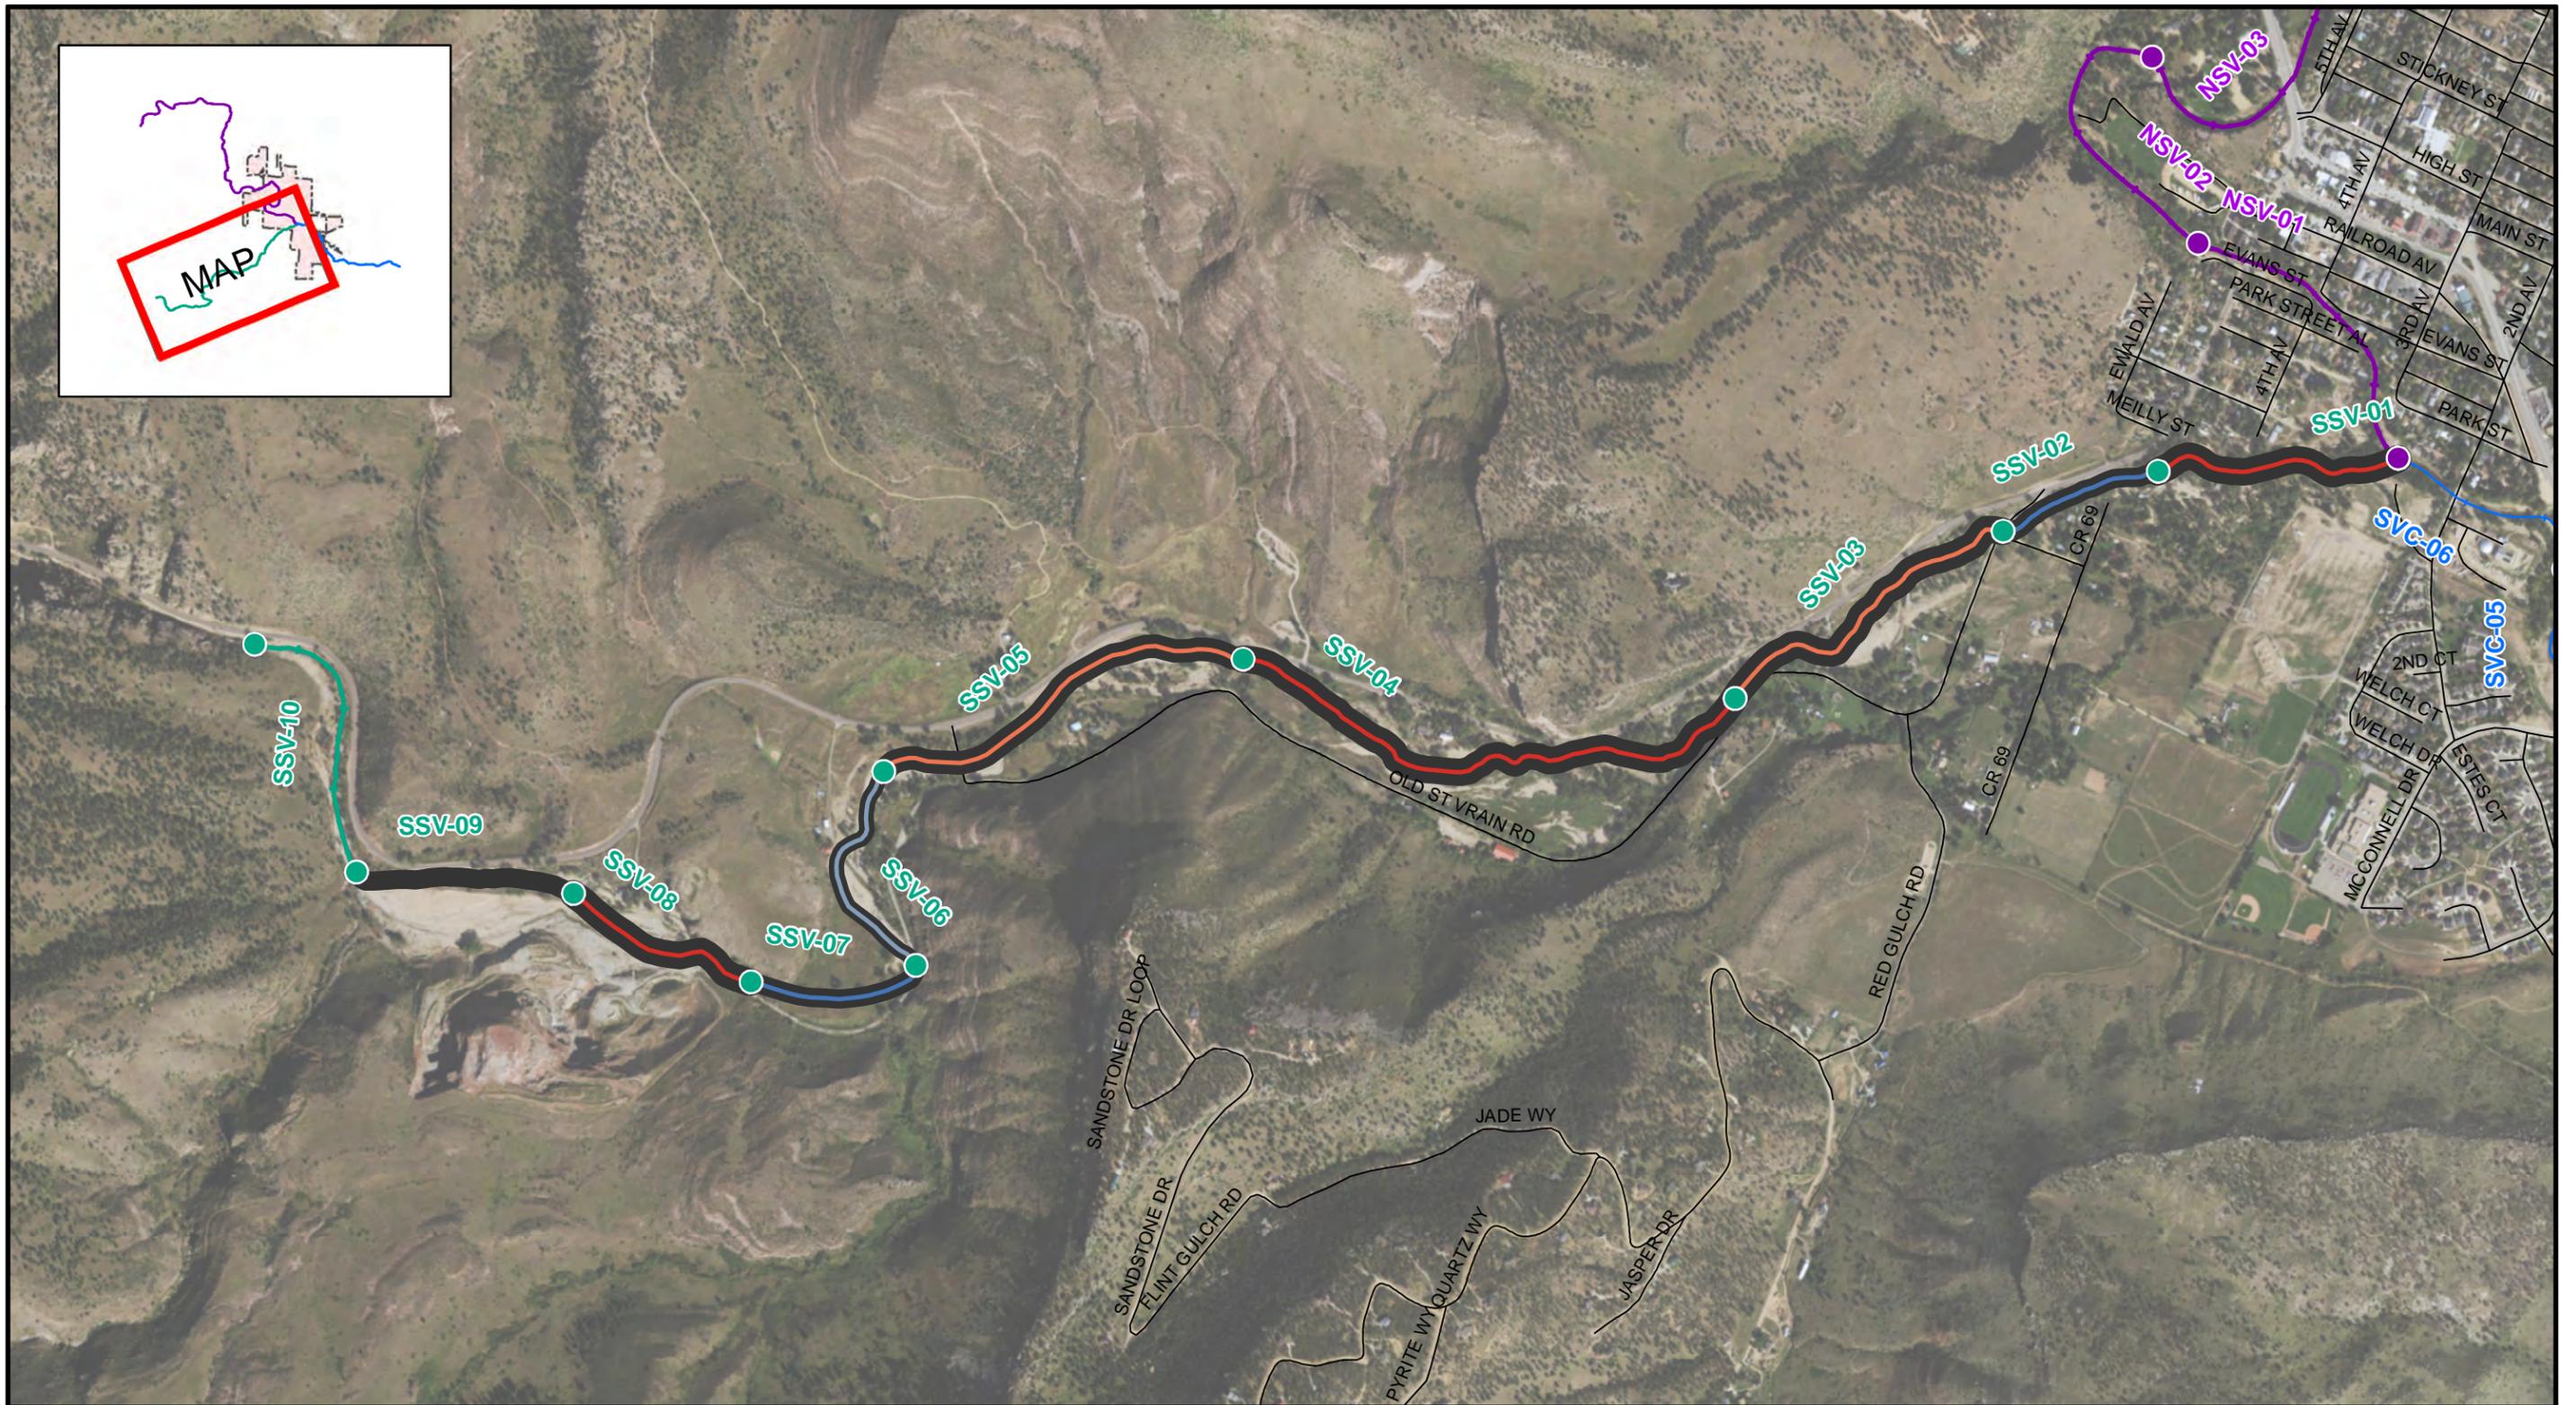
**2yr Transport Capacity Balance (tons/hr)**

EXISTING CONDITIONS  
SEDIMENT TRANSPORT CAPACITY AND BALANCE

**2 YEAR FLOW**

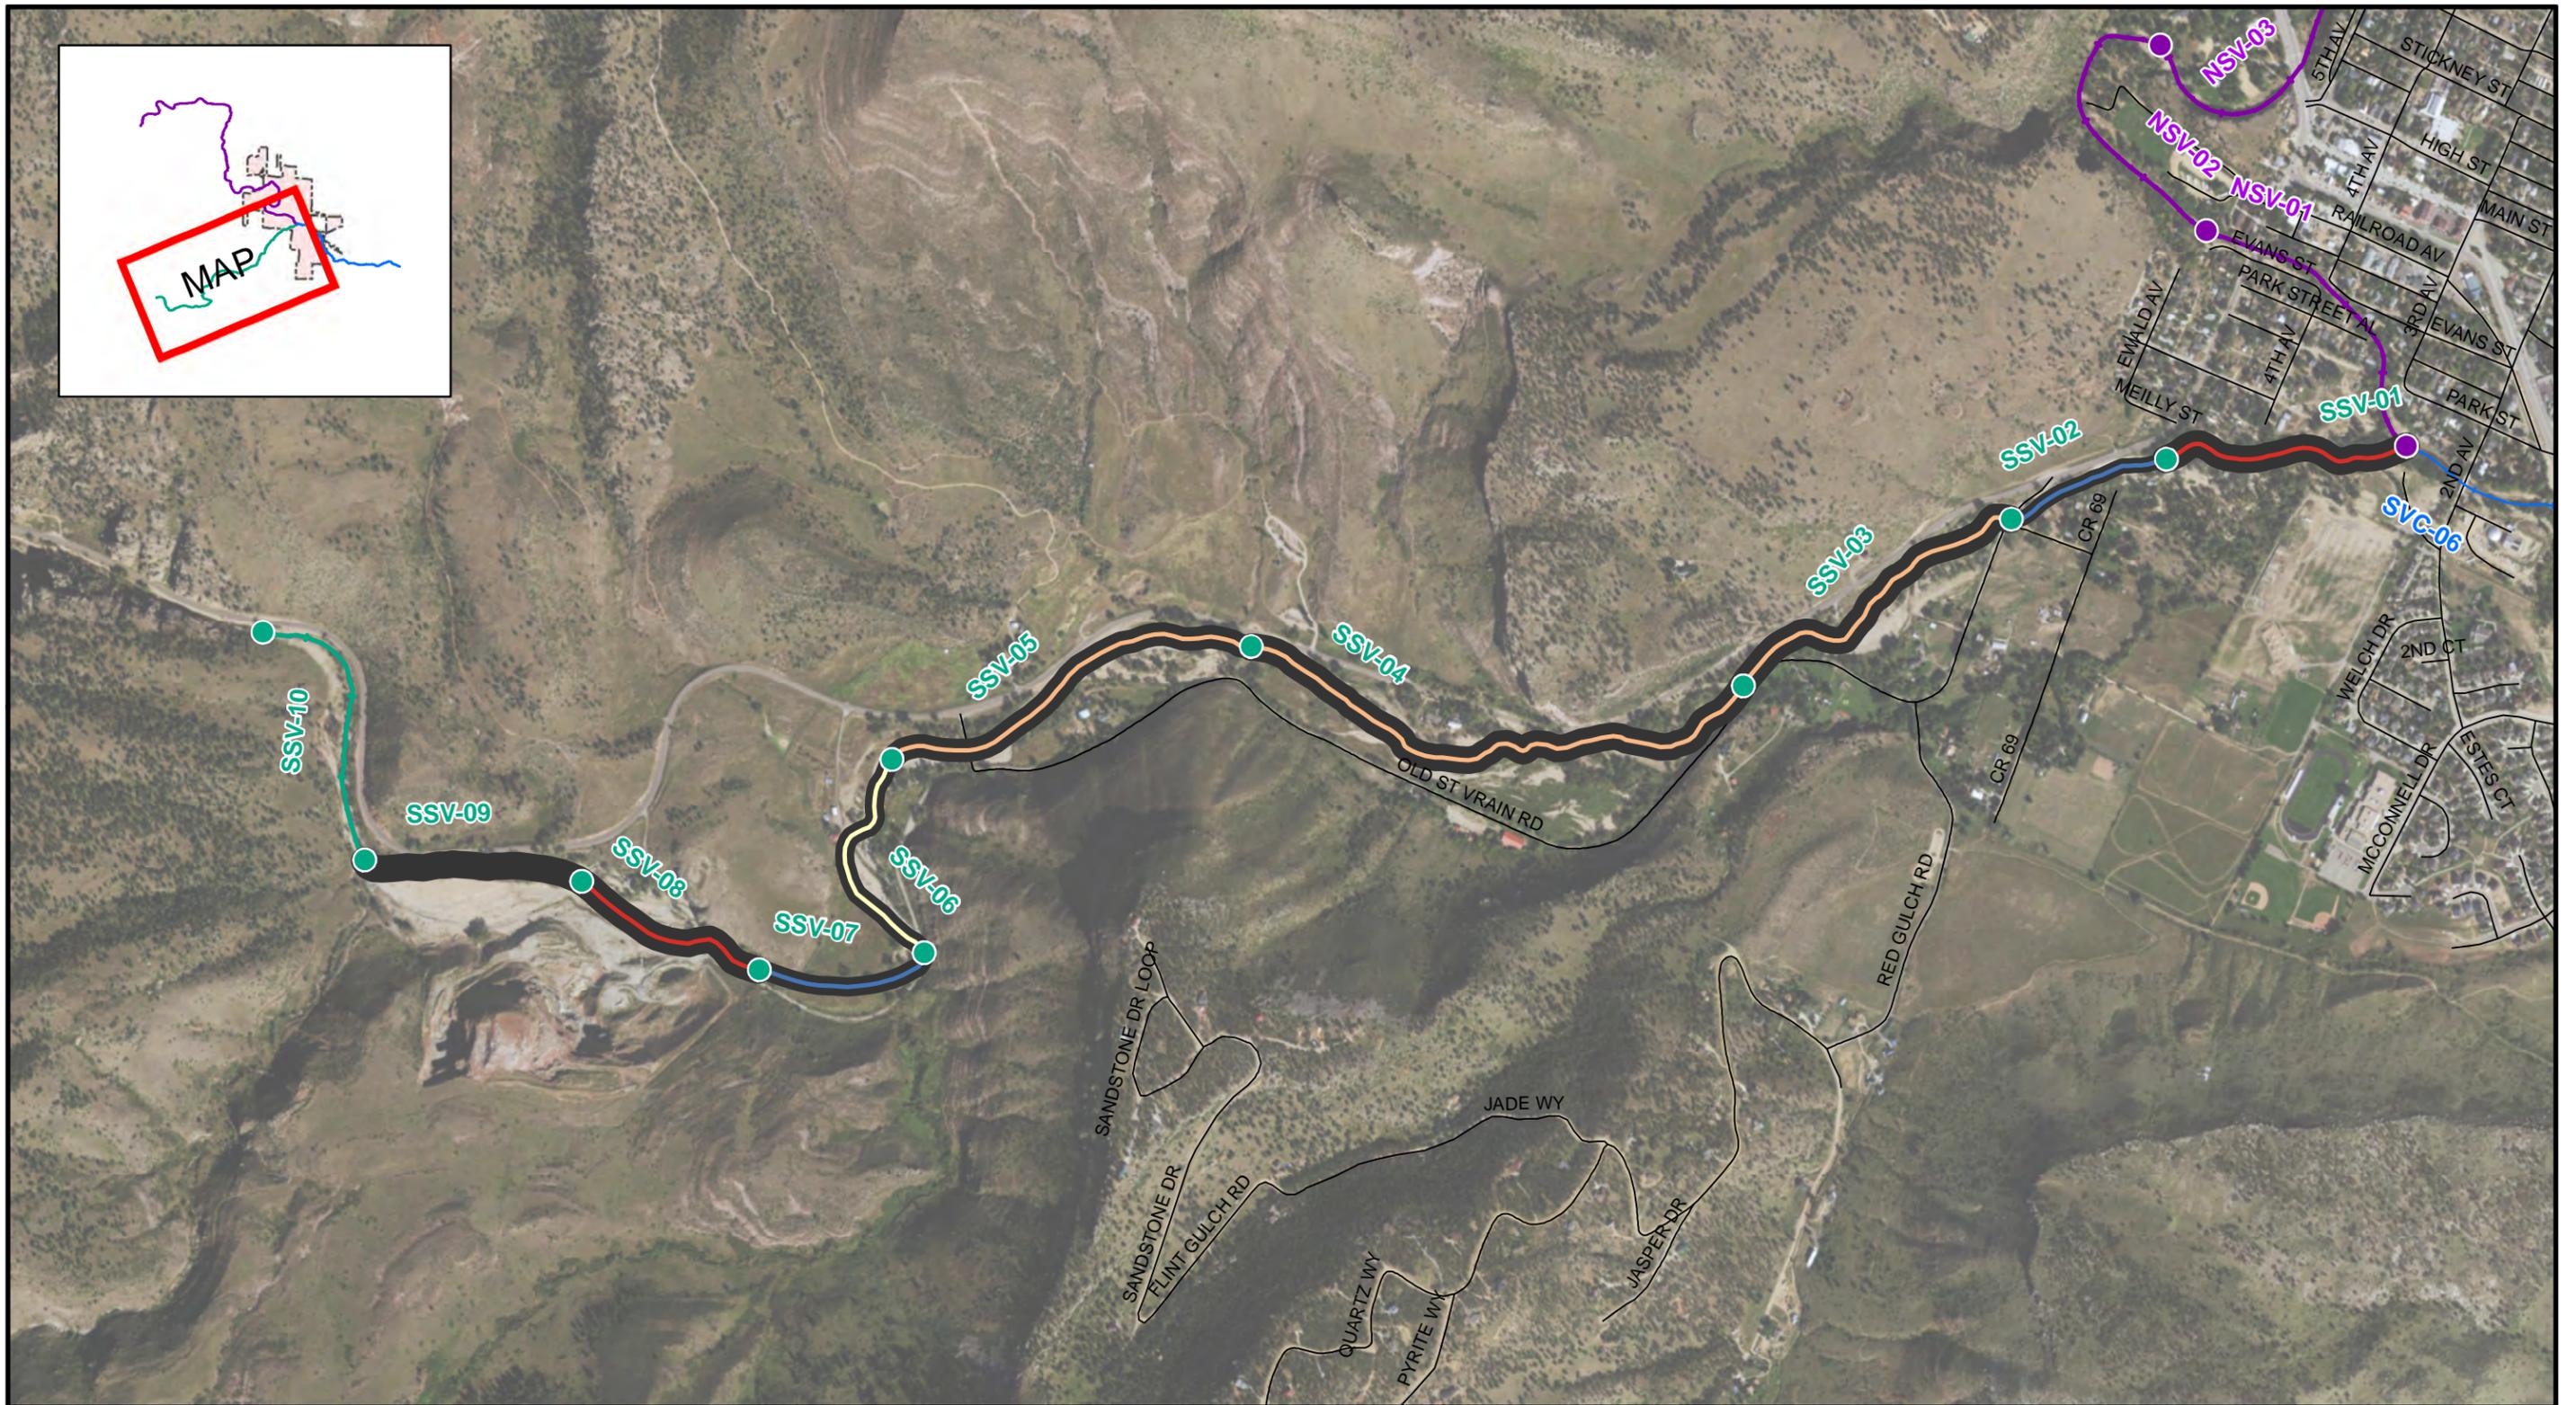
**2yr Transport Capacity Balance (tons/hr)**

Degradation    Aggradation

PROPOSED CONDITIONS  
SEDIMENT TRANSPORT CAPACITY AND BALANCE

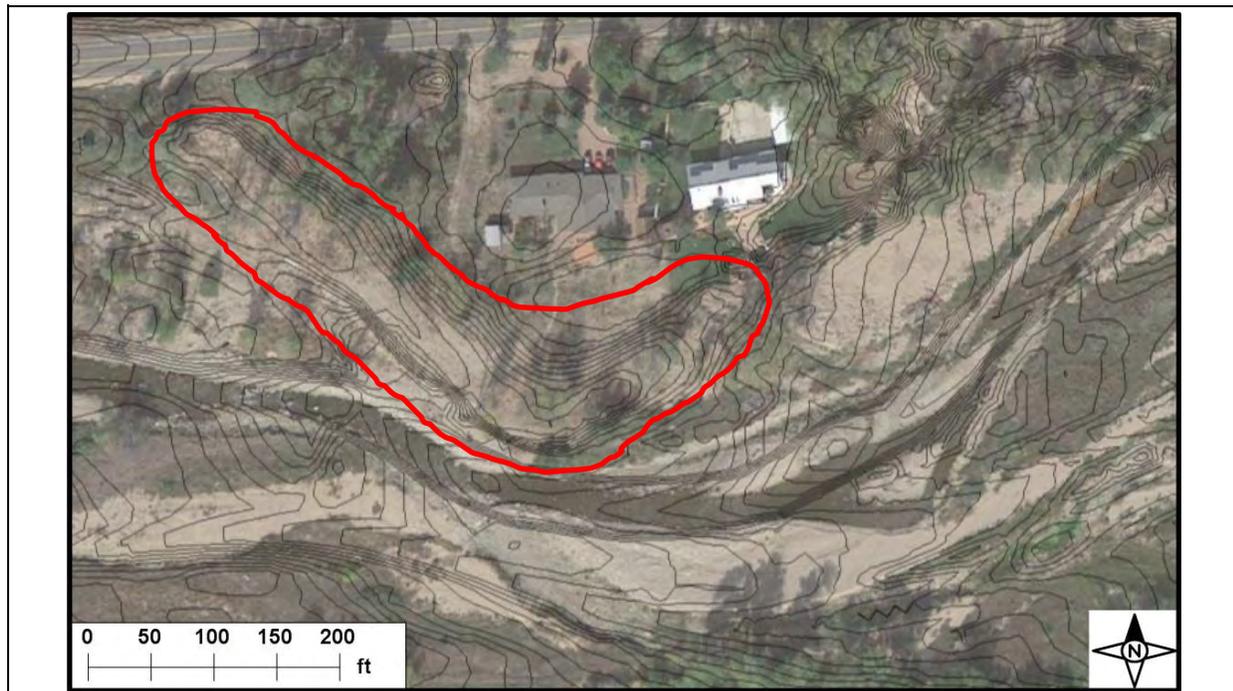
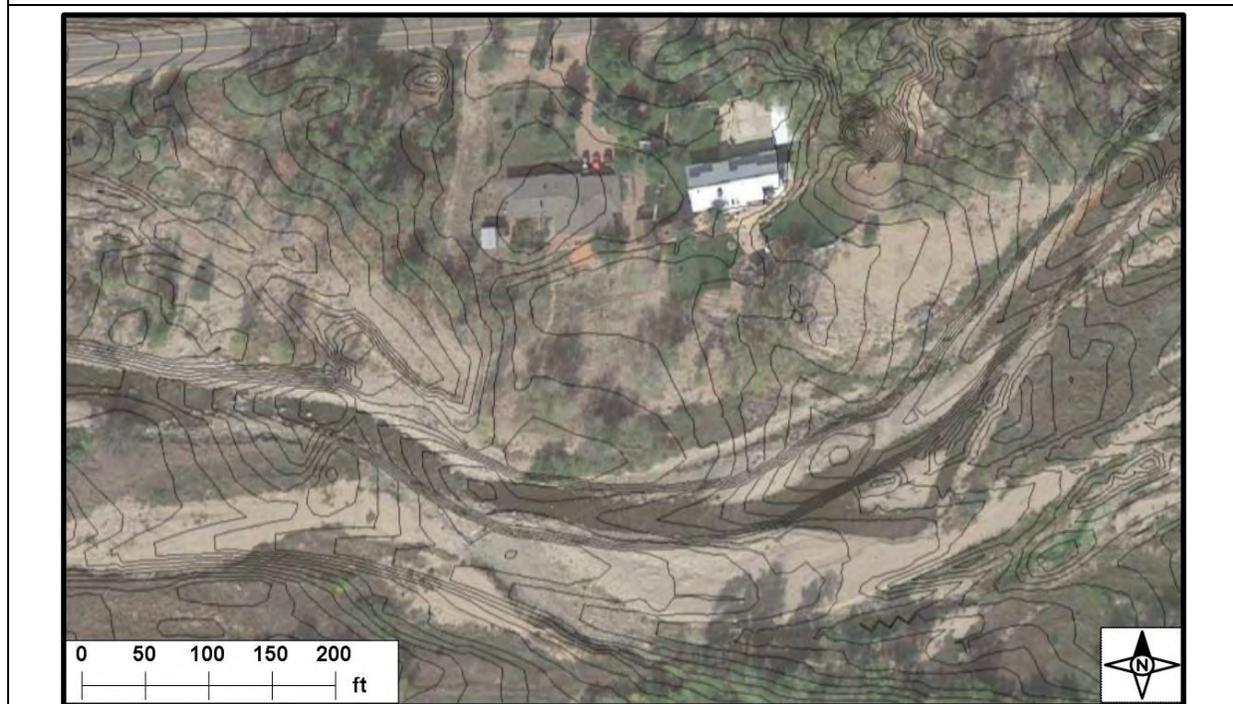
A)

B)

**Figure 1.** Contour map showing focus area with the berm (A) and without the berm (B). The approximate extent of the berm has been outlined in red in (A).

The no-berm scenario was developed on the proposed conditions (PC) terrain model by removing the berm from the data. Removal of the berm was accomplished by identifying points on flat ground adjacent to the berm and straight-grading between them (Figure 1). Therefore, the terrain does not represent a designed condition. In the event that a decision is made to remove the berm, the bank and adjacent will undergo a design process aimed to reconfigure the area to align with the project goals. Simulation boundary conditions in SRH-2D (Lai, 2008) were setup following the methods outlined in the Preliminary Basis of Design Report (Matrix, 2016). Design flows were run to a stable solution for both berm and no-berm scenarios. Results from selected flows are presented below.

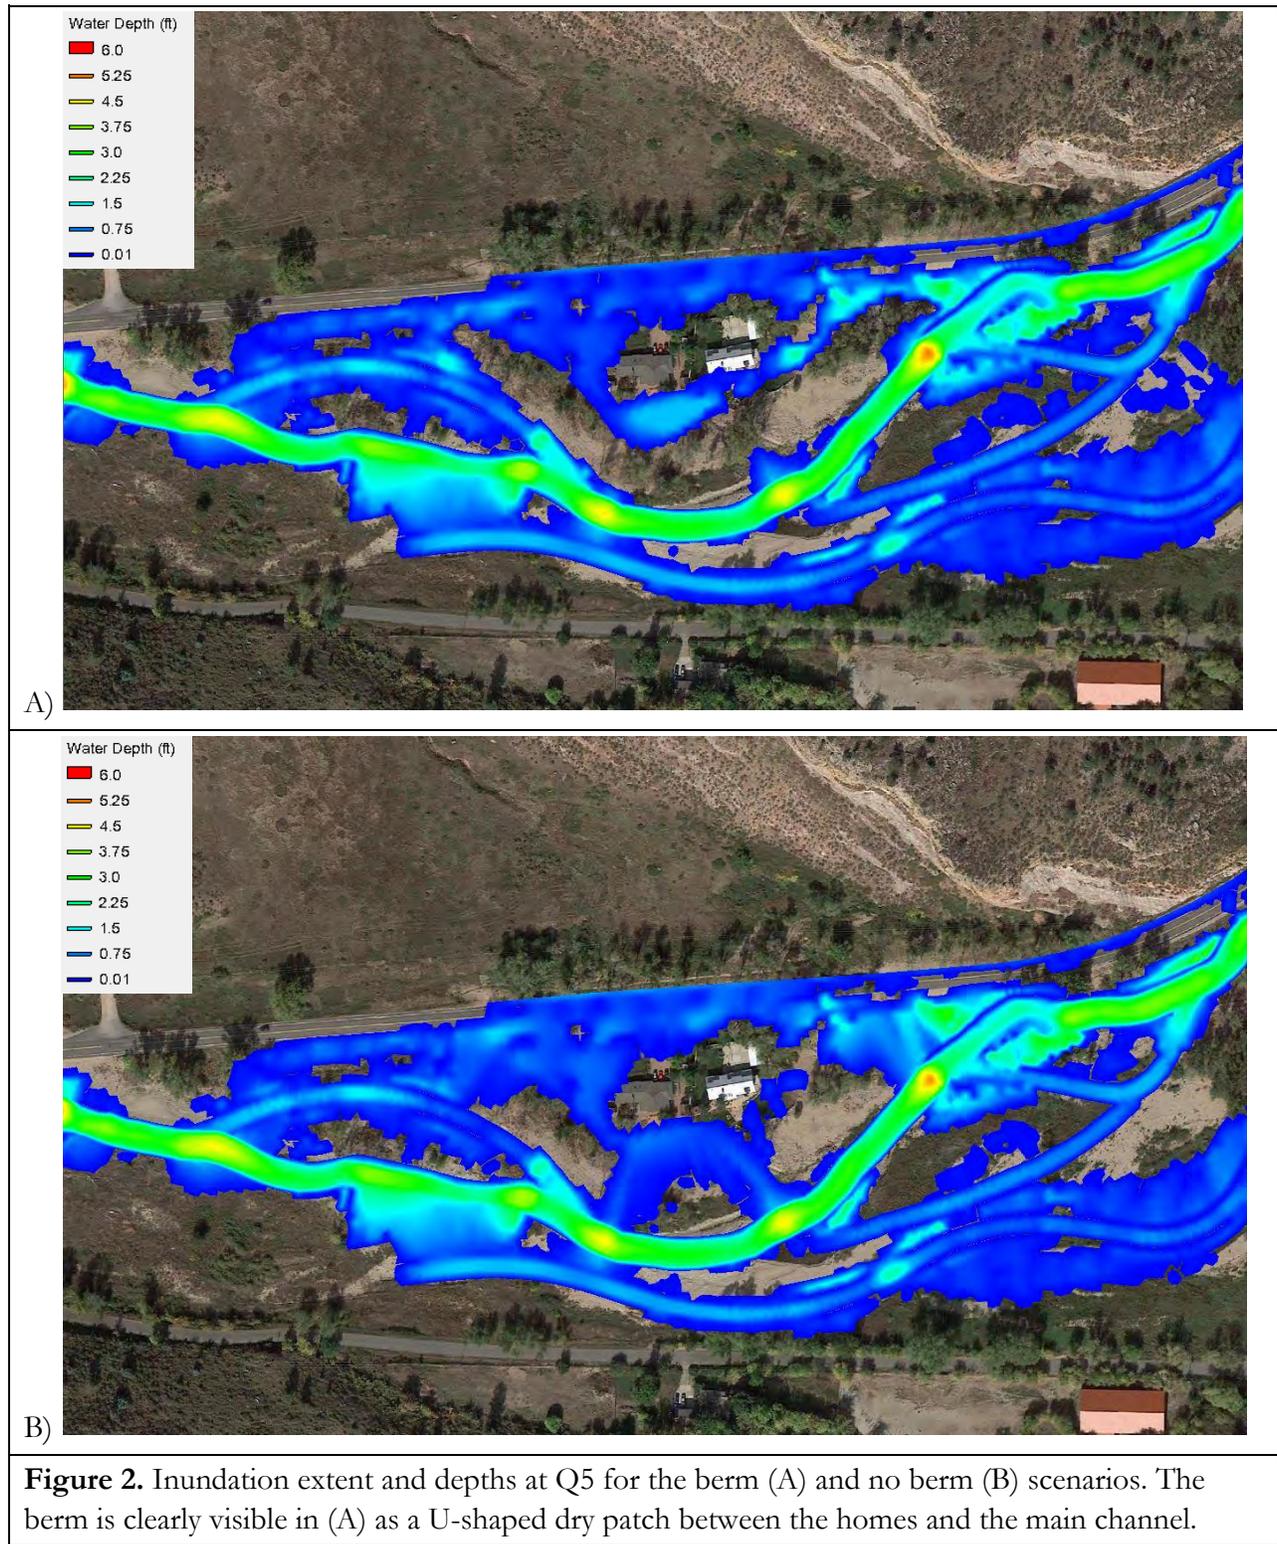
**Figure 2.** Inundation extent and depths at Q5 for the berm (A) and no berm (B) scenarios. The berm is clearly visible in (A) as a U-shaped dry patch between the homes and the main channel.

Figures 2 through 6, below, show inundation extents and depths for the range of design flows examined in this analysis. Figure 7 shows plots of velocity sampled from the model output down the main channel and water surface elevation (WSE) across the floodplain as shown in Figure 7(A). The blue line, denoted A-A' is the cross section and the yellow profile line, denoted B-B', is the location of the velocity data sampled along the profile.

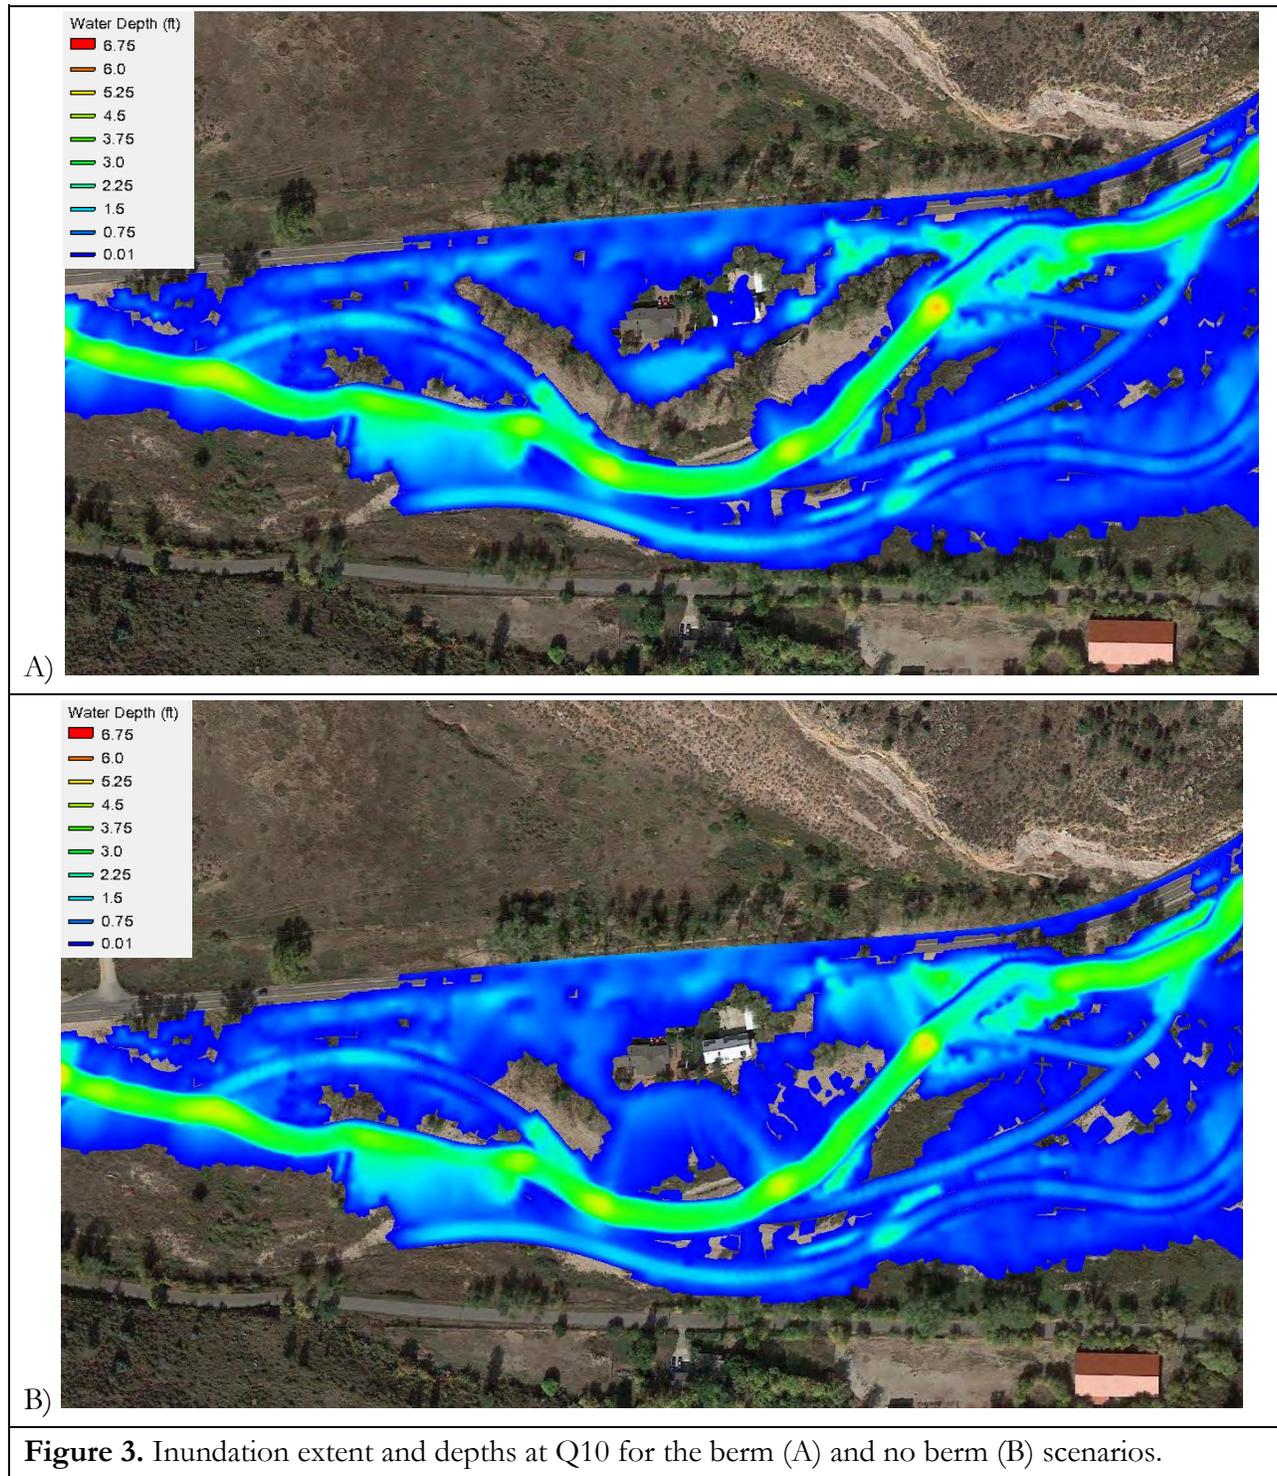
**Figure 3.** Inundation extent and depths at Q10 for the berm (A) and no berm (B) scenarios.

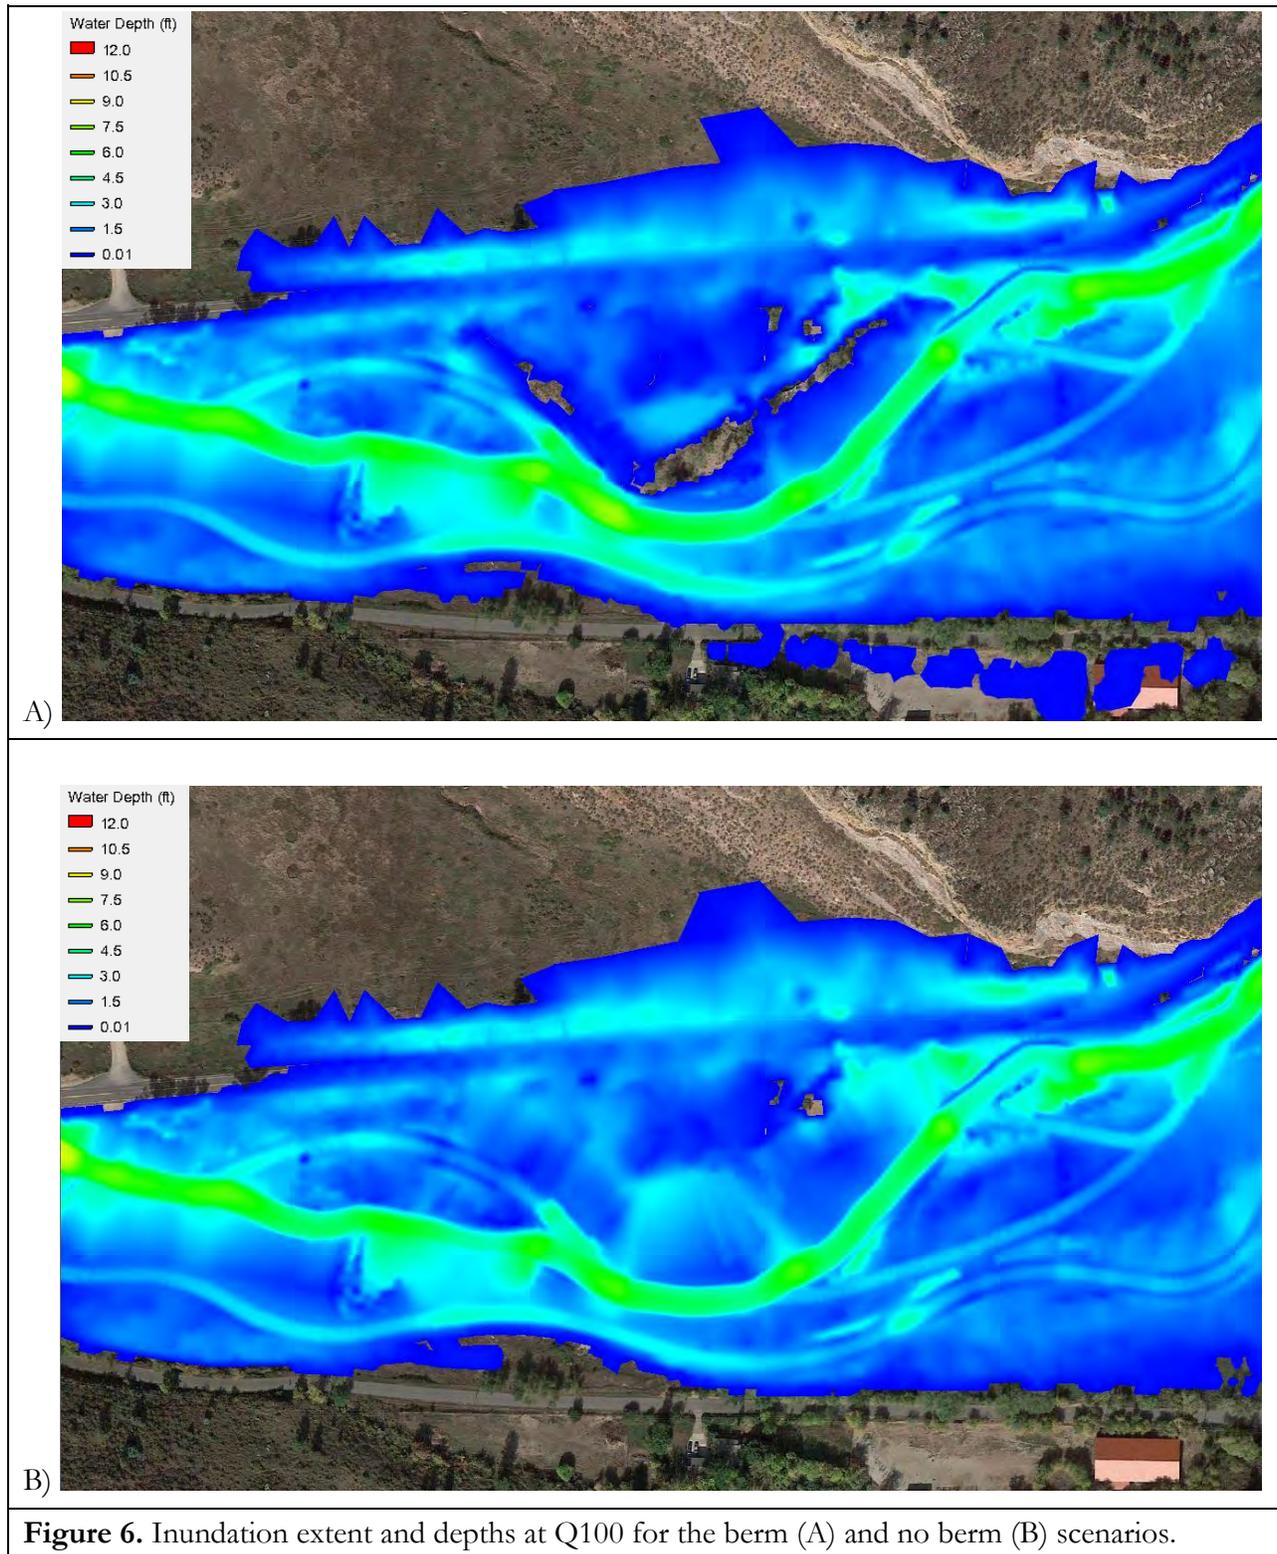
**Figure 6.** Inundation extent and depths at Q100 for the berm (A) and no berm (B) scenarios.

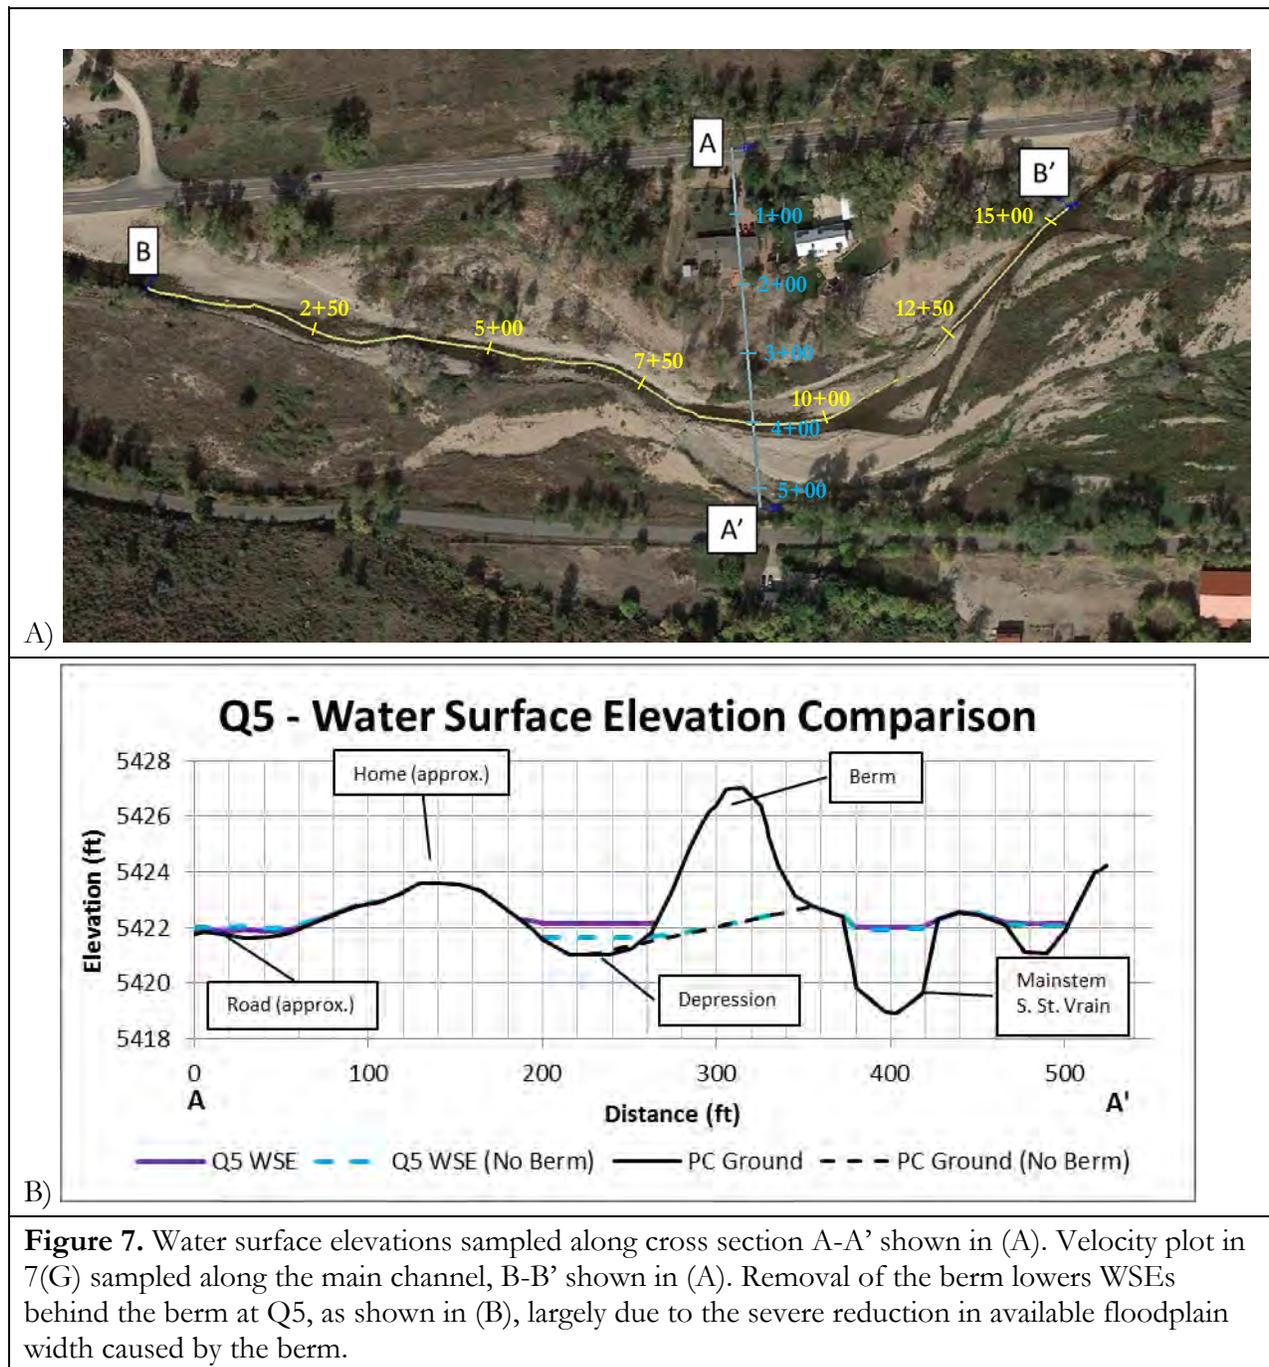
**Figure 7.** Water surface elevations sampled along cross section A-A' shown in (A). Velocity plot in 7(G) sampled along the main channel, B-B' shown in (A). Removal of the berm lowers WSEs behind the berm at Q5, as shown in (B), largely due to the severe reduction in available floodplain width caused by the berm.

As can be seen in Figure 7 (B) (C) and (D) for Q5 through Q25, removal of the berm lowers WSEs (e.g., ~0.4 ft at Q10) in the locations around the house (behind the existing berm). This behavior can be attributed to flow flanking around the northwest end of the berm and ponding behind the berm. This flanking of the berm is seen at all evaluated flows, starting with Q5. Removal of the berm provides an easier path back to the channel and also spreads flow out, lowering the water surface elevations. At higher discharges, Q50 and Q100 (Figure 7 E, F), the berm holds more flow in the main channel, causing elevated water surface elevations in the main channel. When the berm is removed, those higher discharges spread across the floodplain, decreasing WSEs in the main channel (e.g., ~1.0 ft at Q100) and increasing WSEs (e.g., ~0.4 ft at Q100) in the location behind the berm.

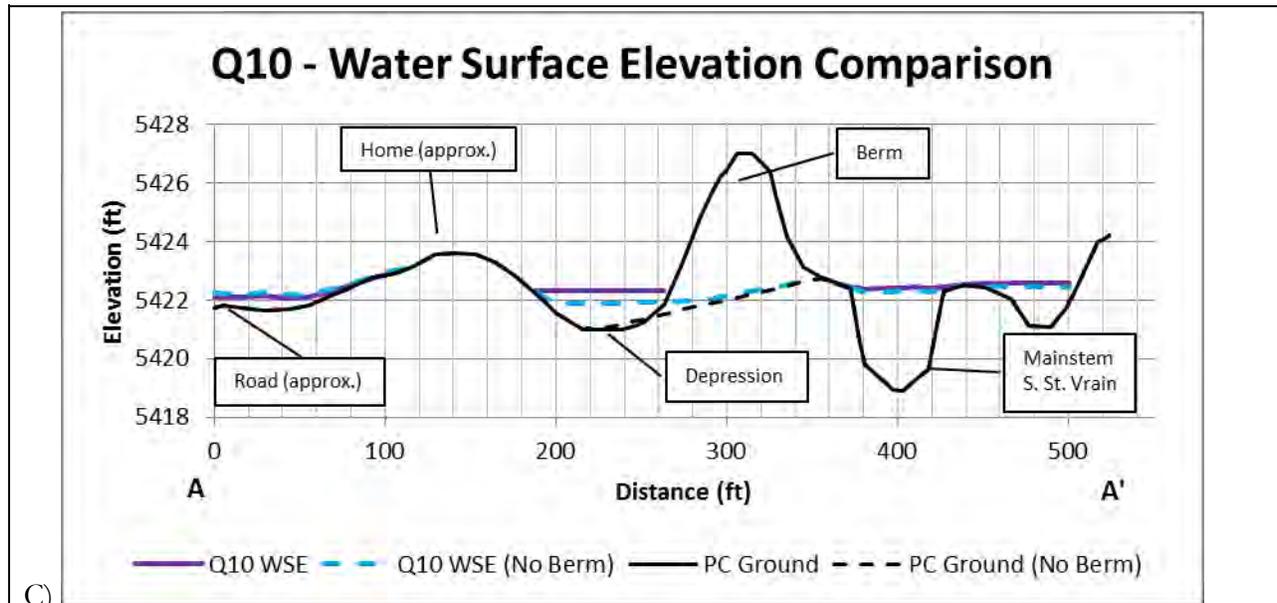
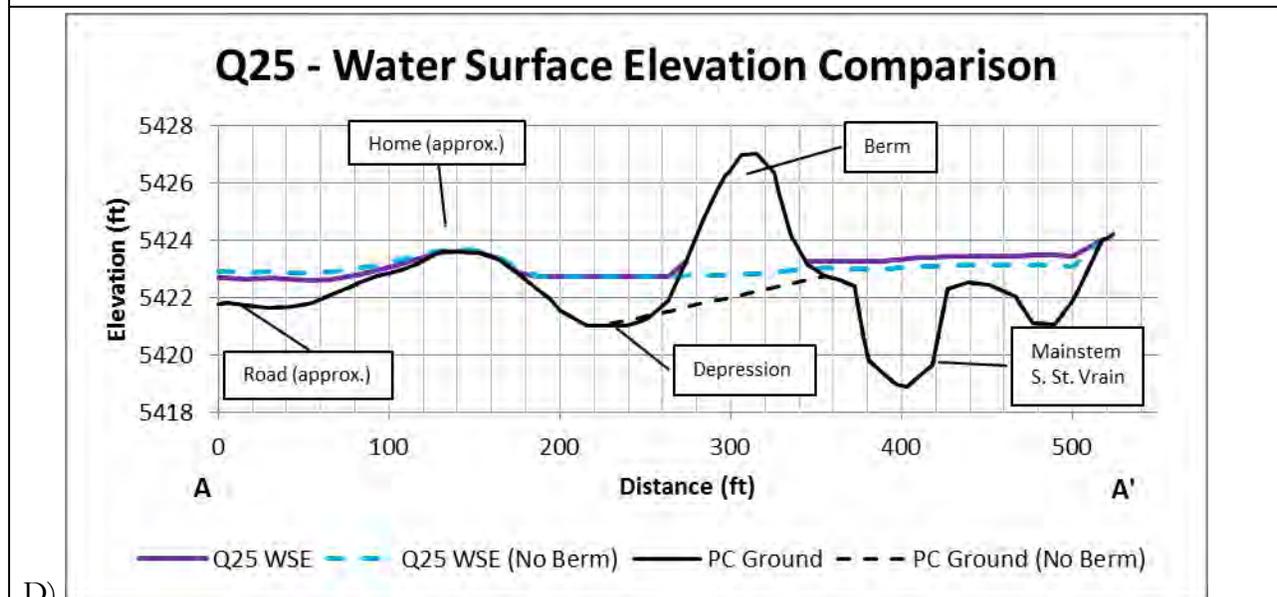
C)

D)

**Figure 7** (continued). At Q25, removal of the berm lowers WSEs in the main channel but has little effect on WSEs behind the berm (D).
