# Preliminary Basis of Design Report

## For South St. Vrain Creek Restoration at Hall Ranch

**Boulder County, Colorado**

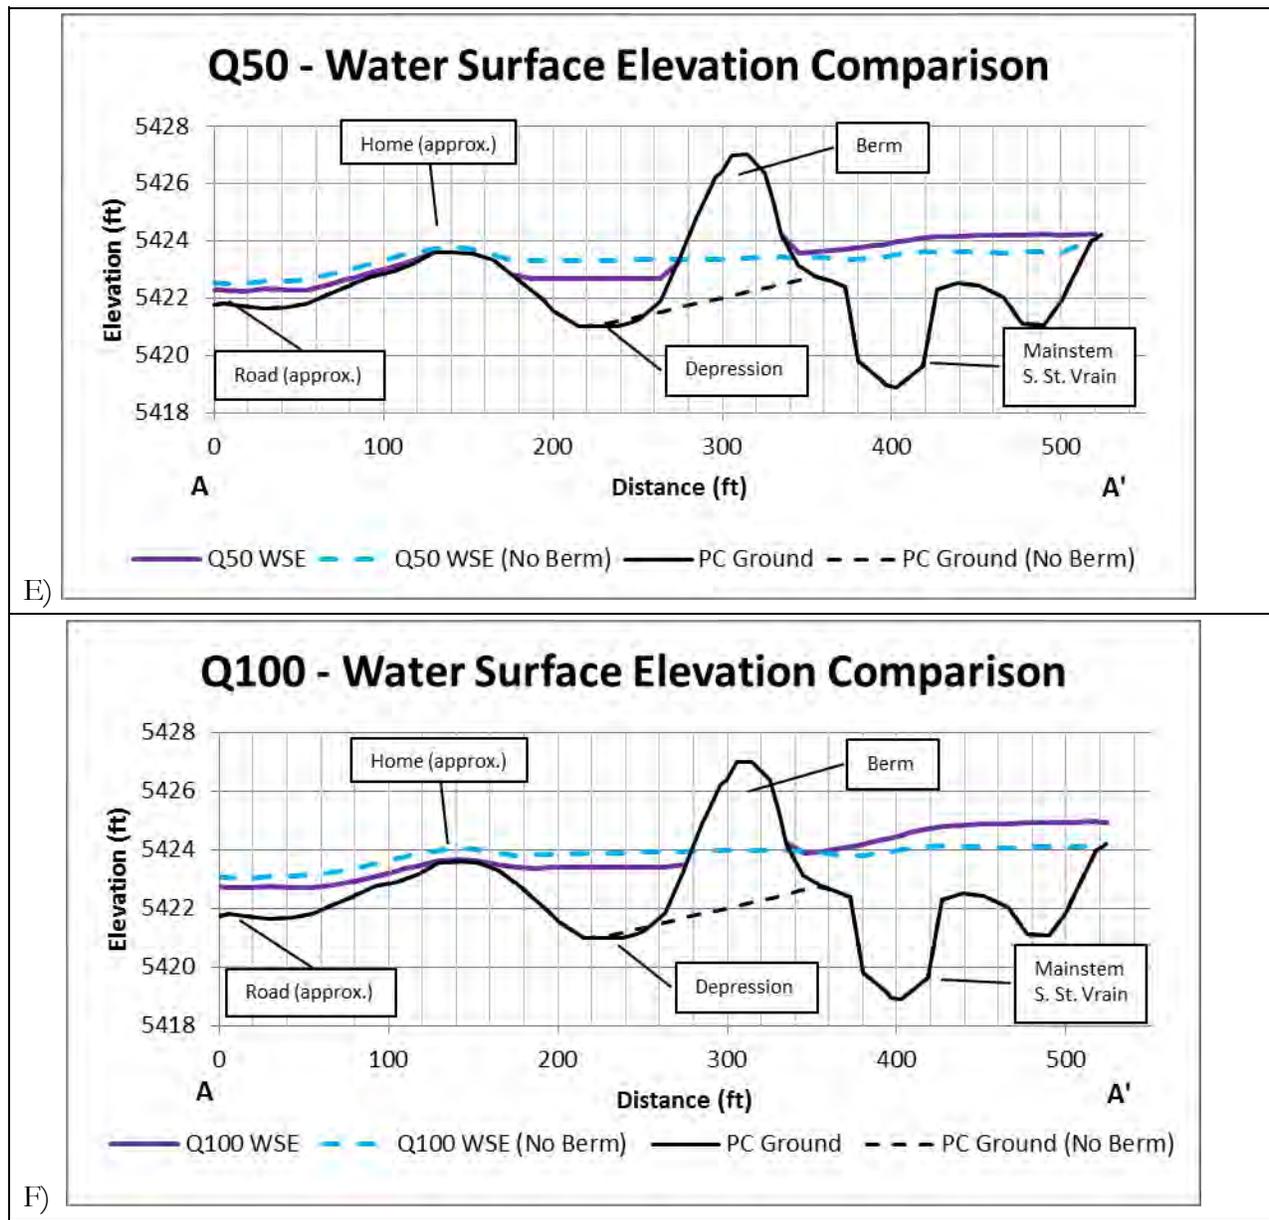
**Figure 7** (continued). At higher magnitude events, removal of the berm lowers WSEs in the main channel but raises WSEs behind the berm (E), (F) because the berm may hold more flow in the main channel, while its removal spreads flow across the floodplain. At the higher magnitudes shown in (E) and (F), it is not likely that the berm will remain intact – the model assumes a fixed bed.

As can be seen in Figure 7 (B) (C) and (D) for Q5 through Q25, removal of the berm lowers WSEs (e.g., ~0.4 ft at Q10) in the locations around the house (behind the existing berm). This behavior can be attributed to flow flanking around the northwest end of the berm and ponding behind the berm. This flanking of the berm is seen at all evaluated flows, starting with Q5. Removal of the berm provides an easier path back to the channel and also spreads flow out, lowering the water surface elevations. At higher discharges, Q50 and Q100 (Figure 7 E, F), the berm holds more flow in the main channel, causing elevated water surface elevations in the main channel. When the berm is removed, those higher discharges spread across the floodplain, decreasing WSEs in the main channel (e.g., ~1.0 ft at Q100) and increasing WSEs (e.g., ~0.4 ft at Q100) in the location behind the berm.

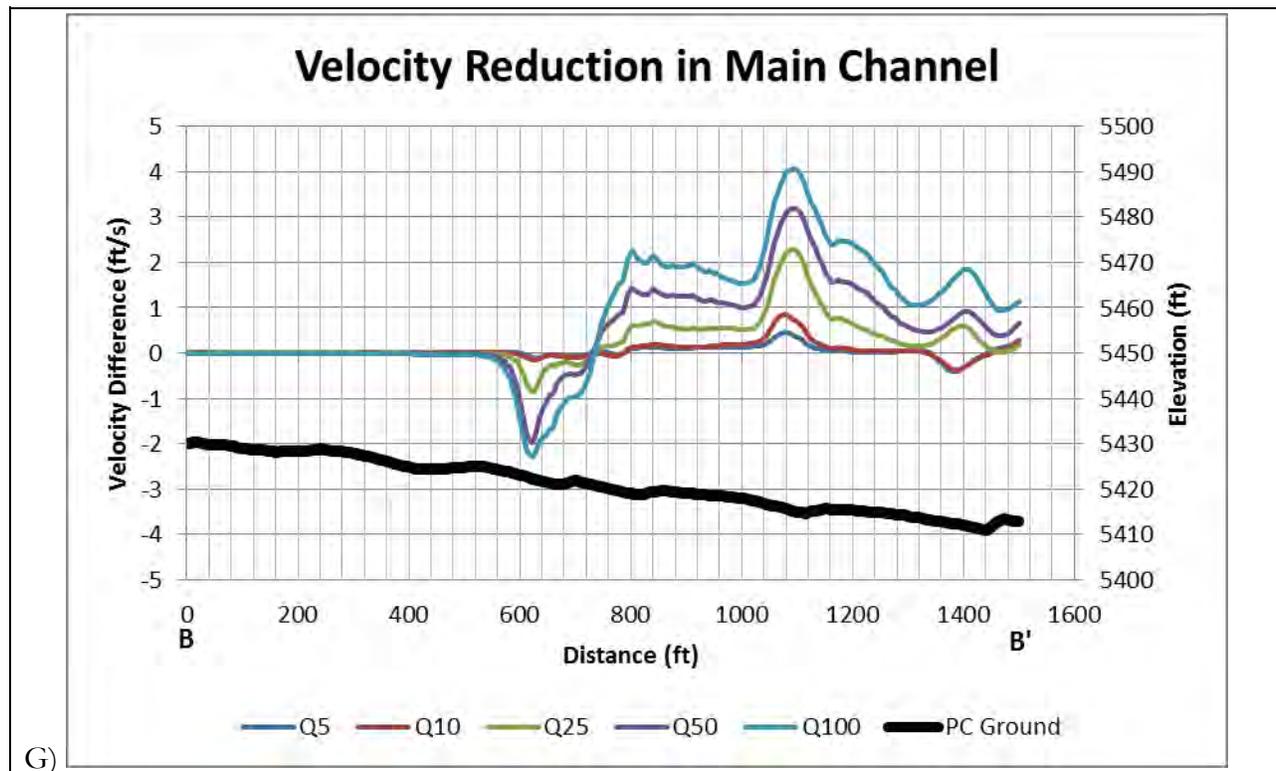
**Figure 7** (continued). Velocity reduction was calculated along profile line B-B' shown in 7(A) by subtracting velocity from the no-berm scenario from the with berm scenario. Negative values indicate an increase in velocity and positive values indicate a velocity reduction. Removal of the berm removes a constriction from the floodplain, reducing backwater and locally increasing velocity (distance 600 ft) upstream of the berm, at the location of a riffle. Velocity adjacent to and downstream of the berm is reduced (G).

Figure 7 (G) shows the difference in velocity between the berm and no berm scenarios, as sampled in the main channel along B-B'. Positive numbers along the left vertical axis mean a decrease in velocity while negative numbers equal an increase in velocity. The model results suggest that the berm has a backwater effect at flows above Q10, as velocities locally increase (e.g., ~2 ft/s at Q100) upon removal of the berm just upstream of the berm location. Closer to the berm location, velocities decrease (e.g., ~4 ft/s at Q100) upon removal of the berm. For reference, under the with berm scenario, in-channel velocities range from 13-15 ft/s and are reduced to 9-11 ft/s under the no berm scenario.
